Design of safe timber structures – how can we learn from structural failures?

Collapses in Sweden 2010

Eva Frühwald Hansson
Division of Structural Engineering, Lund University

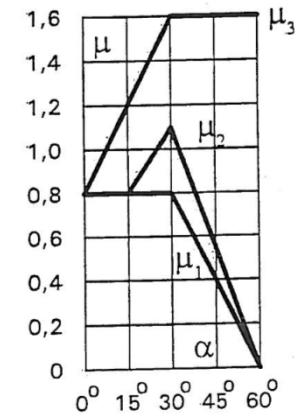
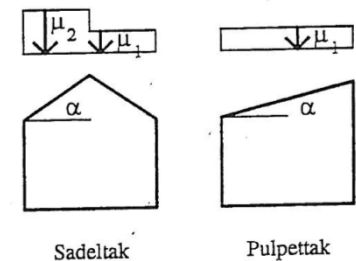
Snowy winter 1976-1977

- Not more snow than in the code (1 exception)
- No occasional thawing and wind from north/east during the whole snowing period led to large snowdrifting → highly nonsymmetrical snowloads
- Nonsymmetrical snow loads even for roofs with low inclination (not at all in Swedish standard; non-symmetry larger than in Eurocode)
- Measured snow load on roof equals snow load on ground (in the standard, a form factor of 0.8 is used?!)
- Large differences in snow depth for large roofs

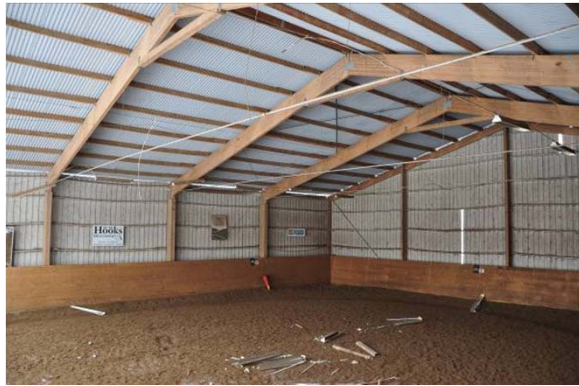
Example 1: error on building site

Three-hinged frame, tension rod

Missing anchor plate leading to
the nut being drawn through
the glulam beam

Collapse after 18 years

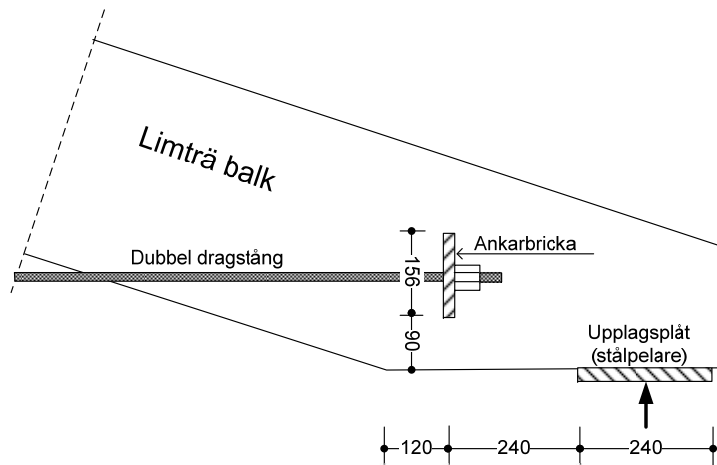
Example 2: error of design

Eccentricity between tension rod connection and steel column

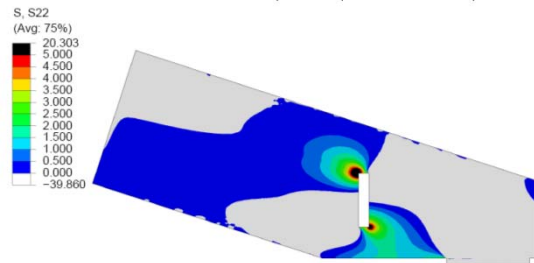
→ high tension stresses perpendicular to grain

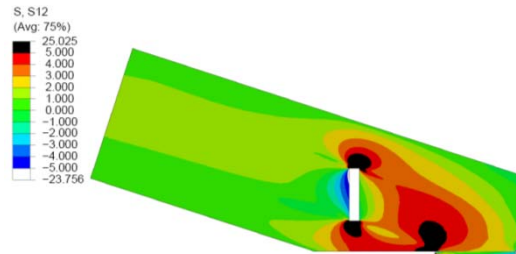
→ High shear stresses
