Structural safety and robustness of connections in wide-span timber structures – evaluation of an exemplary truss system

Philipp Dietsch, Peter Mestek, Stefan Winter, Heinrich Kreuzinger

Abstract

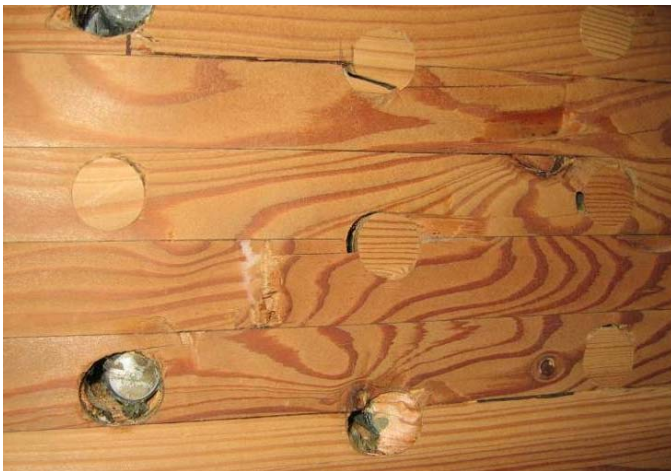
During the inspection of the lower flanges inside the window strips, large cracks were identified which had developed around the steel-plate connection, forming the tension joint in mid-span (see Fig. 3 and 4). The crack pattern indicated failure due to block shear. Horizontal displacements of up to 10 mm between the connection block and the remaining cross-section of the tension member indicated that failure had already advanced considerably.

Fig. 3: Shear and Tension Cracks at the main joint

Reasons for block shear in main tension joints:

- o The truss was calculated under the assumption of pinned connections. The calculation neglected the bending stiffness of the continuous flanges as well as the rotational stiffness of the main joints. The bending moment in the flanges was thereby underestimated by 50%. Combined with a higher reduction of cross-section than assumed, this led to a 65% underestimation of the tension stresses in the lower flange.

- o The substantial rotational stiffness of the main joints results in a bending moment in the connection which leads to a 49% increase of the maximum loads on the fasteners.

- o In a later stage of design, it was decided to move the connection towards the upper surface of the lower flange, thus moving the centroid of the connection away from the centroid line of the glulam flange. The thereby generated bending moment resulted in an additional increase of the loads on fasteners of 51%. This situation was never verified by calculations.

- o The building code in effect during design requests, that for the verification of the timber side-member, the tension load be increased by 50% to account for bending moments due to eccentric load transfer. This verification was not carried out. It is exceeded by 51%. This excess explains the propagation of cracks in tension.

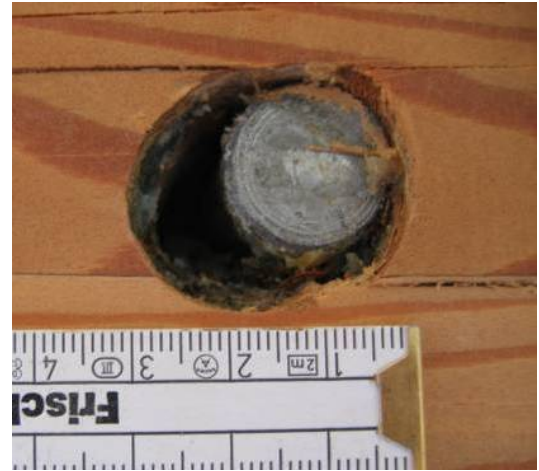
Fig. 4: Indentation of Dowel into Timber

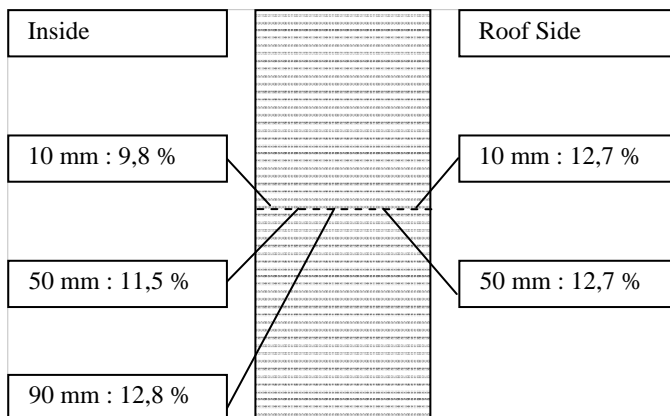
Fig. 5: Moisture Gradient in Beam Depth

- o Shrinkage due to a reduction of moisture content from 15% upon erection to 9% in the outer parts of the cross-section during service reduced the tension perpendicular to grain strength and, in combination with high splitting forces from fasteners, facilitated the propagation of large cracks in grain direction (see Fig. 5).

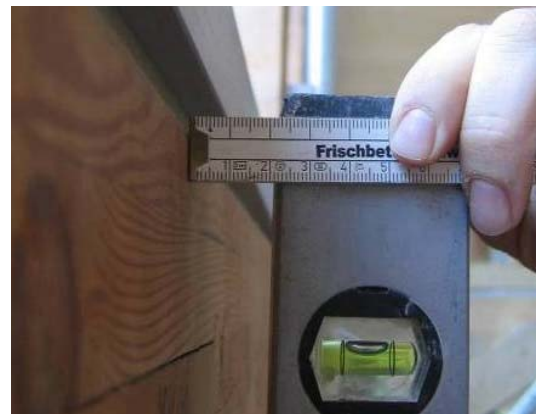
Fig. 6: Rotation of Lower Flange

The lower flanges had additionally rotated around their longitudinal axis, leading to an angle of rotation of up to 3° (see Fig. 6). This resulted in an inclination of the bottom flange which reduced the bearing area at the supports by up to 70%.

- o The connection of the nail-laminated timber plates leads to an eccentric load transfer, resulting in a torsional moment in the bottom flange. During design, the lateral stability of the individual flanges was not considered. The reduction of bearing area due to an inclined bottom flange, established an eccentric load transfer to restore the equilibrium of stresses.

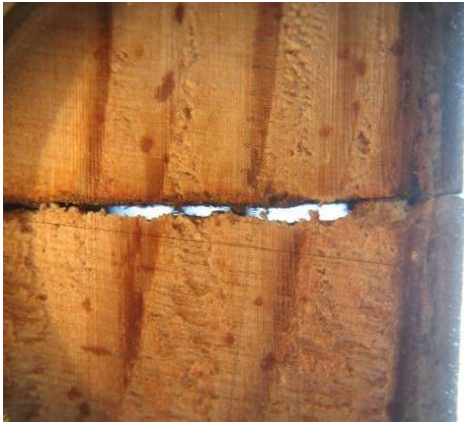
The strength of the resorcinol glue lines could be verified by testing core samples. During this assessment it was detected that cracked glue lines had been sealed during manufacture. Opening core samples at these glue lines revealed that the crack had only been covered but not filled and that the outer areas of lamellas in these areas had never been glued together (see Fig. 7 – 9).

Fig. 7: Crack in Glue Line and Seal

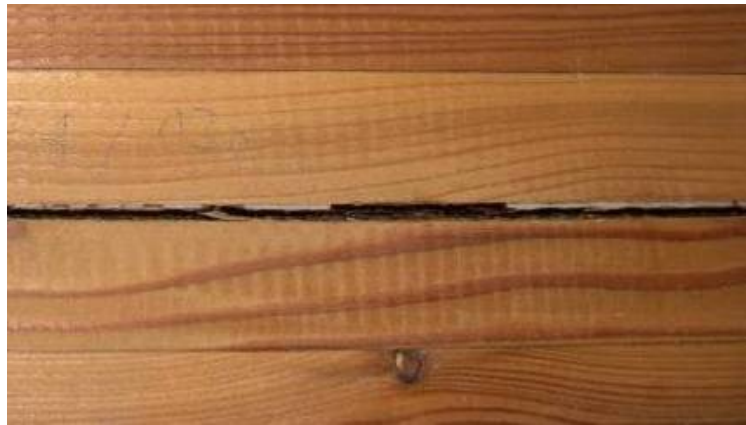
Fig. 8: Crack in formerly sealed Glue Line

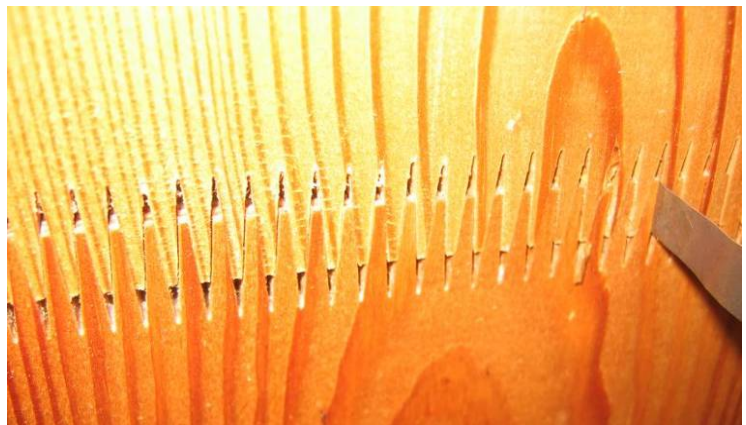
This finding implicated improper manufacture of the glulam members and was therefore followed by an assessment of the finger joints, joining two lamellas. It was found that some finger joints were open, having never been glued together (see Fig. 10).

Fig. 10: Finger Joint without Glue
