Shear failure in glulam frames

An actual case

Kolbein Bell

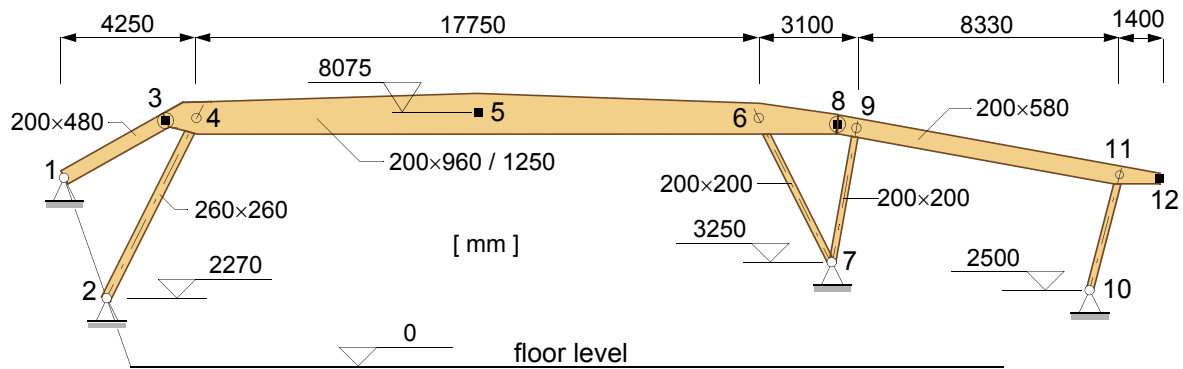
Figure 1 A typical frame

Figure 1 shows one of the identical 14 frames supporting the roof of the sports center. The frames are spaced 3 m apart and they support purlins which in turn support a wooden ceiling on which are placed insulation, tar paper, plastic, gravel and turf.
