**COST E55** – Eindhoven, October 2007

# **Shear failure in glulam frames**

## **An actual case**

sports centre built in 2001

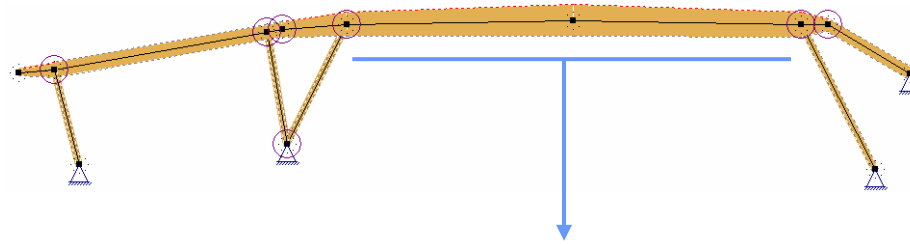
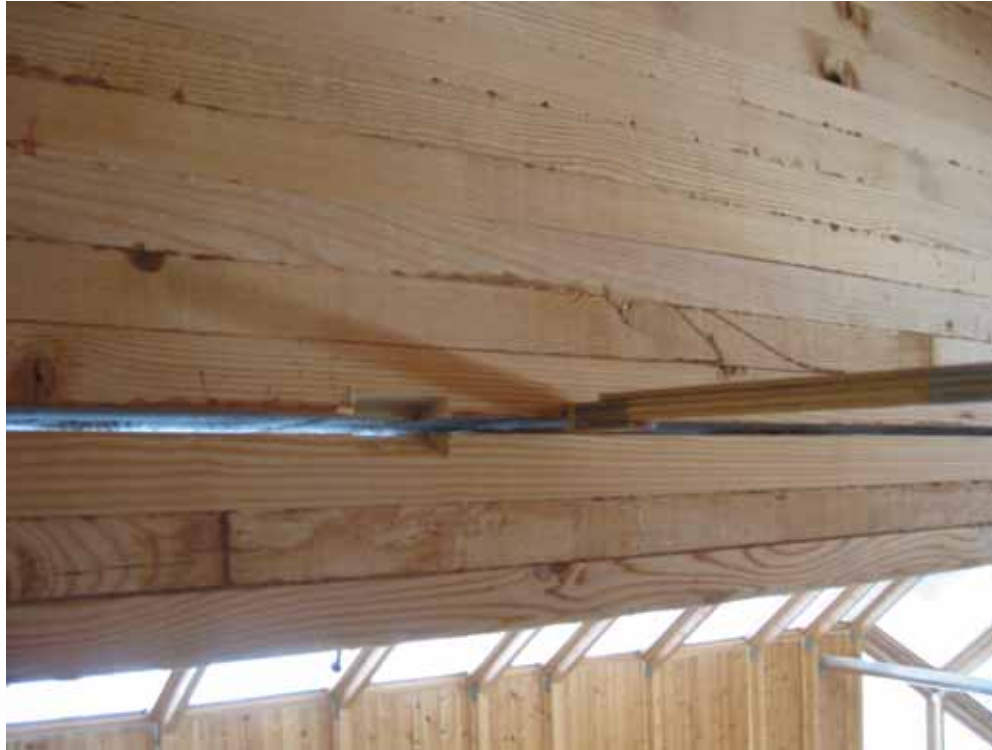
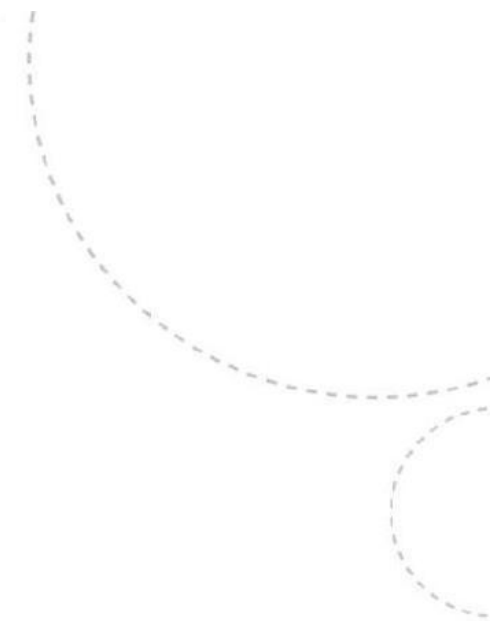
## Frame 2

- At about 8 pm on March 20, 2005, the players of an ongoing indoor bandy training session heard high cracking noise from the ceiling.
- The caretaker was notified and the hall was evacuated.
- In one beam (frame 2) a long crack was visible from the floor.
- On closer inspection severe shear cracks were found in the main beam of 3 frames – number 1, 2 and 10.
- The snow loading was measured the following day; it was found to be from 2,3 to 3,5 kN/m<sup>2</sup>, well below the design load of 5,5 kN/m<sup>2</sup>

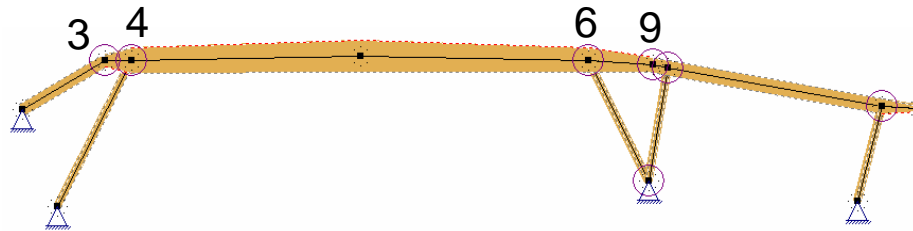
## Most likely failure scenario

1. Failure starts in a defect glue line (21) at point 4 of frame 2 and the crack propagates towards the middle of the beam.
2. The shear stresses at the faulty (3rd) glue line of frame 2 increases and causes a complete collapse of this glue line (from 4 to 6).
3. The resulting sagging of frame 2 increases slightly the loading on frame 1 and this causes a shear failure to start in a defect glue line at node 4 – the shear crack propagates towards the middle of the beam.
4. The additional sagging of frame 1 causes a large rotation at joint 9 which in turn causes a crack due to tension perpendicular to grain – this crack propagates towards, but not beyond point 6.
