FAILURES OF TIMBER STRUCTURES IN SLOVENIA

Jelena Srpčič
ZAG Ljubljana
E-mail: jelena.srpcic@zag.si
<http://www.zag.si/>

TYPICAL FAILURES OF TIMBER STRUCTURES

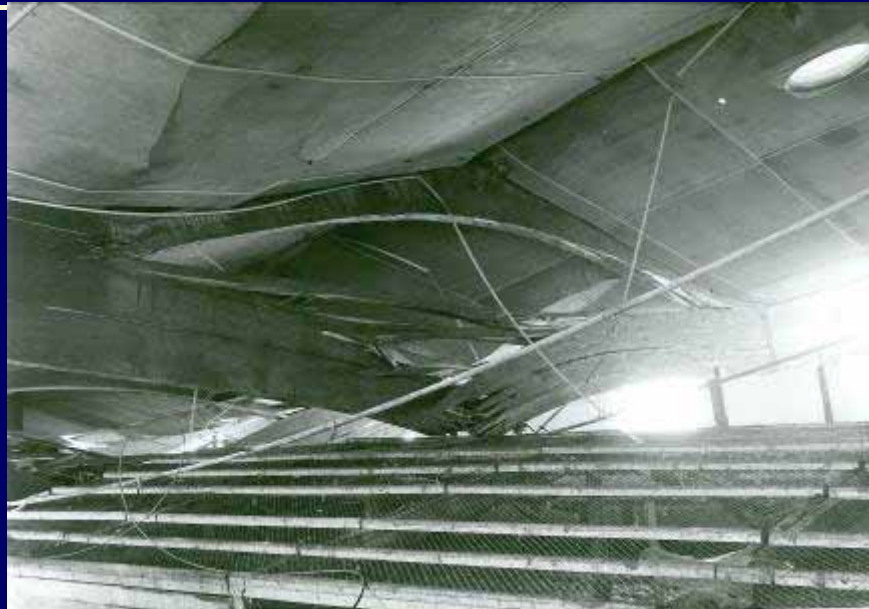
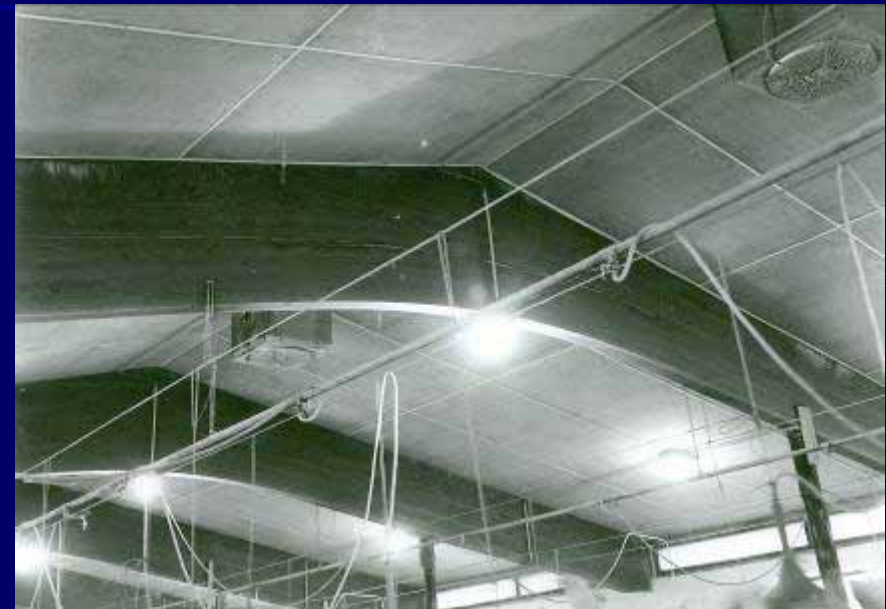
Markovec near Cerknica, November 1979

- 3 buildings for chichen stables, in each 15 curved and tapered glulam roof beams, span 13,65 m, height 0,58 - 1,04 m, depth 0,145 m
- all 15 elements in one building failed
- in other buildings cracked elements
- estimated snow load 0,8 kN/m²
- radial stresses not controlled - failure due to exceeded perpendicular to grain tensile strength

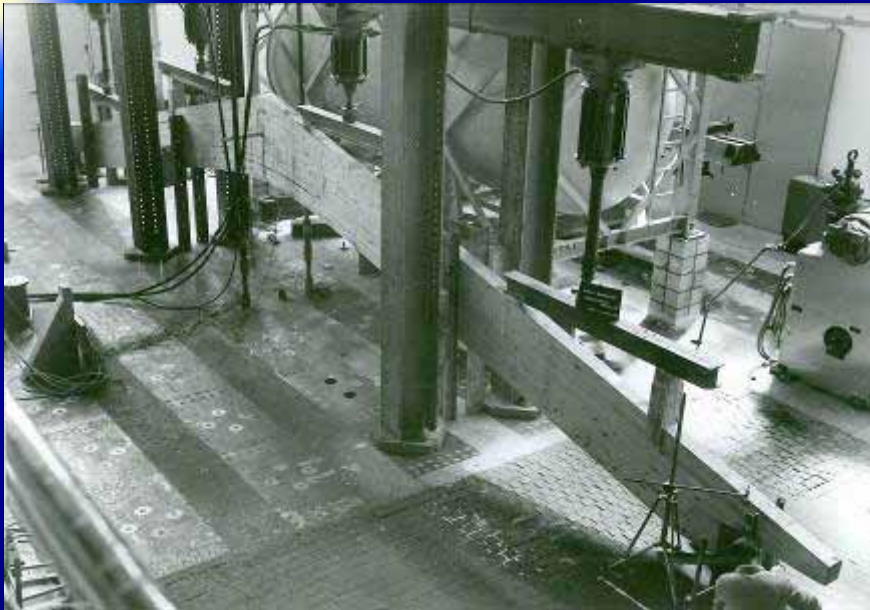
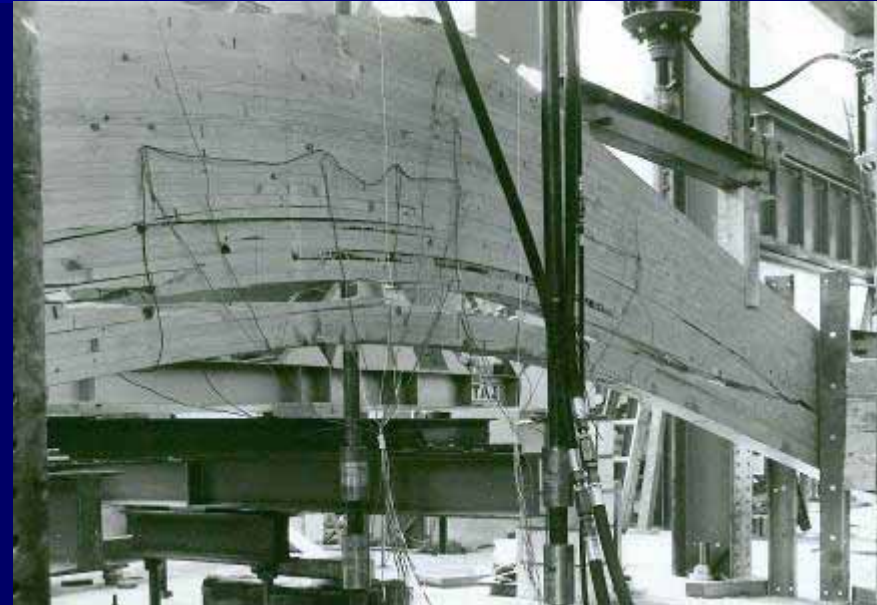
Laboratory tests of the same type of beams

- load bearing capacity ca 3-times higher than estimated load at on-site failure
- different position of origin of failure
- failure in the wood, no failed glue lines
- difference in load bearing capacities caused also by hindered movement of supports (friction)
- beams of the collapsed building were (according to users) exposed to weathering

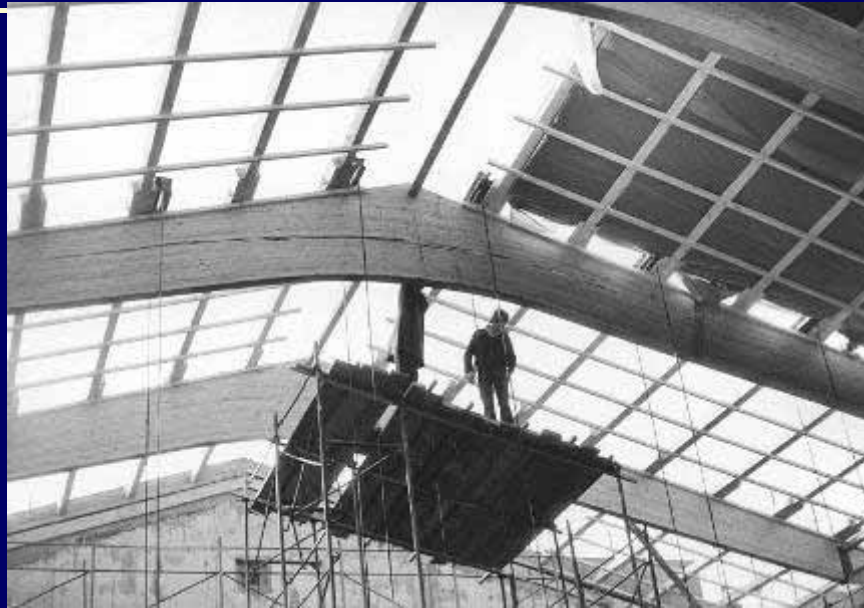
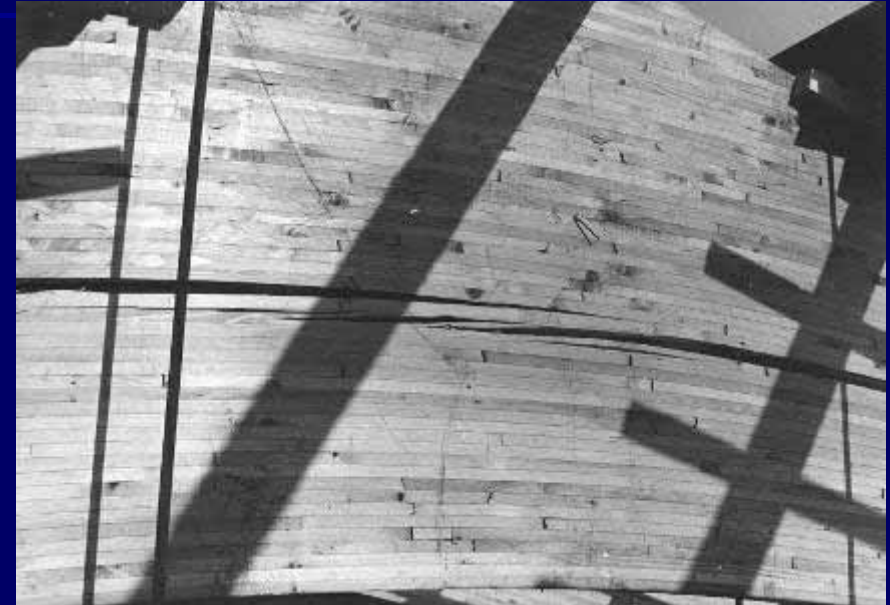
On-site loading test, Sport hall Ig, February 1980

- failure during the test at 1.16-times design load
- brittle failure without increasing deflections
- failure in the wood and partially in glue lines
- beam was removed and brought to laboratory to study strengthening methods (ties in radial direction, tensile tie between supports)

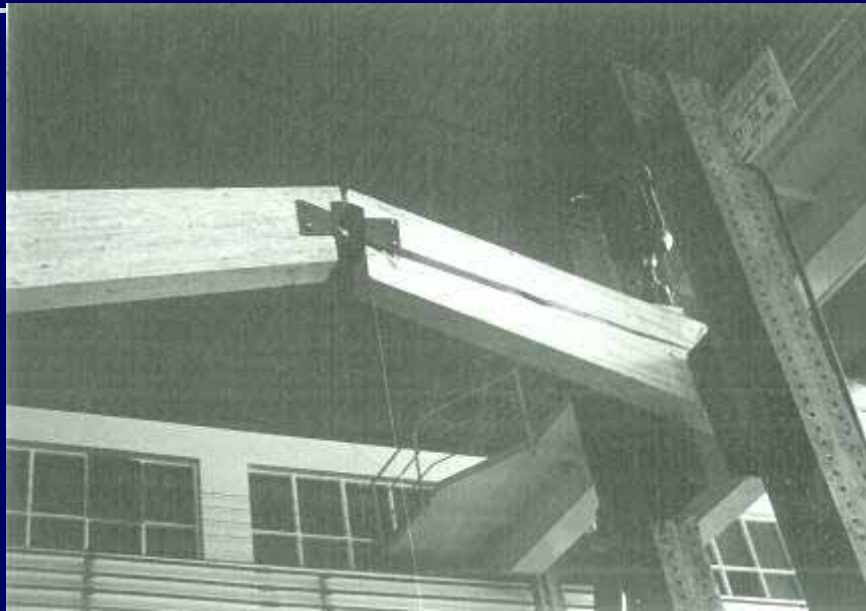
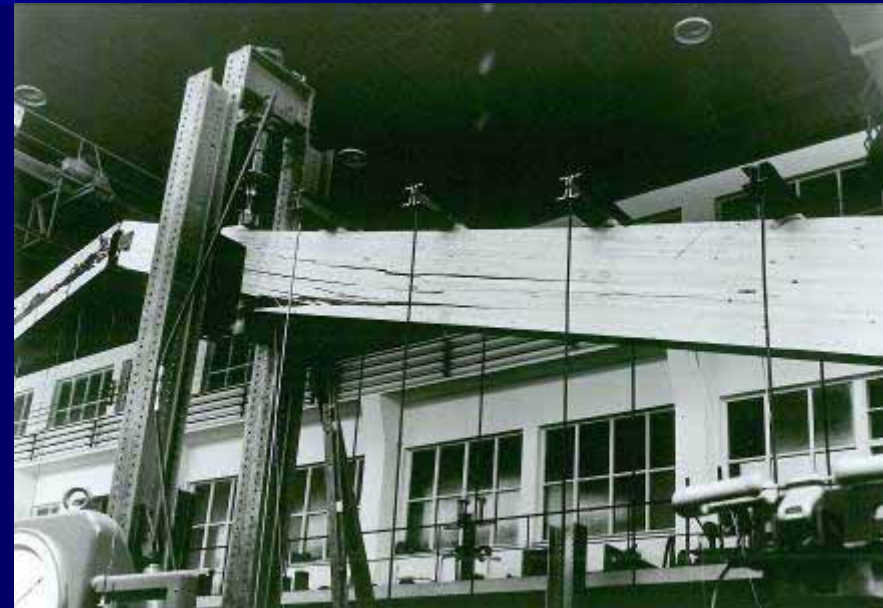
Three hinged arch, laboratory test 1982

- non-symmetrical load
- brittle failure due to exceeded perpendicular to grain tensile strength below the middle hinge (detail with two dowels)
- redesigned hinge detail: three fixing dowels, additional transverse dowel
- increased load bearing capacity for ca 100%
- failure due to bending stresses in the element - increasing deflections noticed

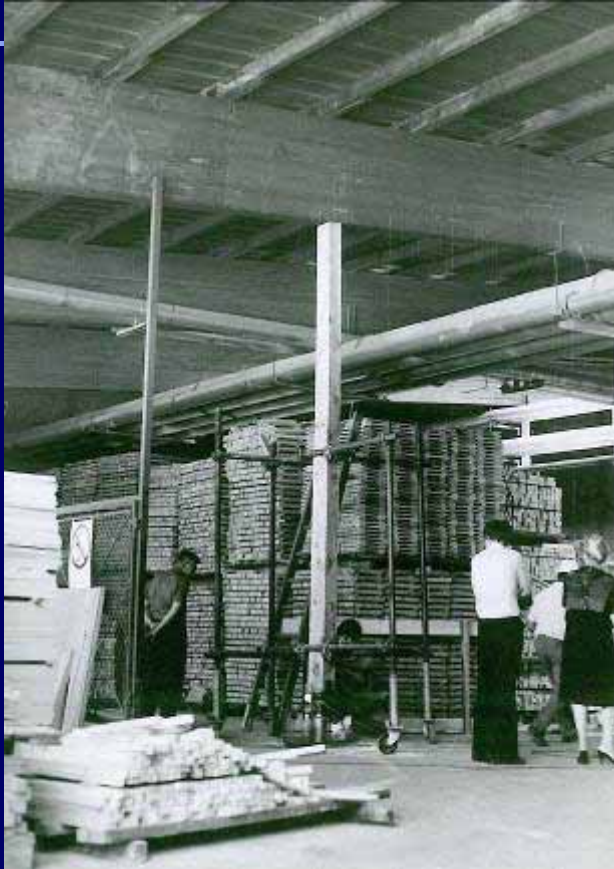
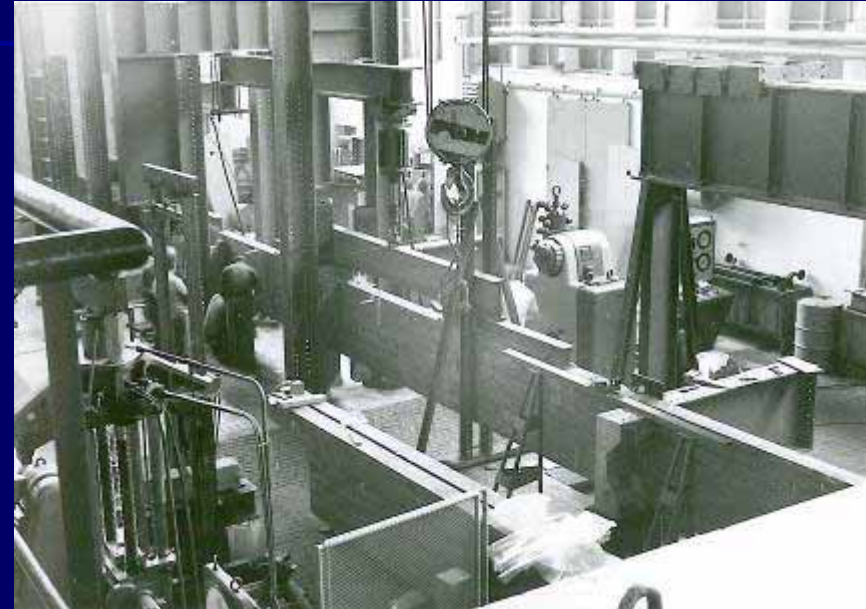
Gerber hinged beam, 1983

nondestructive testing for assessing fitness for use (measuring deflections by lifting)

- in straight roof beams (span: 17,5 +3m, 15m, 3+17,5 m) visible cracks
- cause: improper use of glue (casein glue in the industrial premise)
- laboratory tests to the failure of three beams
- big differences in load bearing capacities proved on-site measurements

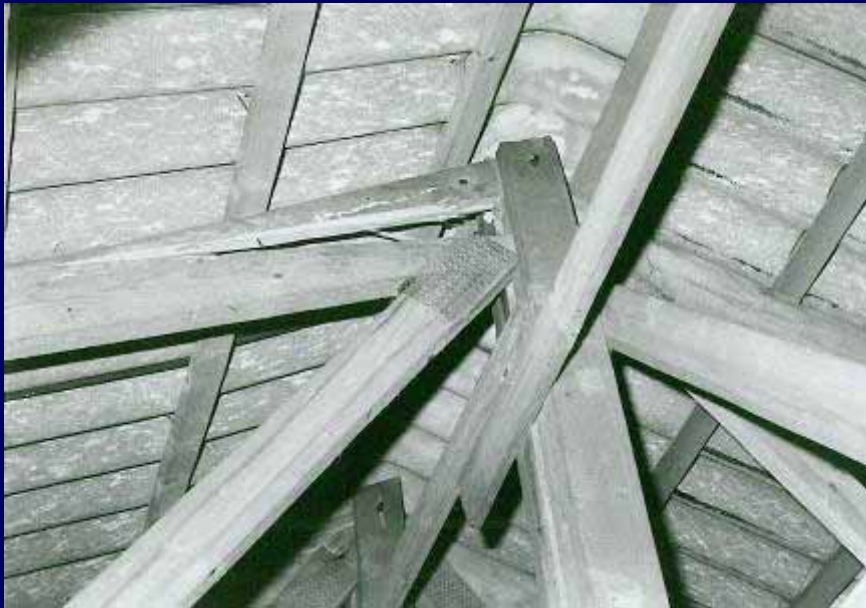
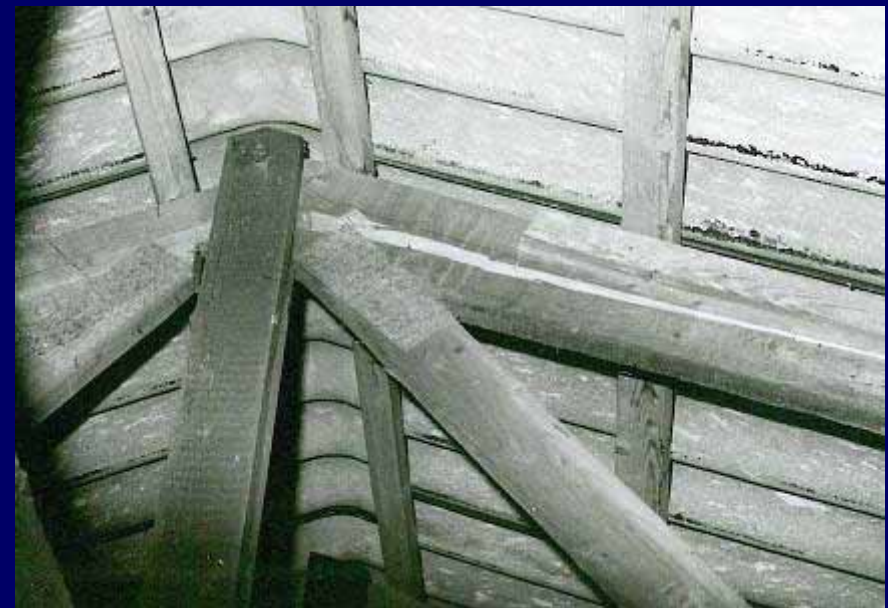
Trusses with nail plate connections, Črnomelj, 1987

- roof trusses in school building
- failure observed on the deformed roof plates
- failure due to improper location of nail plates - out of centre line
- exceeded perpendicular to grain tensile strength

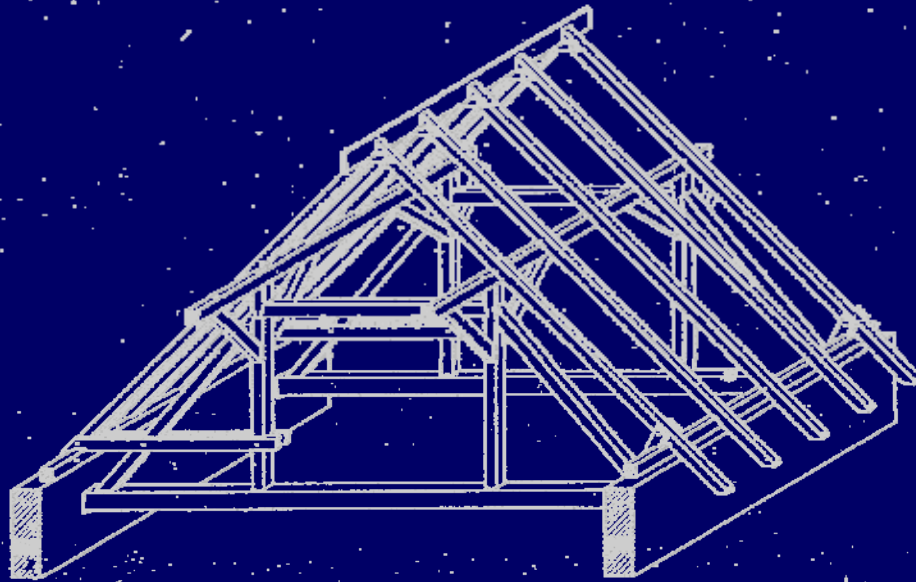
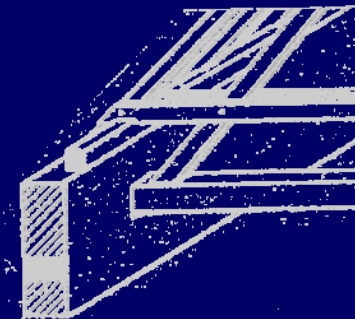
- Roof structures
 - classical roof structures from solid wood - strutted and suspension frames
 - problematic details: supports on outer walls

timber elements closed in walls

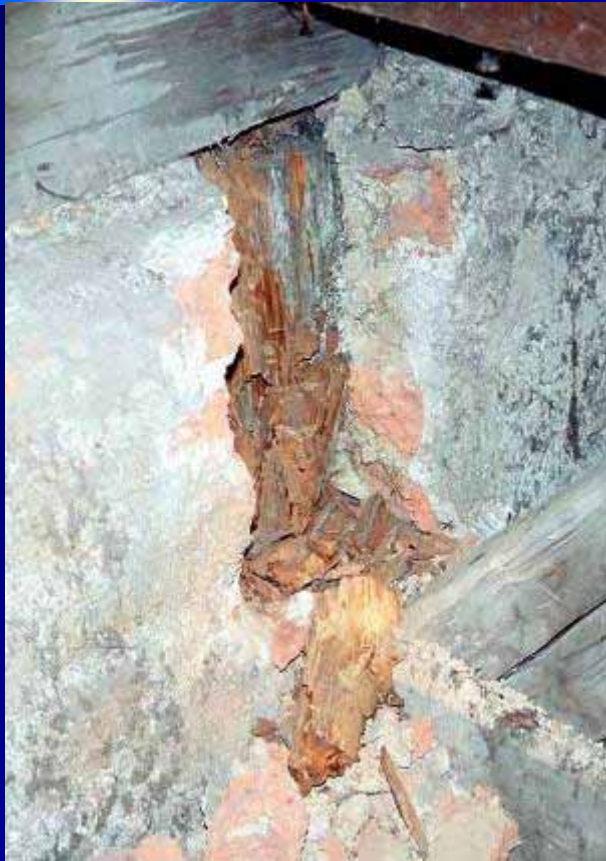
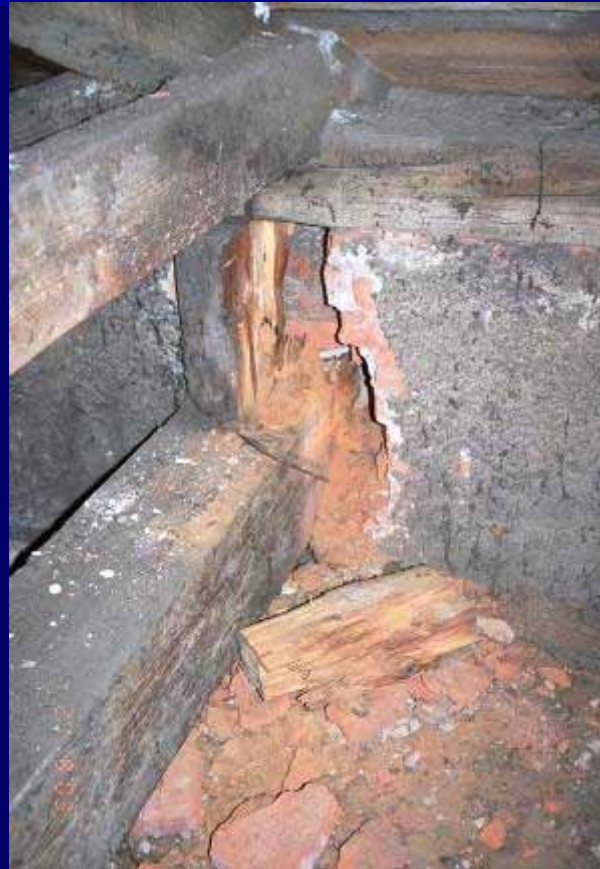
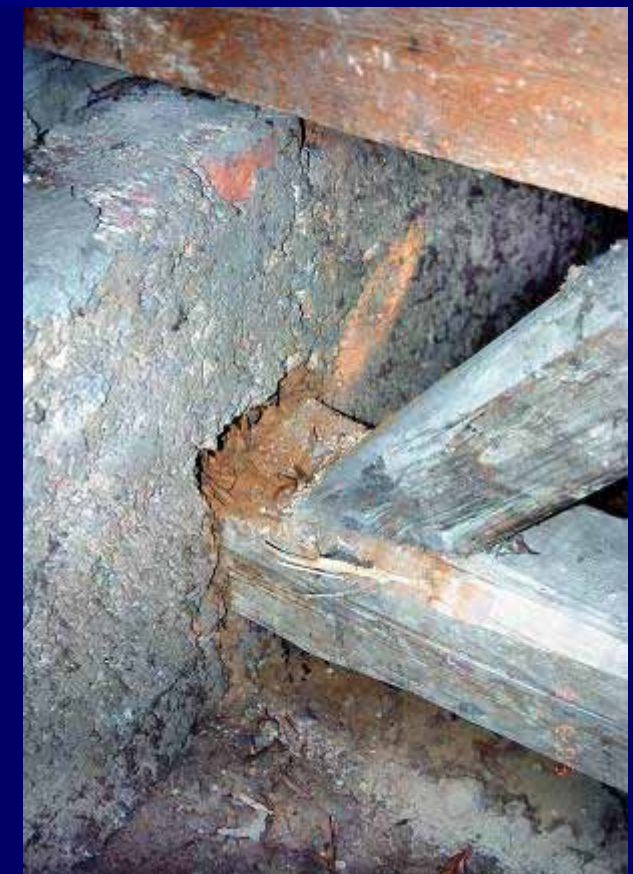
Damaged roof structures - examples

- constant moisture in wall - ideal for **fungi attack**
- usually wood attacked by rotting fungi (brown rotting, loss of integrity and load bearing capacity)

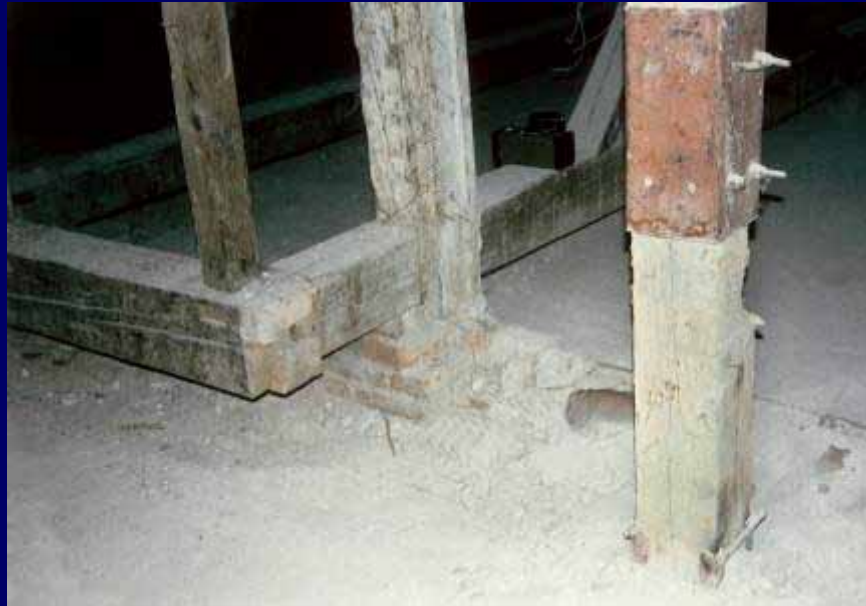
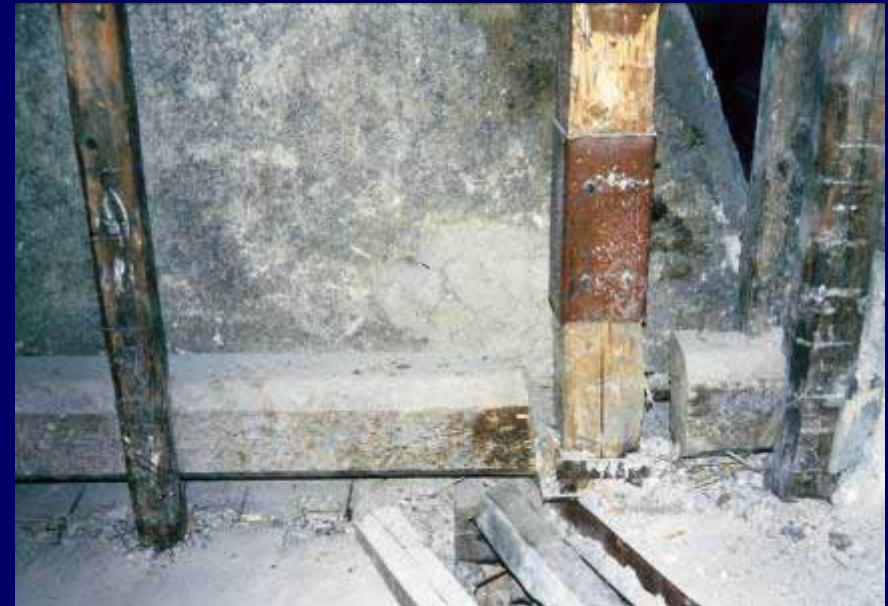
Roofs: problematic construction measures during use

The most common (and problematic) measure at classical roof structure is **cutting lower chords** to make passages

- central posts near the cutting points are elongated to the attic floor level, lower chord is supported by temporary short studs,
- on other spot the height difference of about 10 centimetres between cut parts occurred
