FAILURES OF TIMBER STRUCTURES IN SLOVENIA

Jelena Srpcic

Slovenian National Building and Civil Engineering Institute

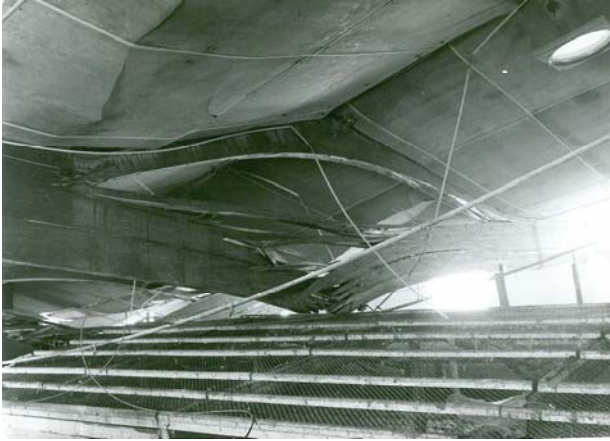
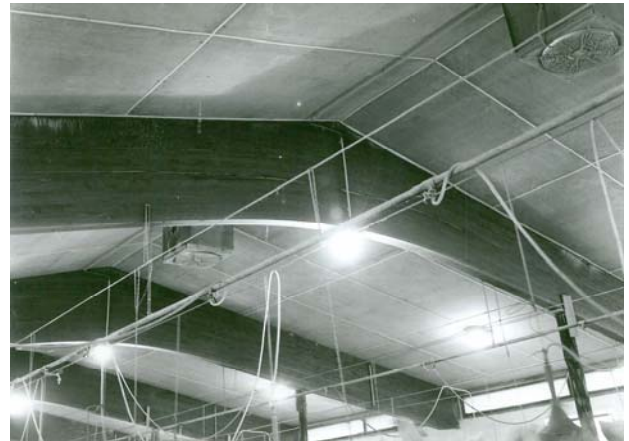
In the autumn 1979 in Markovec, 60 km from Ljubljana, 15 roof beams in one building of the chicken farm collapsed, and some elements in other two buildings cracked. The beams were curved and tapered glued laminated beams with relatively small radius of curvature.

The type of failure was so called "tension perpendicular-to-grain failure" which was in 70-ties quite often and well known, but recently, according to our knowledge, no more such failures are noticed. The reason is improvement of design: in Eurocode 5 (and in national codes before that) for these types of structures precise formulas for controlling stresses in radial direction are introduced.

Figures 1, 2: Failed and cracked curved and tapered beams

We like to point out that also in the mentioned case failure was partly caused by the bad gluing and the additional "trigger" for the failure was exposure to the changing climatic conditions. An influence of friction on supports also played a certain role because the same type of element, produced after failure to be tested in laboratory, carried much higher load.

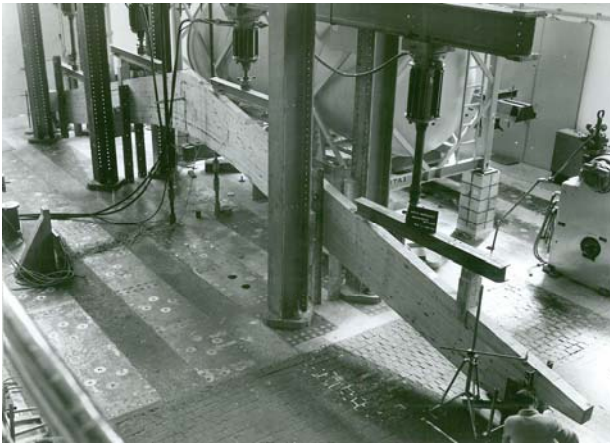
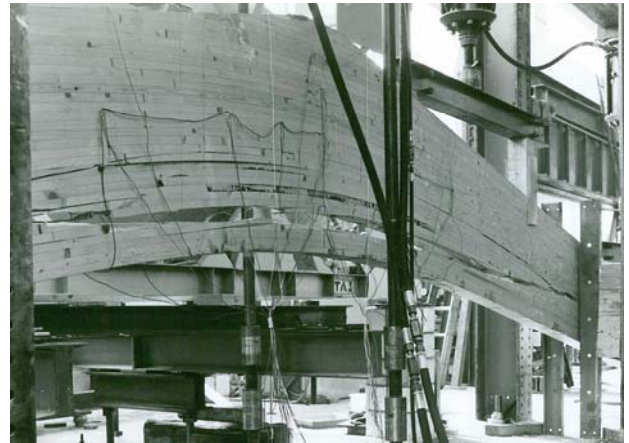
Figures 3, 4: Laboratory test of new beam with the same geometry

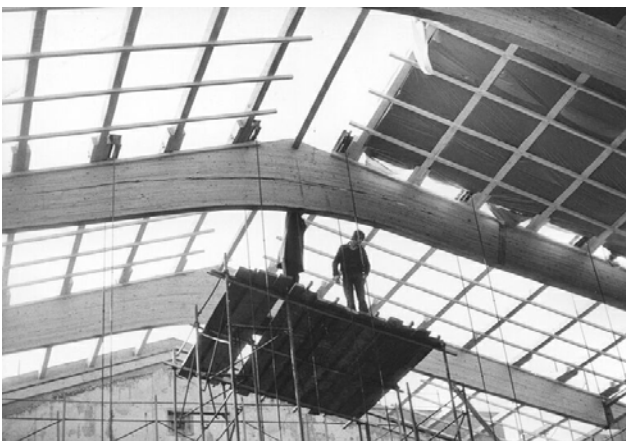
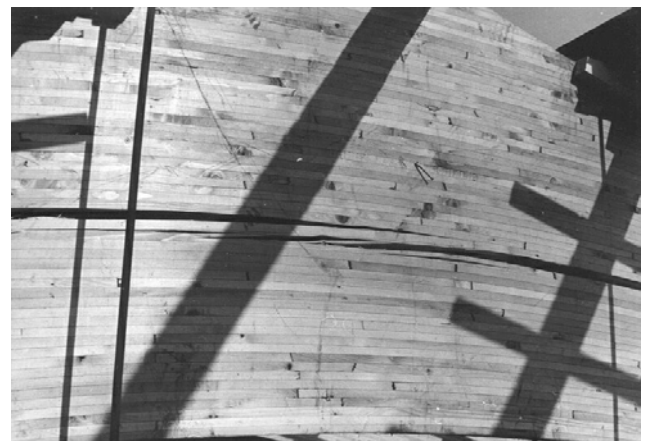
Being warned by this failure an on-site investigation of the same type of elements has been performed. The result was failure of roof element during the on-site loading test. The sudden failure happened at 1.16 x design load, just one step before we wanted to finish the loading. After the test beam was removed and brought to laboratory to study possibilities of strengthening (glued-in rods, tensile tie...).

Figures 5, 6: Failure of beam during in-situ loading test

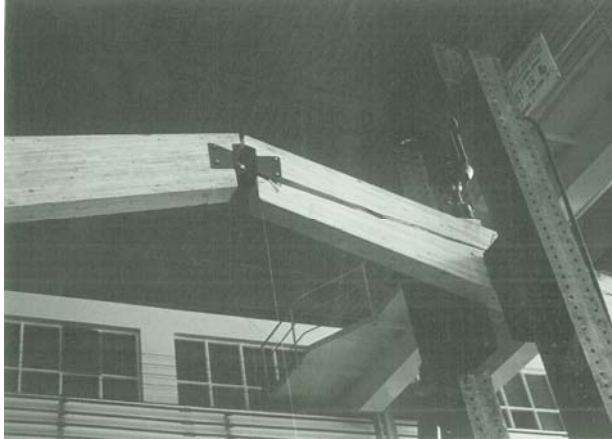
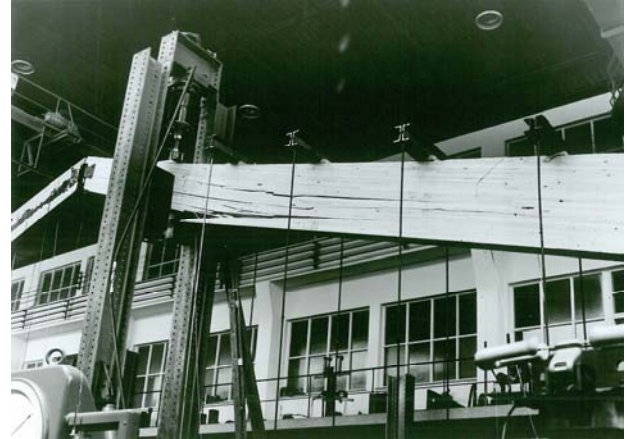
Another problem with tension perpendicular-to-grain was noticed in 1982 when three-hinged arch was tested in laboratory. Proposed solution of fixing the middle hinge with two dowels caused the unfavourable failure: splitting the wood below the dowel (Figure 7). Changing the detail - fixation of hinge with three dowels, additional transverse dowels - improved the load bearing capacity for almost 100% and also changed a mode of failure (Figure 8).

Figures 7, 8: Unfavourable tension failure and changed mode at redesigned hinge of arch beam

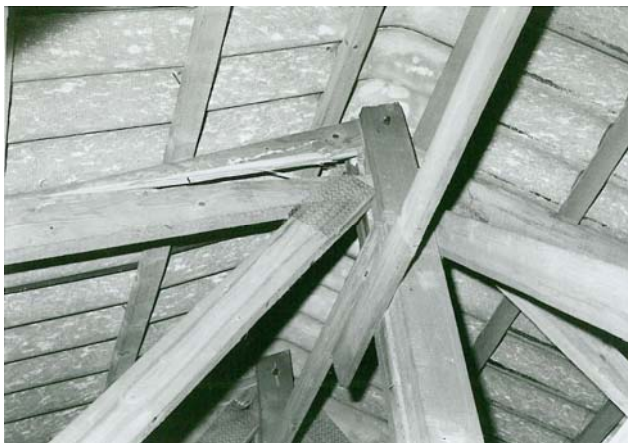
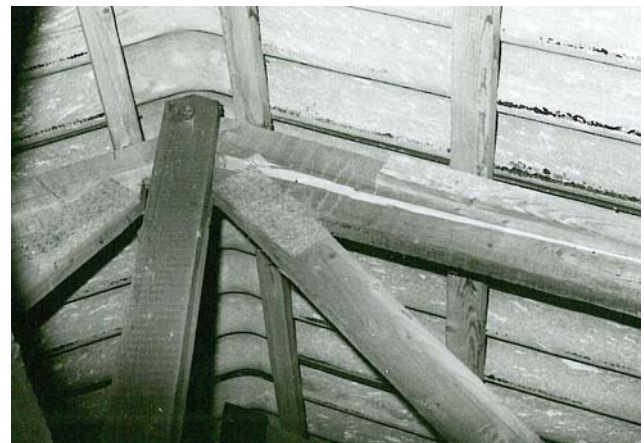
In 1987 failure was noticed on roof trusses where connections were made by metal nail plates. As seen from the pictures, the plates were situated out of centre lines of upper chords and transverse stresses were higher than perpendicular to tension strength of timber (Figures 9, 10).

Figures 9, 10: Failure details of roof trusses connected with nail plates

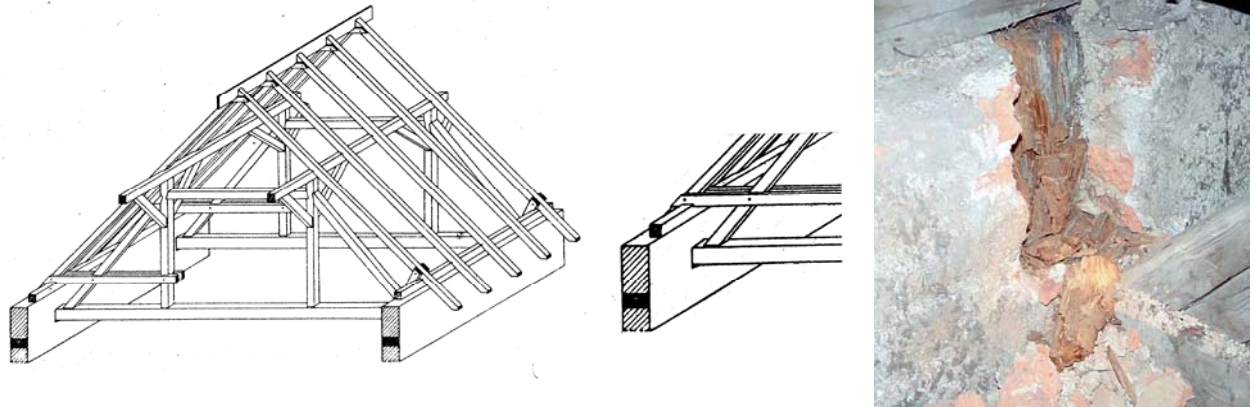
Classical roof structures were made from solid wood and mostly used structural systems were strutted and suspension frames. Strutted structures have supports on outer walls which are sometimes in the attics floor level but most commonly they are raised on so called gable walls to achieve the bigger height of the attics. Transfer of load from poles to the lower chord is made through vertical struts, which are usually built into gable wall. Because they are closed in the brick or stone walls and therefore not ventilated, deterioration of wood is very often observed. Typical roof with gable wall and detail of the support is presented in Figure 11 and typical deteriorated strut in Figure 12.

Figures 11, 12: Typical detail of roof structure support and deteriorated strut

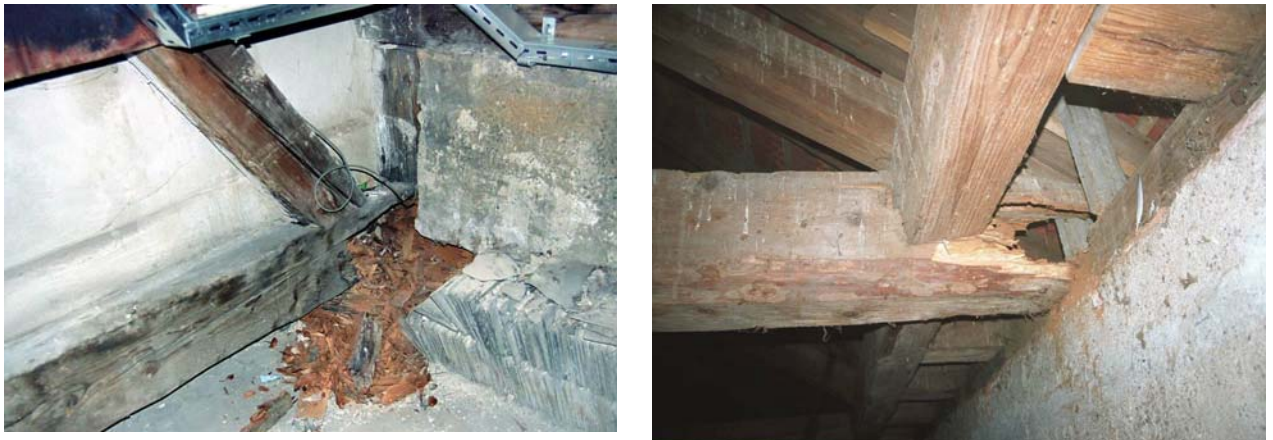
As seen from Figures 13 - 18 old roof structures have several potential deterioration weak points.

Figures 13, 14: Failed lower chords of roof beams

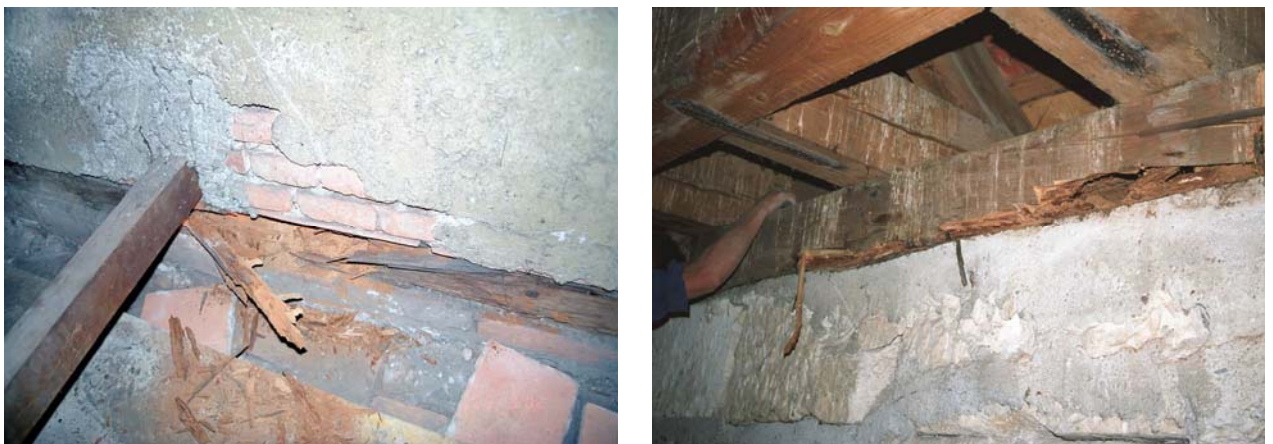
Figures 15, 16: Destroyed supporting beams of roof structures

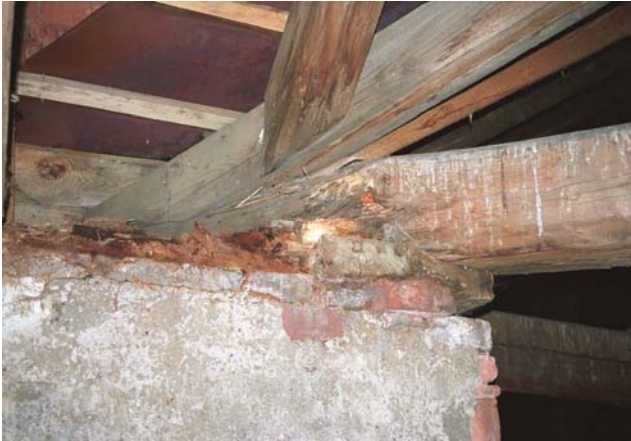
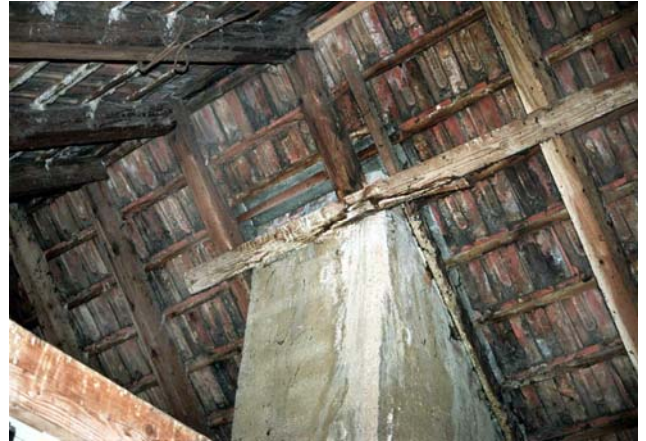
Figures 17, 18: Typical wetting points of roof structures

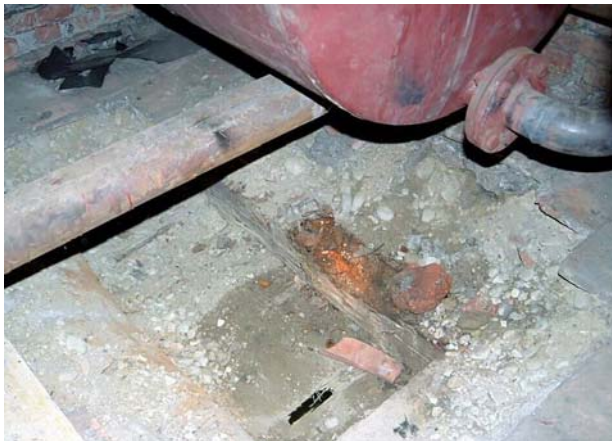
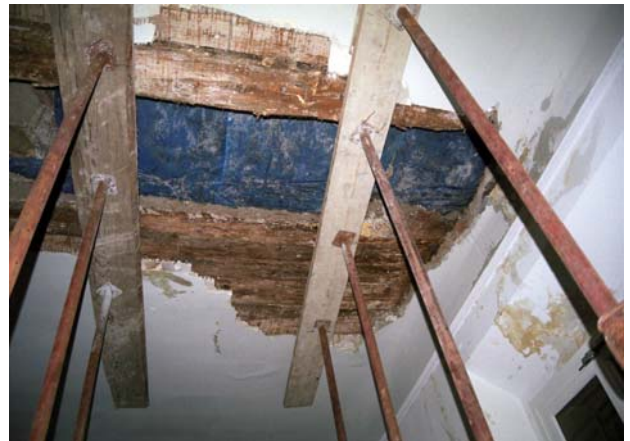
Usually the problems are spotted during the inspections performed before restoration works, but failures sometimes can occur also during the use. As we can see from Figures 19 and 20 they are mainly connected with constant wetting of timber. Whereas in some cases floor beams are only damaged (e.g. under the water tank placed in attics- Figure 19), in second case three floor beams totally collapsed (Figure 20). The reason was heavy constant wetting caused by bad drainage details under the later constructed terrace.

Figures 19, 20: Wetting of floor beams and failed floor

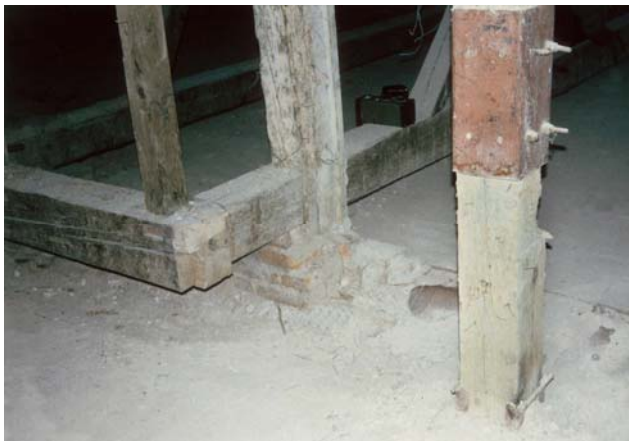
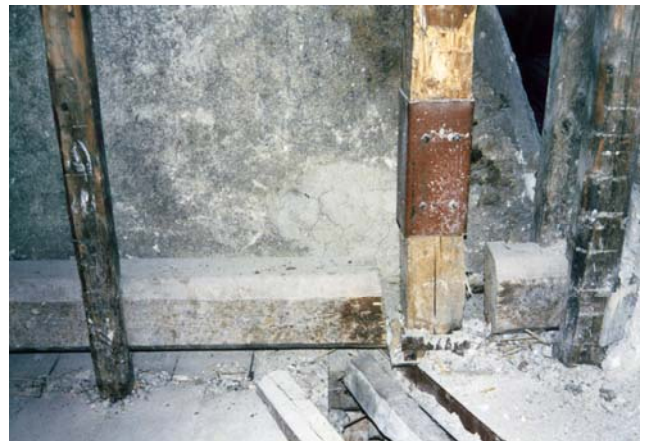
Somehow different approach is proposed for historical structures. Design of such a structure is usually not available and, in principle, we do not recalculate the structure. There are two reasons for that: we can measure the geometry of structure but we can not define the characteristics of connectors (nails, dowels...) so the accurate control is impossible. On the other hand we suppose that if structure survived 50 - 100 years (in these times roof structure survived probably heavy snow loads) and structure is not damaged if no additional load is foreseen there is no reason for reducing load bearing capacity. But we strongly recommend a check of all construction "improvements" made during the life cycle. These changes are quite often by renovation of attics where some roof elements are cut or replaced (Figures 21, 22)

Figures 21, 22: "Professional" construction measures
