## **Introduction, Failure Assessment Publication**

Tomi Toratti, VTT Finland

## **2. Survey of failures in buildings and other built facilities with timber as the main structural material - Nordic study**

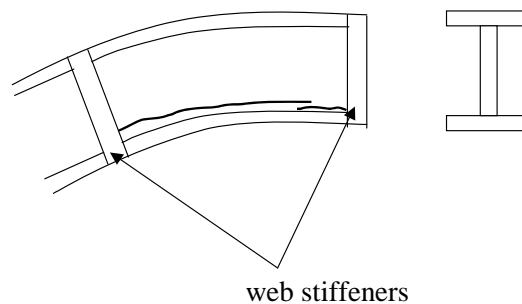
An on-site inspection was performed. The crack that had led to the call for an inspection was measured, and is schematically shown in Figure 1.

**Figure 1. Schematic of arch apex with cracks. The crack length was about 4 m.**

In addition to the cracks it was also noticed that the bolts holding the flanges together had loose fittings. Distances of about 5 mm were measured between the nuts and washers.

The original investigation concluded that the failure was due to the changing climate conditions after insulation was added to the roof. By placing the insulation in between the arches instead of on top of the existing roof, a temperature and thus a moisture gradient was created. The drying of the wood induced the perpendicular to grain failure. Calculations showed that the loading by self weight resulted in approximately 0.2 MPa perpendicular to grain stresses, which is about the allowable stress. The moisture gradient induced stresses were estimated to be also about 0.2 MPa, and thus the strength of the material was reached. The moisture variation was assumed to be linear over the beam depth, with a difference of 6% MC between the inner and outer parts of the arch.

The conclusions from the original investigation seem adequate. The failure can be classified as being due to poor knowledge about moisture induced stresses in wood. This failure shows the importance of accounting for other loads than mechanical ones when designing load-bearing structures.
