Introduction, Failure Assessment Publication

Tomi Toratti

Further look of the failure cases in Finland

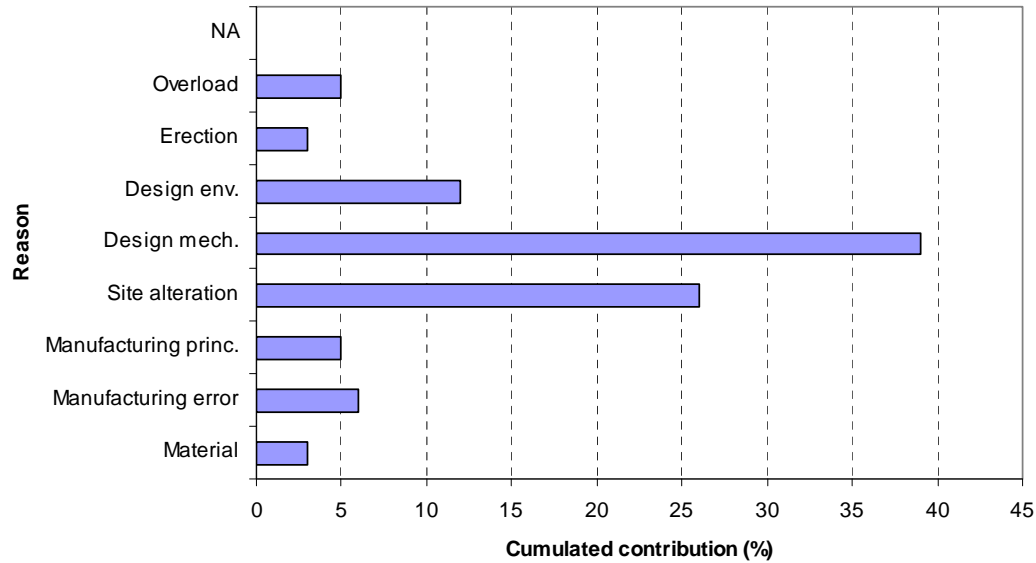
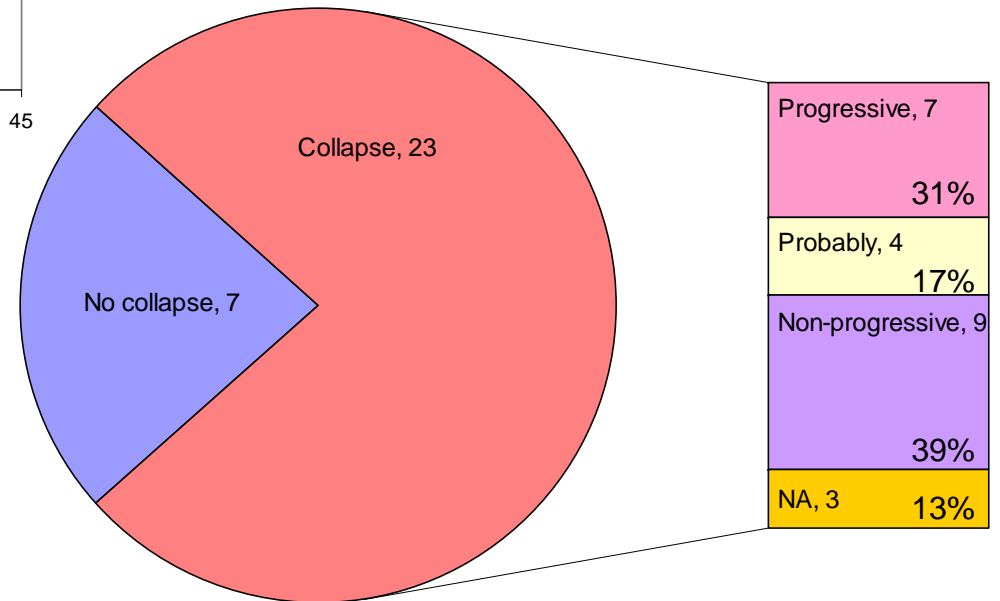
Typology of structural failures

"Typical" progressive collapse scenario

- Local buckling of the upper chord (or other local failure) develops in a truss, due to the lack of lateral support of the chord.
- The failed truss drags other trusses, which are unable to resist the lateral force due to the lack of sufficient bracing.
- The "domino" effect brings down the entire - or large part of the - truss roof.
- Possibly walls are also dragged by the roof trusses.
- Almost total collapse – or large part – of the structure occurs.

- Progressive collapse is a problem in Finland.
- Timber trusses with minimal bracing and lateral support are especially vulnerable.
- Better design rules to achieve more robust truss-roofs should be a goal.
- It is especially important that precise detailing solutions are provided to the designers. General statements in the code are often overlooked, or interpreted generously in "real-life".
