Snow storm damage in Denmark

22 February 2007

Jørgen Munch-Andersen,
Danish Timber Information Council
Jørgen Nielsen & Erik Steen Pedersen,
Danish Building Research Institute

COST E55, Helsinki 13-14 March 2008

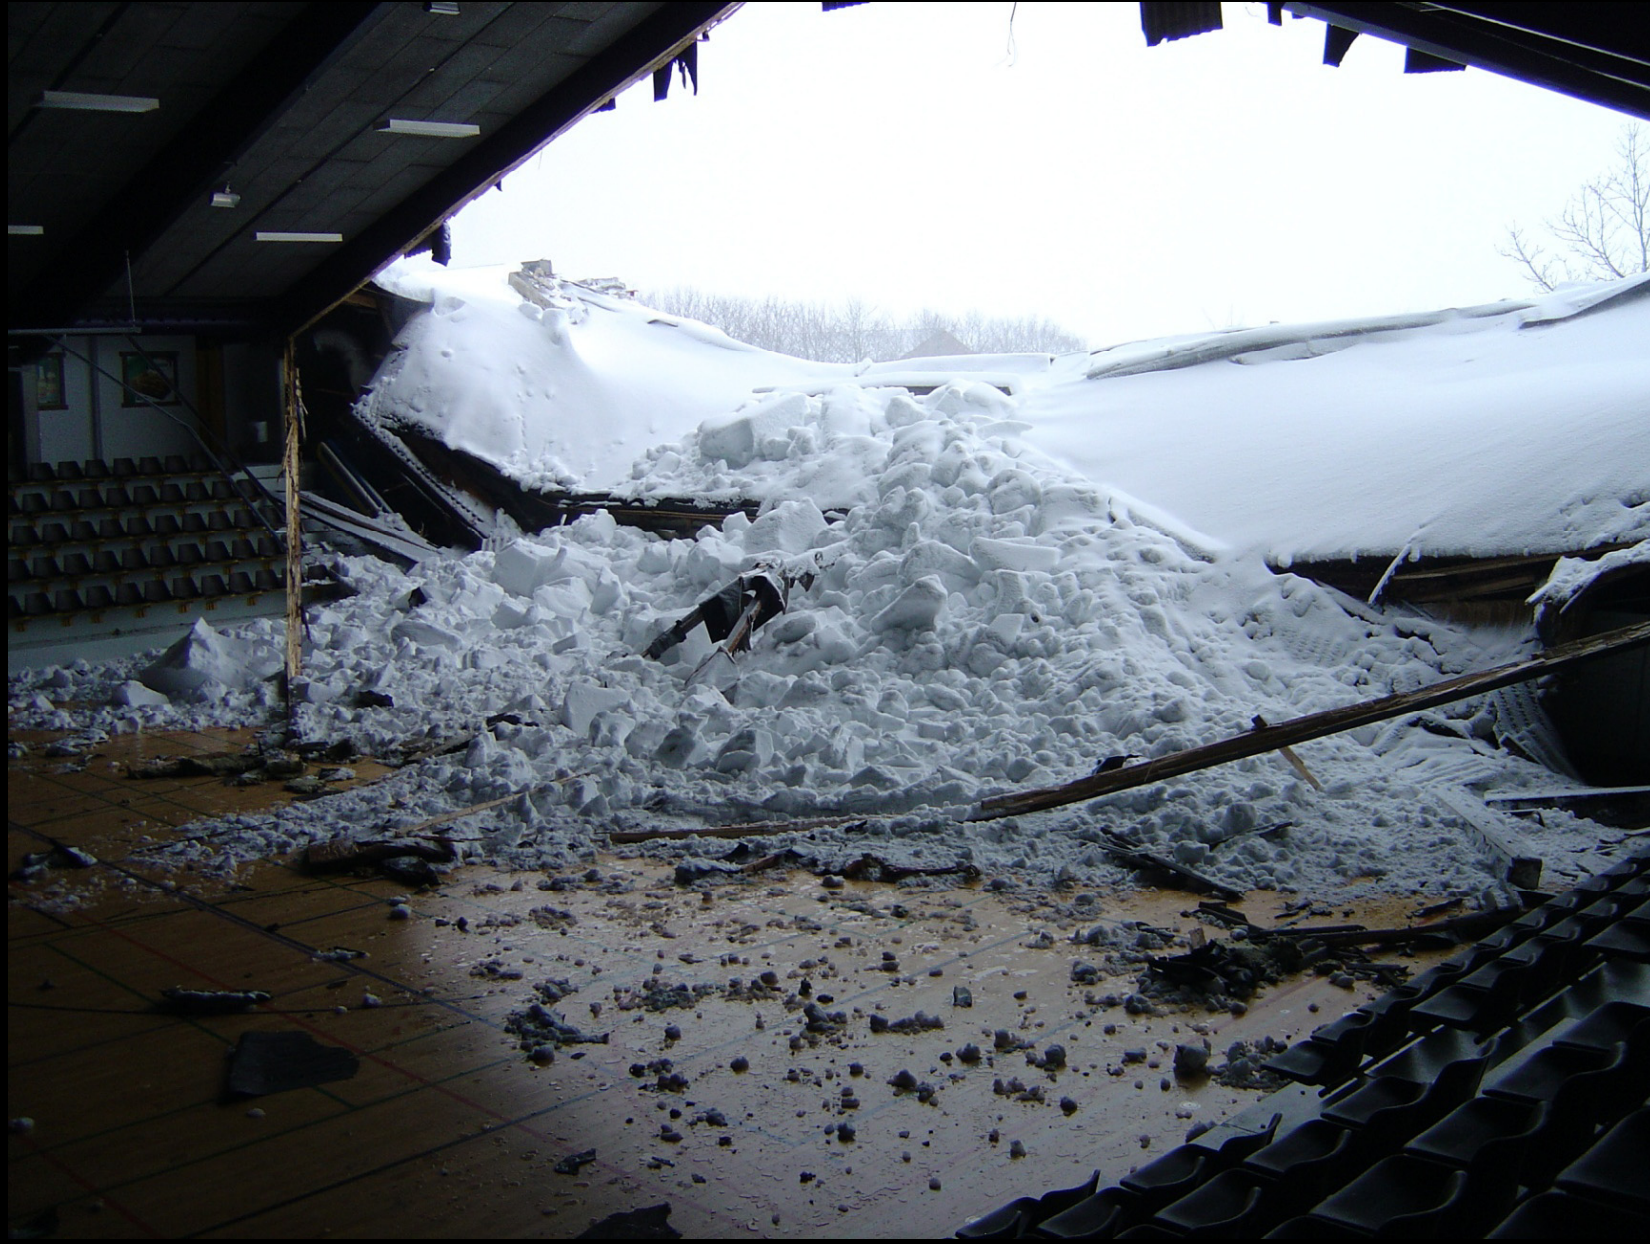
Sports arena with low extension at west gable

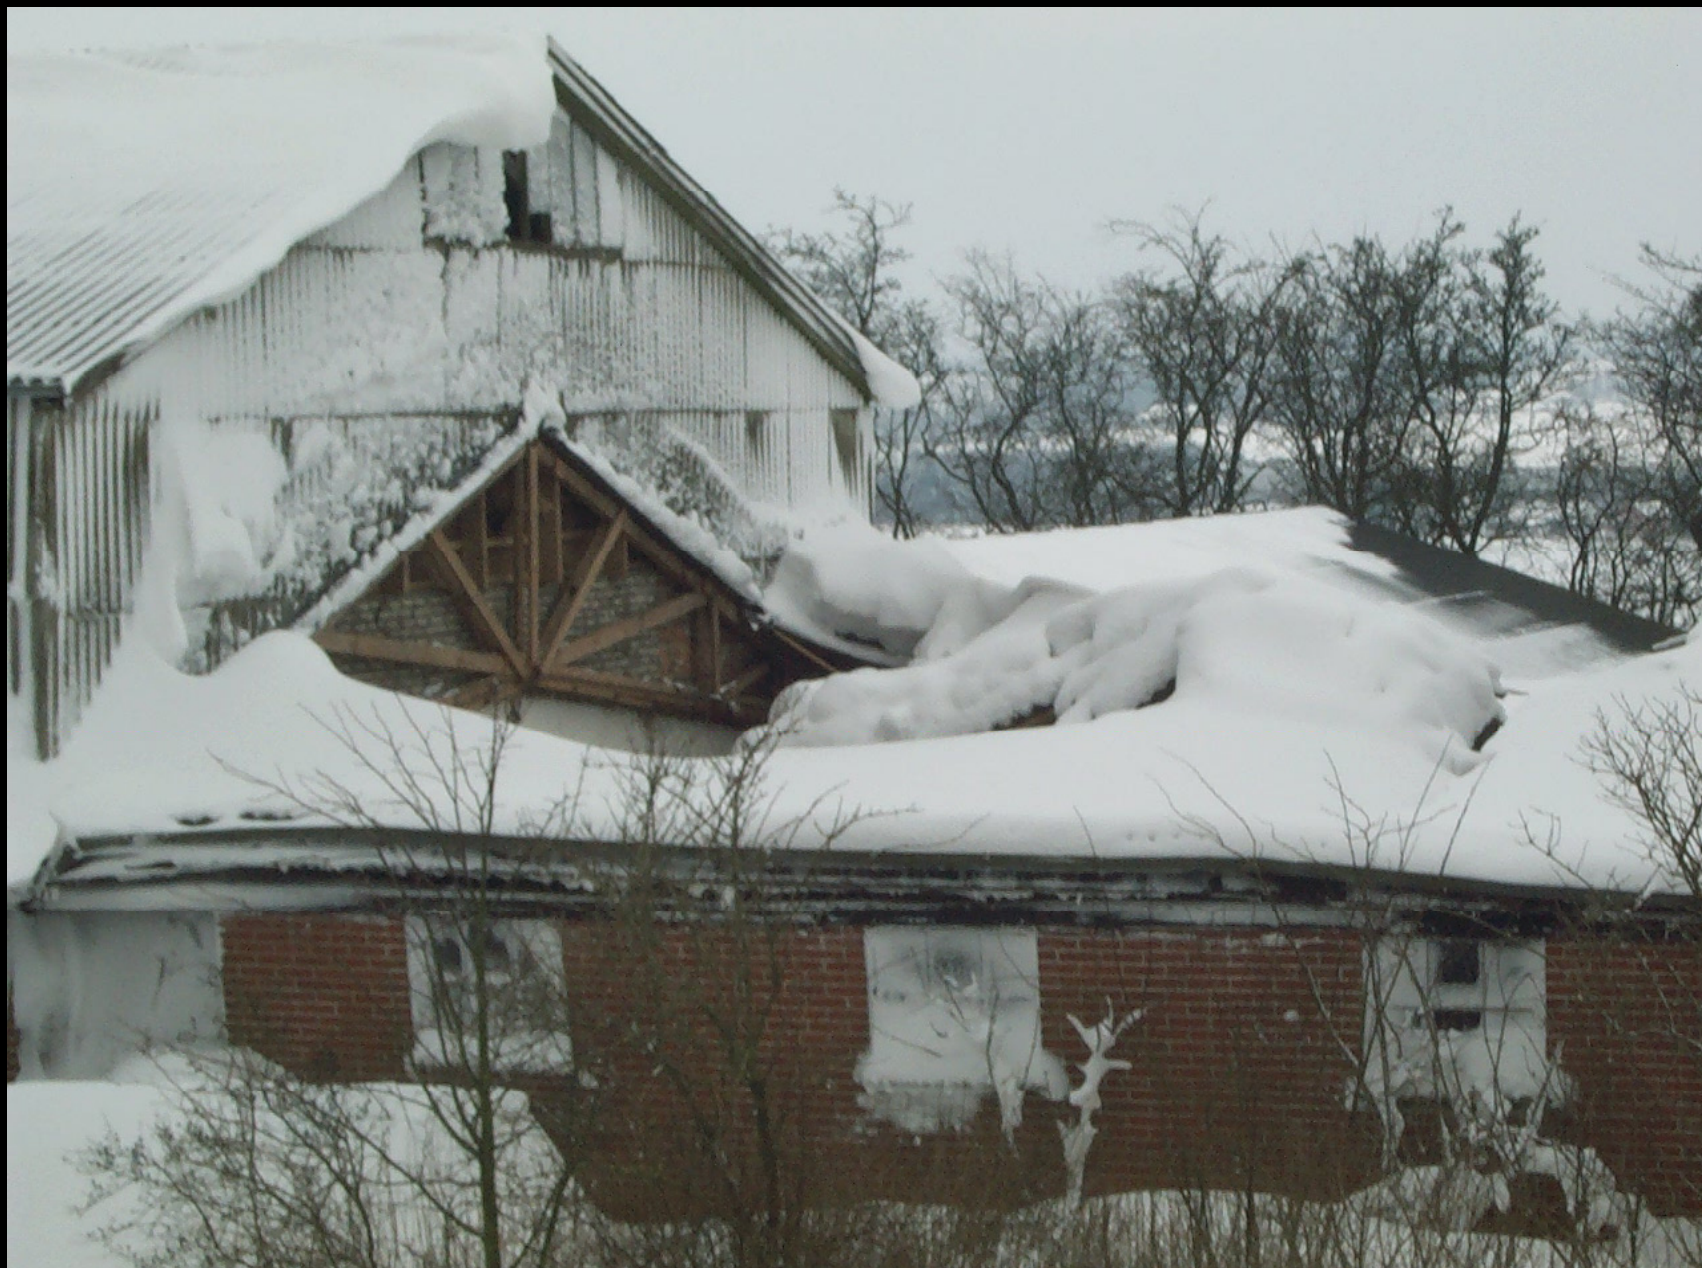
Stable placed on west-side of a (later) barn

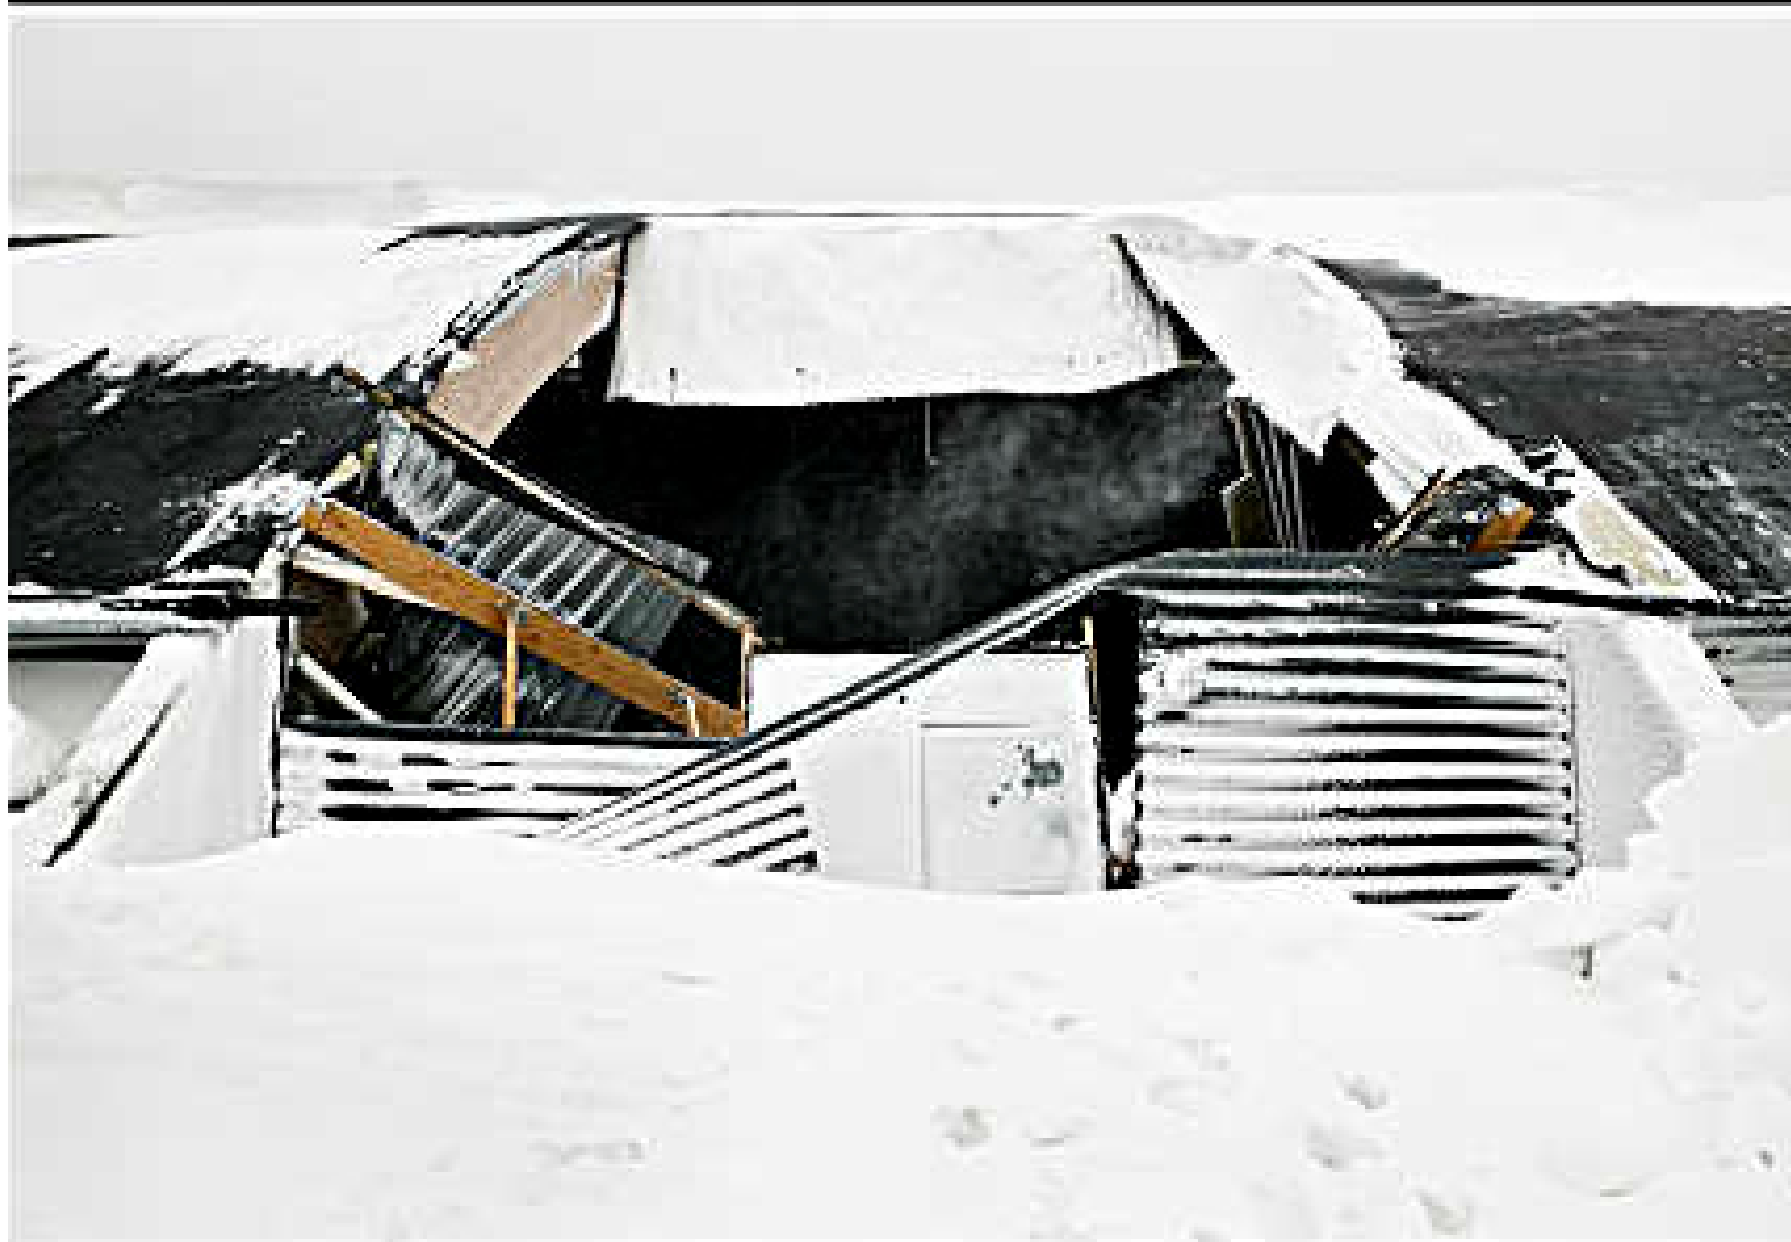
Arena with failed secondary beam

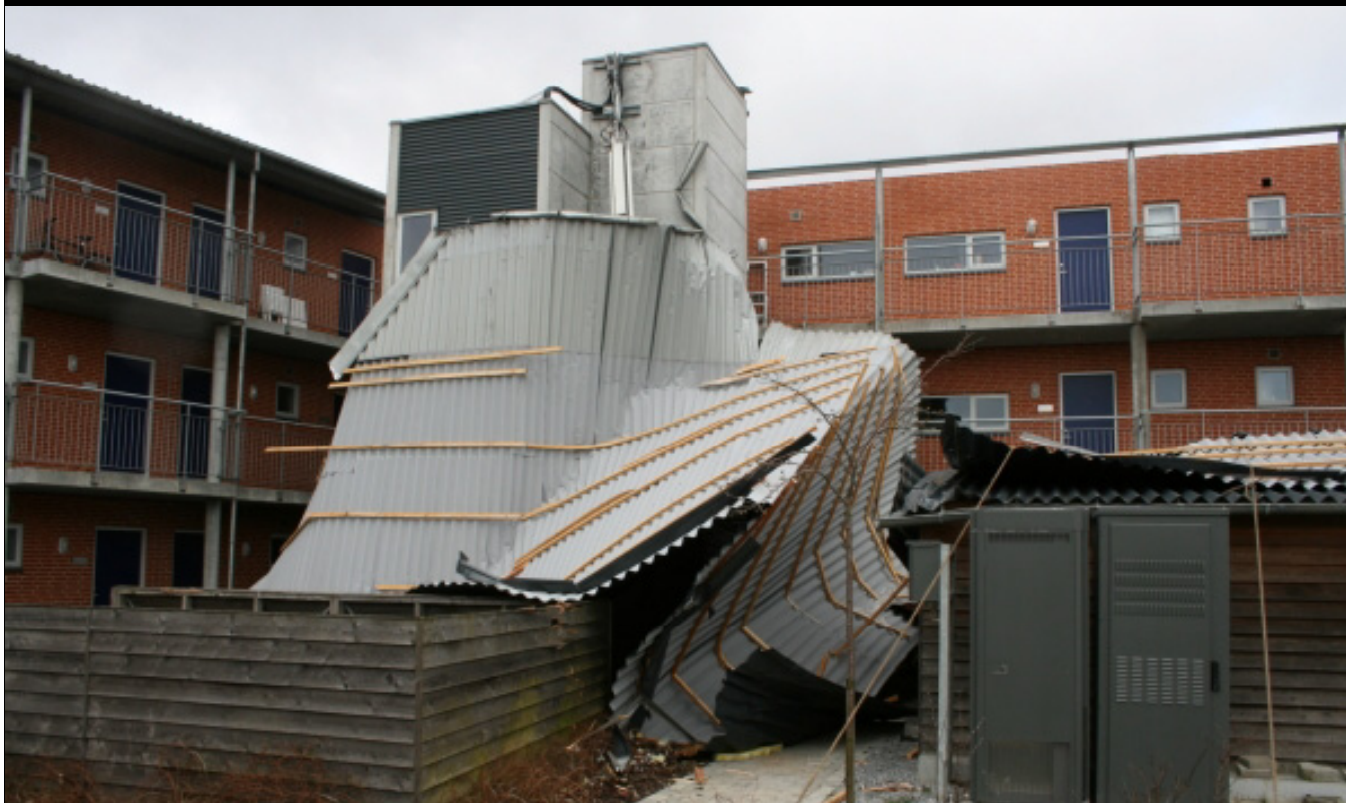
Roof of steel plates

- 300 m² blew off
- Wind speed far from characteristic
- Other part of the roof blew off 3 years ago
- No strengthening considered!

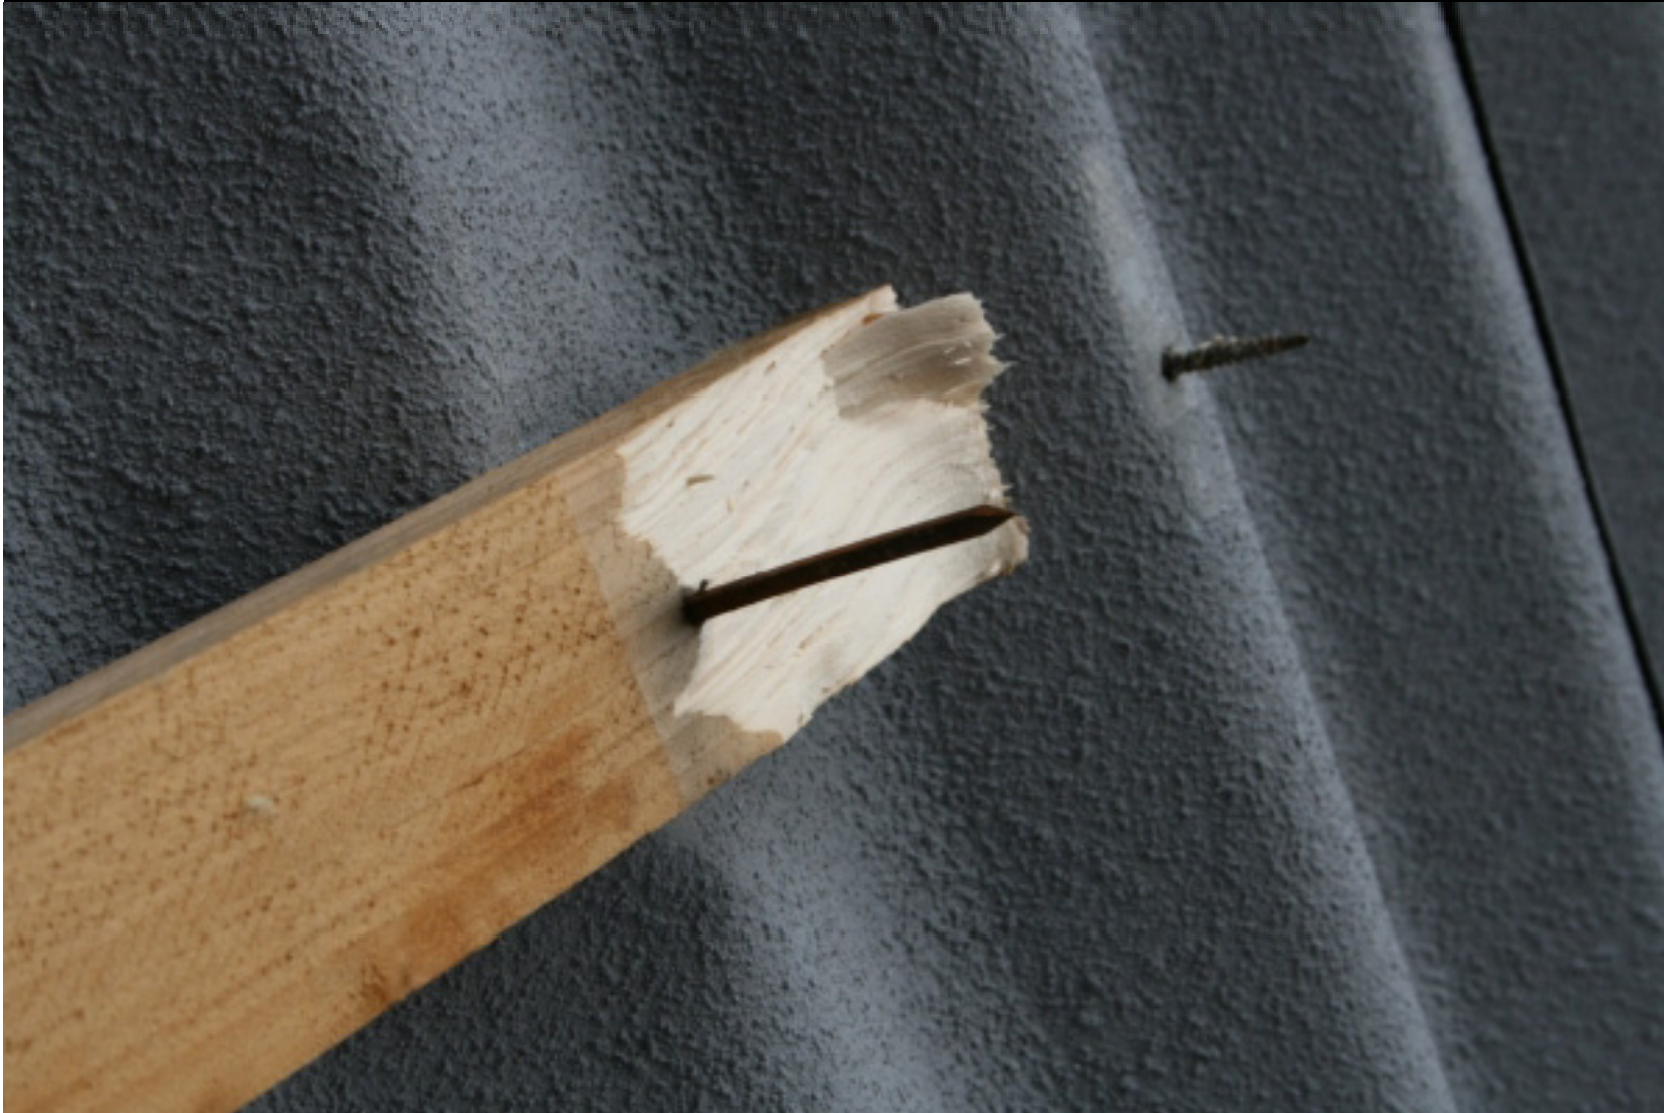
Cause

- Battens fastened with smooth nails (square and rusty)
