The Bad Reichenhall Ice-Arena Collapse

A contribution to COST action E55

2. The collapse of the Bad Reichenhall ice-arena structure

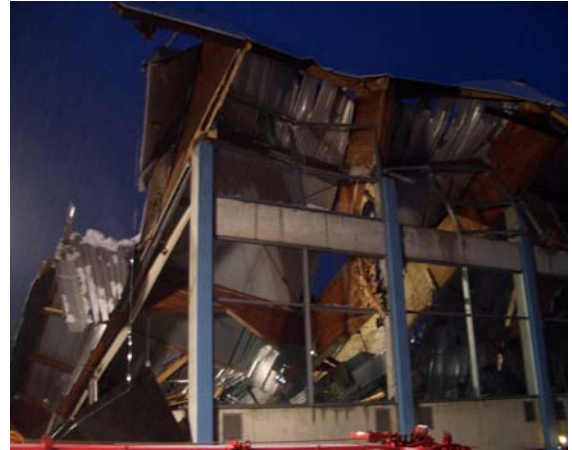
Figure 2: Partial view of the collapsed roof structure

According to the findings of the experts, one of the three main box-girders on the east side failed first. Due to the stiff cross girders, the loads were shifted from the box-girder that failed first to the neighbouring girders. These box-girders, which were already pre-damaged were also overloaded, due to which the entire roof collapsed like a zipper.”

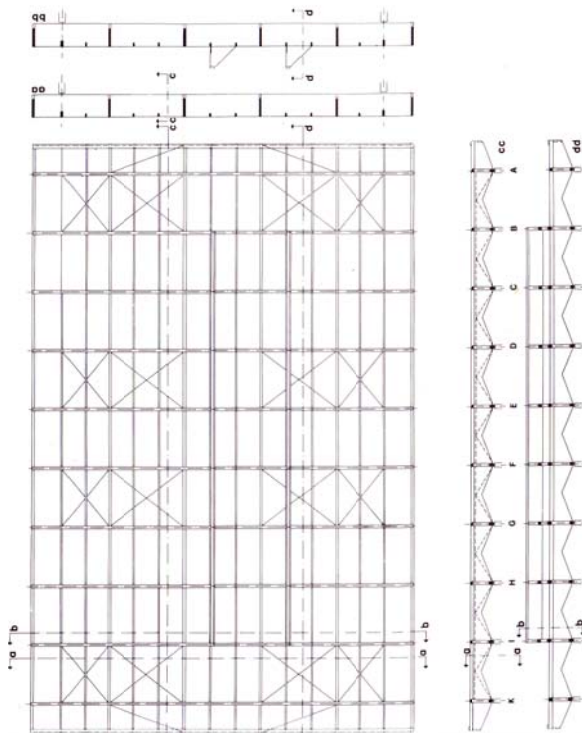
Figure 3: Layout of the arena and side view of the girders (extracted from [1])

The members of the secondary system (purlins) were planned to carry vertical loads and act as lateral bracing (K-bracing) for the main box-girders (see Figure 3). This resulted in very strong and stiff cross girders as well as very stiff connections between these members and the main box-girders. This enables the roof structure to redistribute loads between the girders. A random local failure would therefore not have caused collapse. This also means that the box-girders are not key elements in the usual meaning of the term.

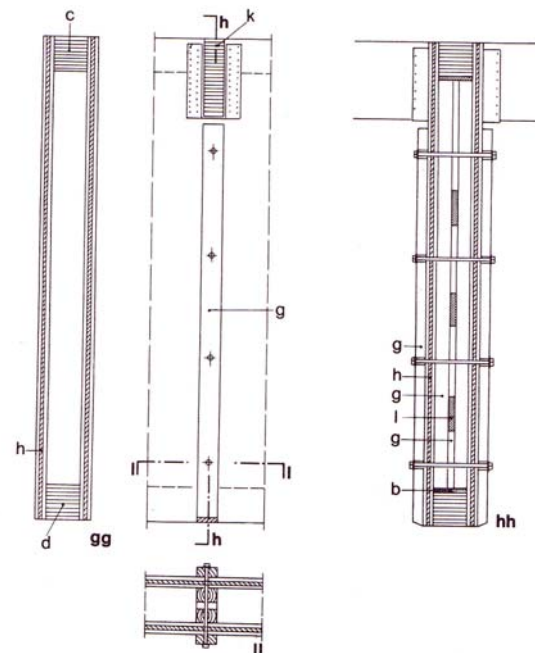
Figure 4: Cross-section of the box-girders in the ice-arena (from [1]); c-upper girder, d-lower-girder, h - Kämpf web-board, k-purlin, g-reinforcement (to avoid buckling)

The production process for the box-girder cross sections of the main girders by means of block gluing between girders and web-boards did not correspond to the recognised rules of technology at the time [gluing secured by nails was and is limited to a board thickness of max. 35 – 50 mm]. The production of the vertical general finger joints of the web-boards must also be regarded as difficult and not very robust. The quality of the glue lines in these finger joints of the webs differed. Added to this was prior damage to the large-format web-boards due to changing humidity exposure. These structural defects were involved in causing the collapse of the arena.
