The Siemens Arena collapse in a robustness perspective

Jørgen Munch-Andersen, Danish Timber Information, 2009-03-03

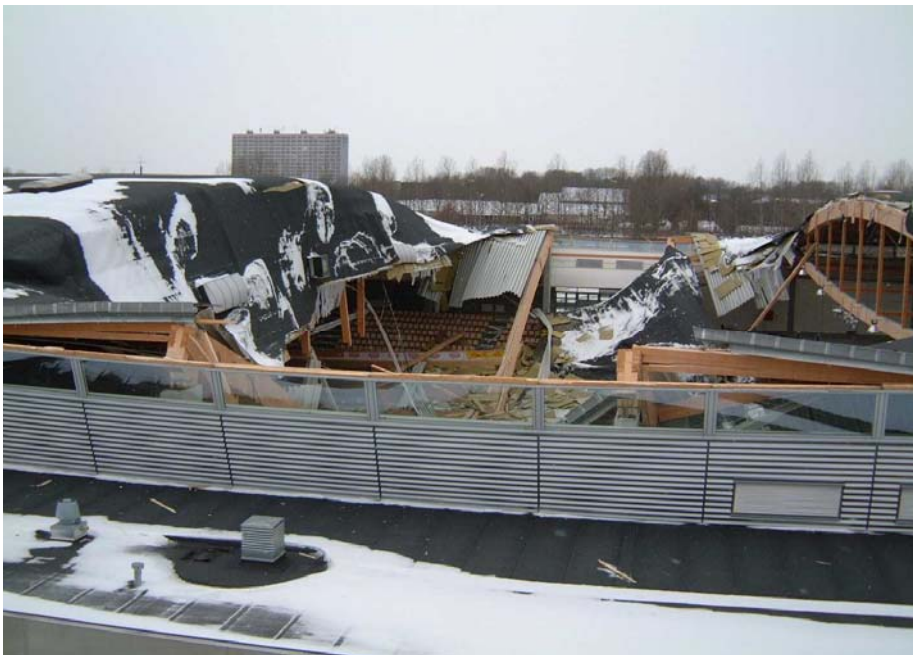
On one morning two trusses in the roof of Siemens Arena suddenly collapsed, see Figure 1. It happened just a few months after the inauguration of the arena and a few days before a major event should have taken place.

Figure 1. The roof of Siemens Arena after the collapse of two trusses. An intact truss is seen to the right.

The failure occurred without warning at a time with almost no wind and only a few millimetres of snow.

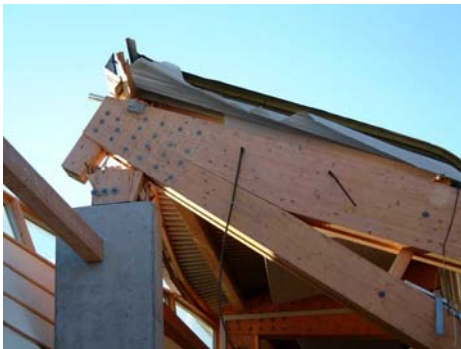
- A 48% too high design strength was used for the timber part
- The reduced height of the cross section near the ends of the arches, see Figure 2, was not considered
- The reduction of the cross section due to holes in the timber for steel plates, bolts and dowels, see Figure 3, were not considered

Figure 2. The corner has concealed steel plates which connects the timber parts. Between the visible bolts numerous dowels are placed.

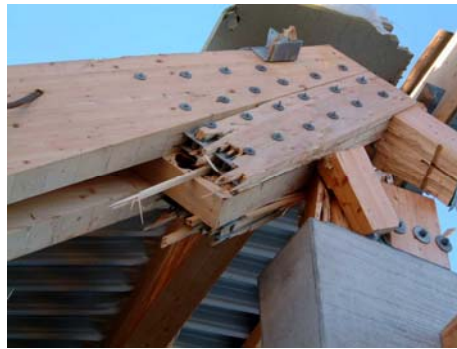
An investigation [1] showed that the problem could be localised to one critical cross-section at the corner in the tension arch where the strength was found to be between 25 and 30% of the required strength, see Figure 3. By mistake, this cross-section was not considered at all in the design.

The expected short term capacity at the critical cross section happened to be only slightly larger than the force from the self weight of the structure. Therefore the collapse could take place at a time with no special external load, just due to the decreasing strength over time (i.e. k_{mod})

Figure 3. Rupture at the critical cross section in the corner connection. Note the dowels and steel plates.
