COST E55, Trondheim, 2009

# Some statements on cracks in grain direction

Details from the research project:  
“Failure analysis on timber structures in Germany”

Matthias Frese

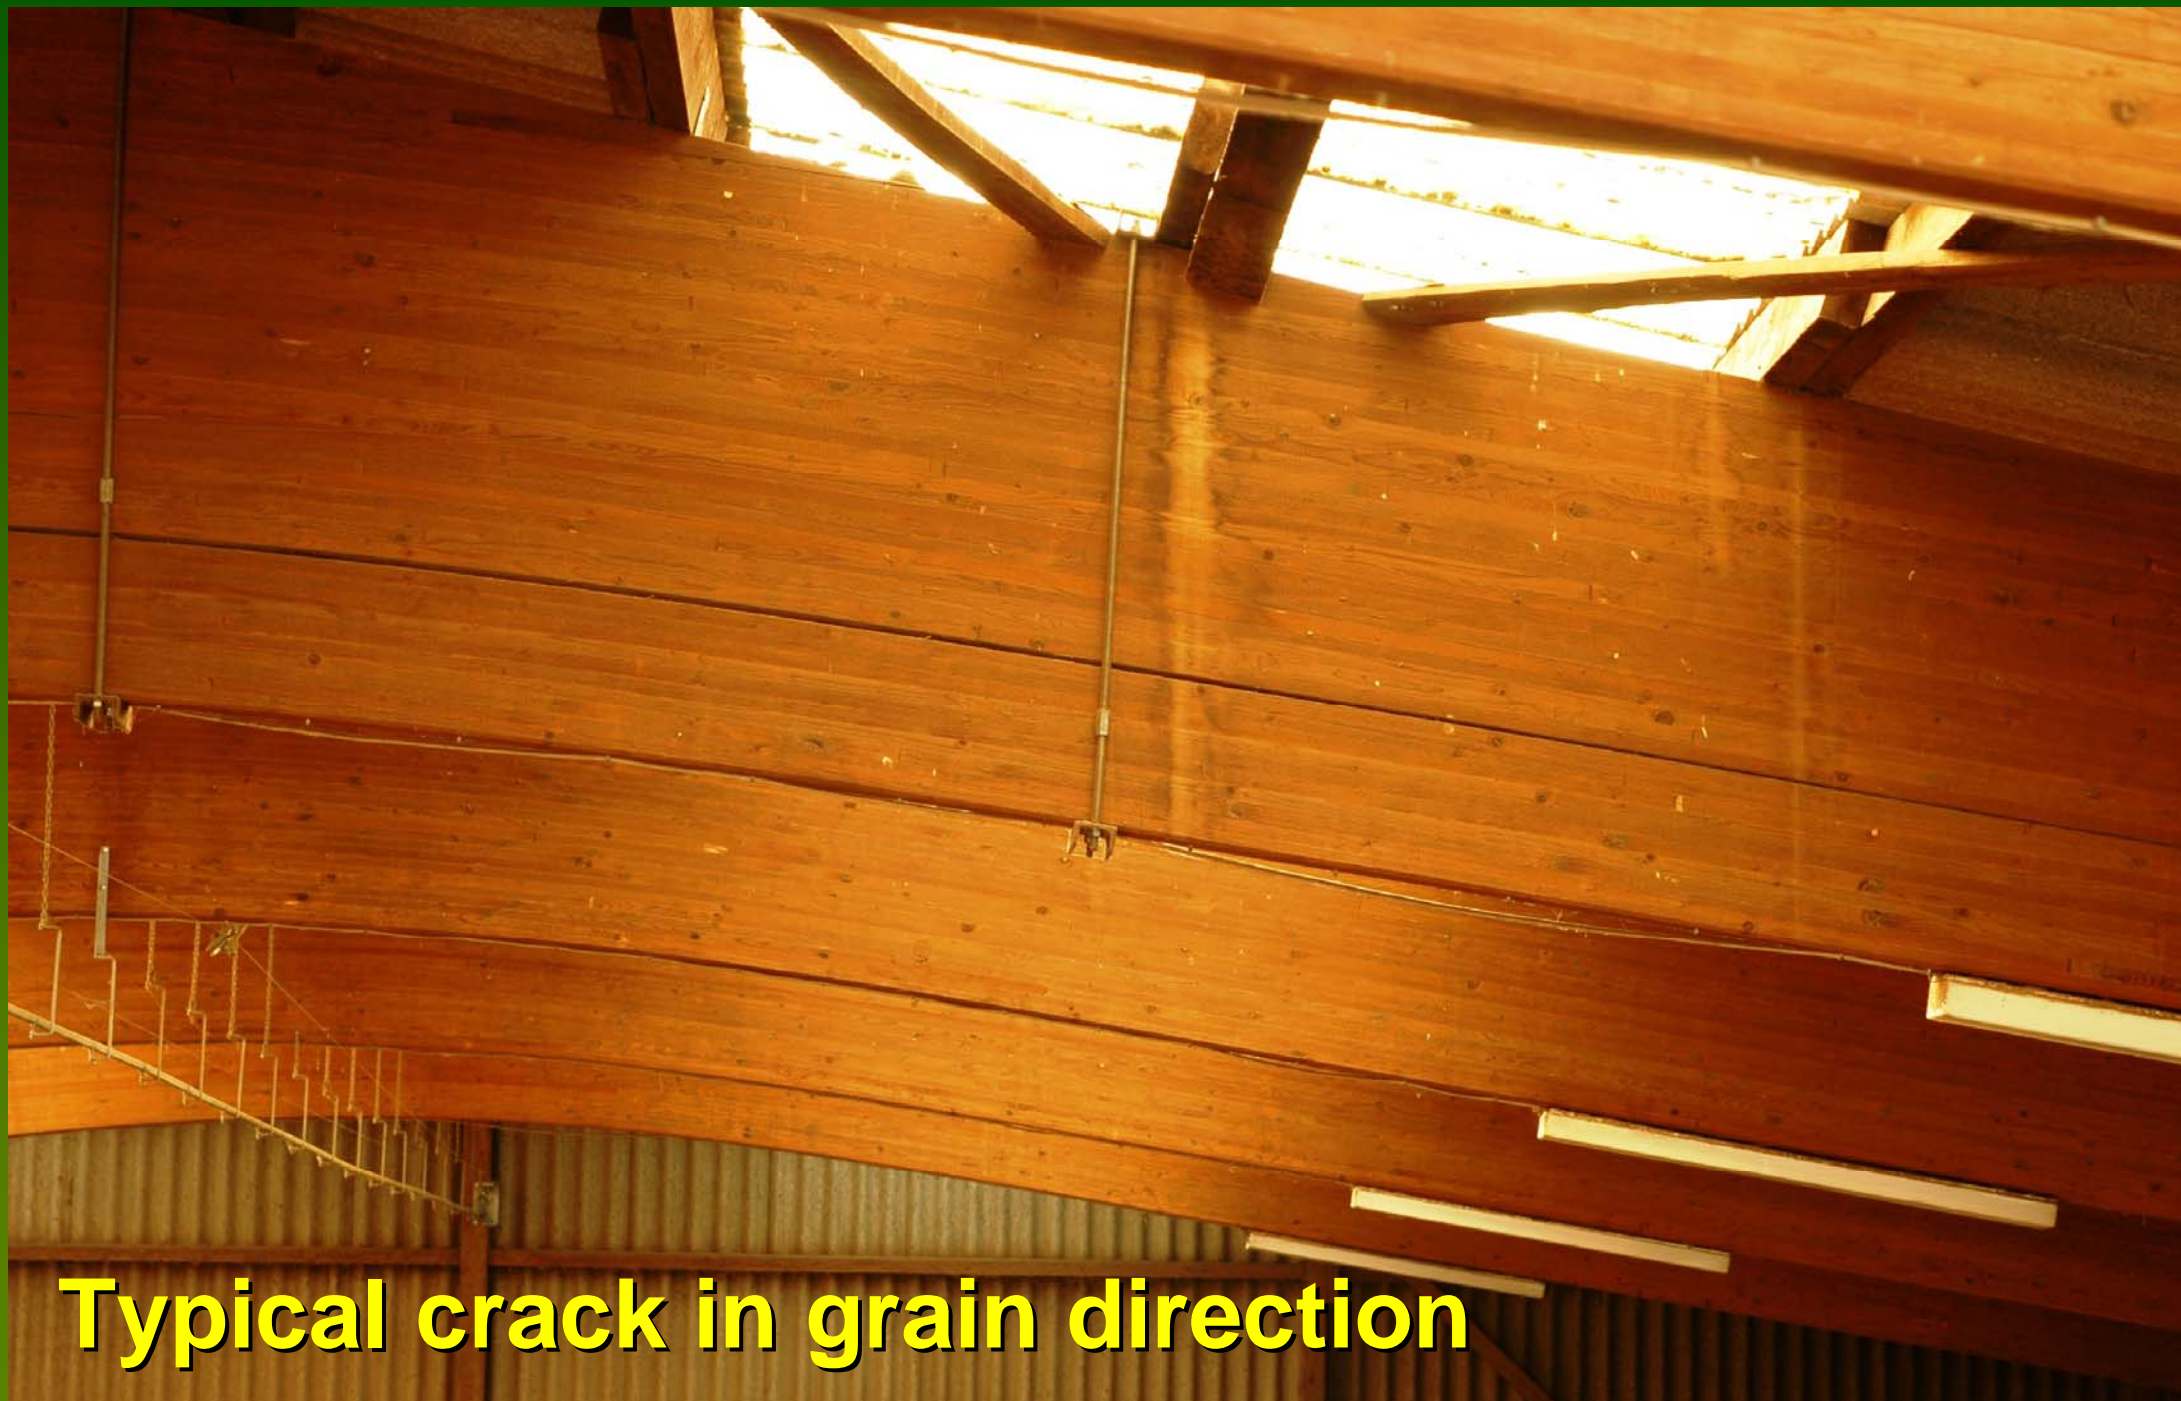
## Typical crack in grain direction

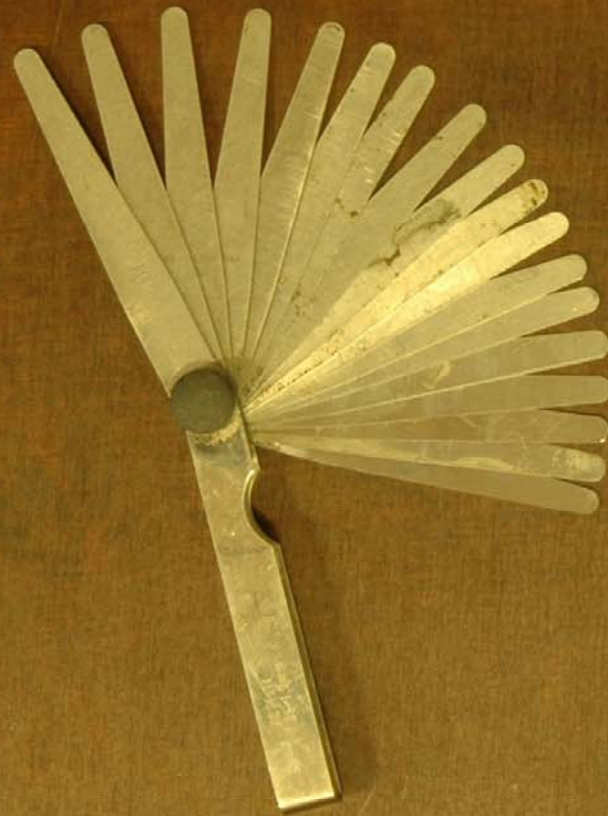
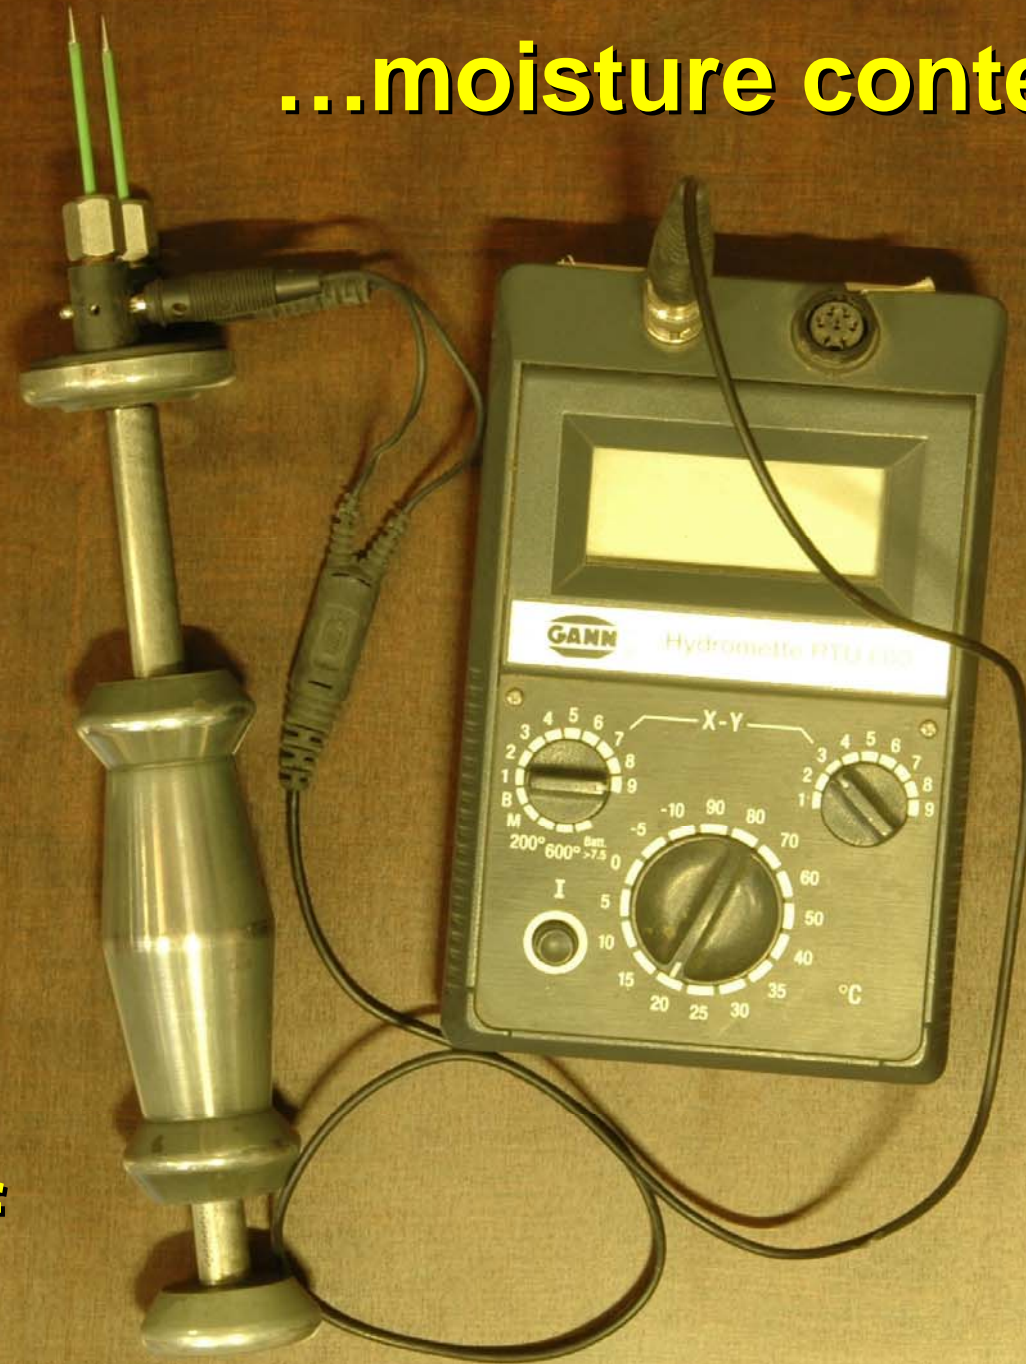
Measurement of  
crack depth
