Evaluation of wide-span timber structures - results and recommendations

Summary

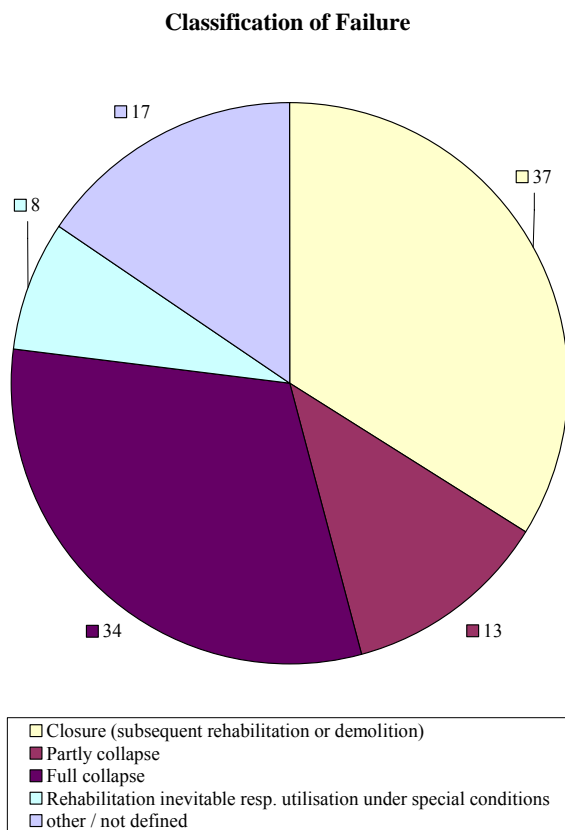
Fig. 1: Classification of Failure

In total, 109 structures were included in the evaluation. The majority of information was received for structures in Bavaria. This can be explained by strong snowfall and administrative divisions, both leading to an accumulation of structural investigations. Only investigated (or visibly failed) structures can become noticeable. All failures were classified into total collapse, partly collapse, closure (also temporary) and rehabilitation (see Fig. 1). 71% of the reported buildings included structural elements from timber (77 in total), the reason partly being the high sensitivity of authorities towards timber structures after the Bad Reichenhall ice-arena collapse, having led to increased investigations on timber structures. In 54% of all collapsed structures, structural members in timber were the main reason for failure. 62% of the classified timber structures were glulam structures (see Fig. 2), mirroring the prevalent utilization of glulam for wide-span timber structures but also indicating problems associated with this building material (e.g. reinforcement of curved and pitch cambered glulam beams), which are nowadays mainly covered by the new code generation. Since information received was partly scarce, all diagrams include a partition "not defined". For reasons of failure, multiple answers could be given, which explains the variation in total numbers in these diagrams.

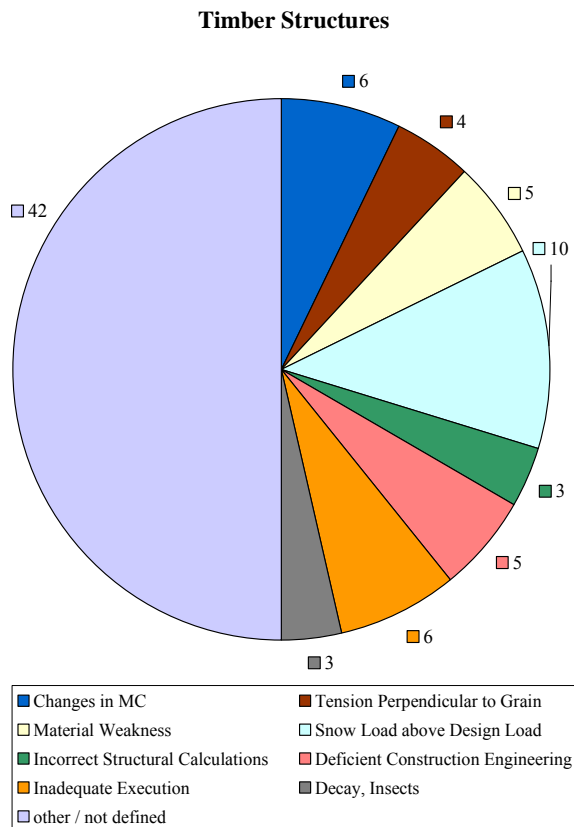
Fig. 3: Timber Structures

The most common cause of failure are errors in design, construction and maintenance due to human error (incorrect structural calculations, deficient construction engineering, inadequate execution, on-site alterations), accounting for 33%, (resp. 43% for glulam structures) of failures (see Fig. 3 and Fig. 4). The quota of failed structures in which the execution differed considerably from checked

Environmental conditions, leading to low or high moisture content (and eventually to decay) were in 21% (20%) of the cases the cause for failure. Human error is again the main reason for the occurrence of these failures due to a lack of consideration of environmental effects during planning or conversions during the lifetime of the building (e.g. open structures being converted into closed exhibition halls). Structures with large cross-sections are especially at risk if they, due to the respective use (e.g. ice-rink arenas, riding rinks), are exposed to high changes in moisture content (MC). The changing moisture gradient leads to a progressive crack formation, especially when free shrinkage is hindered by e.g. highly offset fasteners.

Material weakness, including tension perpendicular to grain failure accounted for 21% (23%) of the causes of failure, again being influenced by human error. For example, the reinforcement against tension perp. to grain stresses is state of the art since 1980 but was not always applied. Further examples include the use of inappropriate glue (e.g. the use of urea formaldehyde glue in moist climates) or the use of inappropriate finger joints or cup shake.

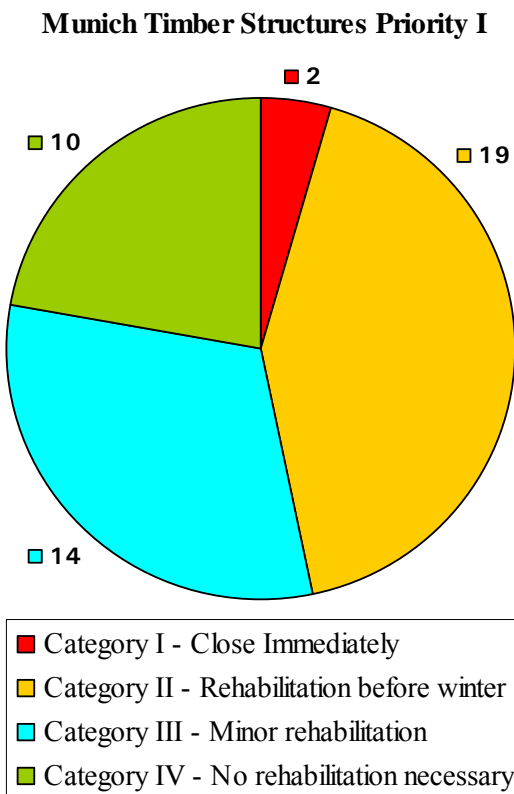
Fig. 5: Munich Timber Structures - Priority I Fig. 6: Munich Timber Structures - Priorities I-III

The highest priority had to be assessed in short timeframe to enable potential rehabilitation measures to be carried out before the next snowfall. Therefore, the assessment of the Priority I structures was linked directly to a categorization of these structures for further rehabilitation measures (see Fig. 5).

From 45 buildings, classified priority I, two structures had to be closed until the completion of rehabilitation measures. In both cases, the bracing system was insufficient or inexistent. 19

structures (= 42%) could remain open but had to be rehabilitated before the next snowfall (see Fig. 5). Structures in this category had shown various failures, prevalently in the structural calculations or execution of bracing systems, joints or large glulam beams.

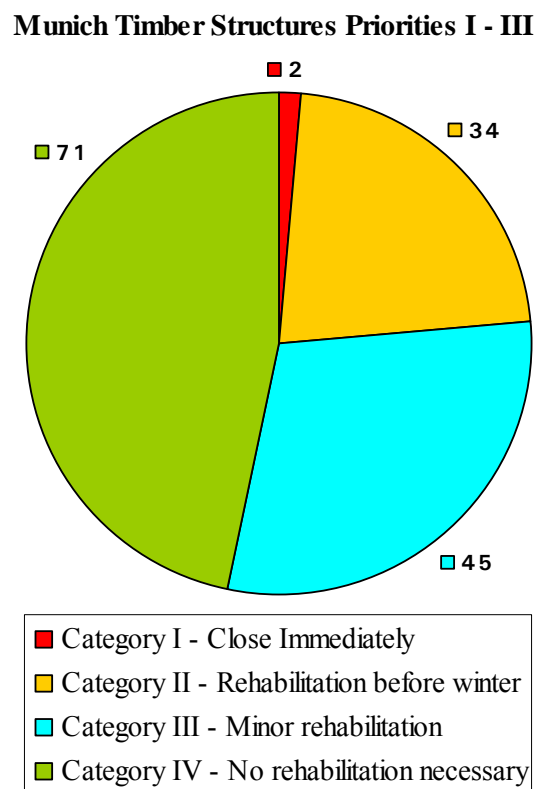
Buildings in Priorities II and III revealed better results. Of all 152 classified buildings, the majority of buildings (76 %) fell into categories III and IV, leaving 24 % of buildings which had shown structural failures (see Fig. 6).
