The Bad Reichenhall ice-arena collapse and the necessary consequences for wide span timber structures

**Univ.-Prof. Dr.-Ing.
Stefan Winter, TU München,
Chair of Timber Structures and Building Construction, TUM
Munich, Germany**

Summary

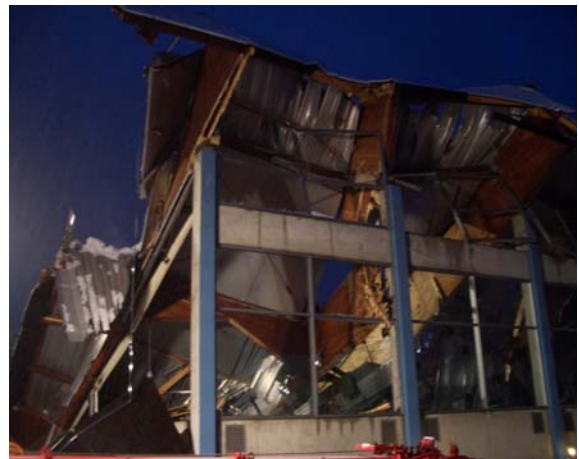
Figure 2 Partial view of the collapsed roof structure

According to the findings of the experts, one of the three main box-girders on the east side failed first. Due to the stiff cross girders, the loads were shifted from the box-girder that failed first to the neighbouring girders. These box-girders, which were already pre-damaged were also overloaded, due to which the entire roof collapsed like a zipper.”

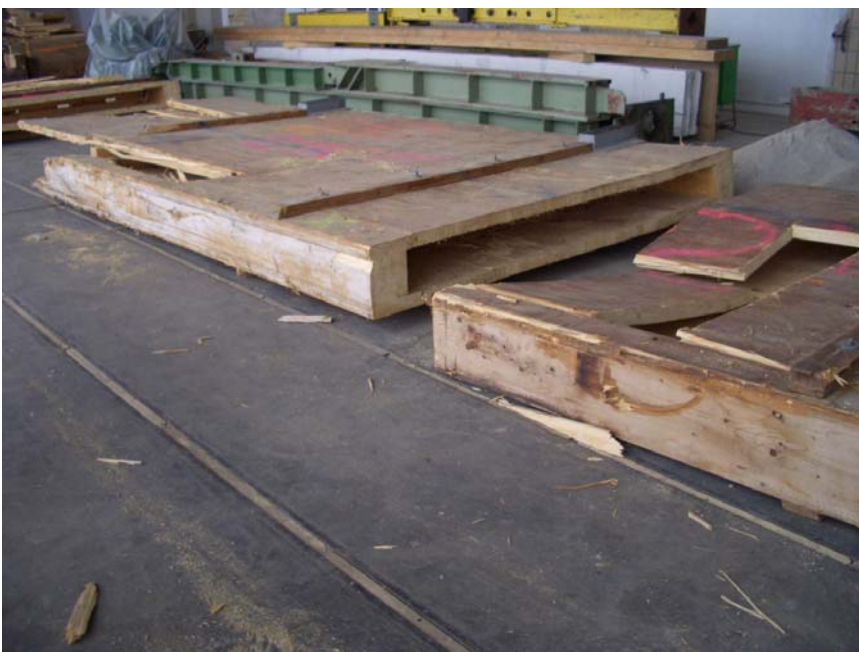
With the ice-arena in Bad Reichenhall, significant regulations in the technical approval for the Kämpf web-girder construction were violated and the scope of experience at that time was abandoned. In particular, the maximum girder height of 1.20 m according to the approval was far exceeded in the construction of the Bad Reichenhall ice-arena, with a girder height of 2.87 m. An applied-for extension of the approval to the planned type of construction with box-girders without a height limit was not granted by the German Institute for Building Technology in 1971. Therefore, a so-called “Approval for an individual case” by the Supreme Building Authority of the Free State of Bavaria for executing the special structure would have been necessary. According to the findings to date, such an approval was not applied for by those involved in construction and was not available.

Figure 5 Box-girders with Kämpf web-boards with $h = 2.87$ m

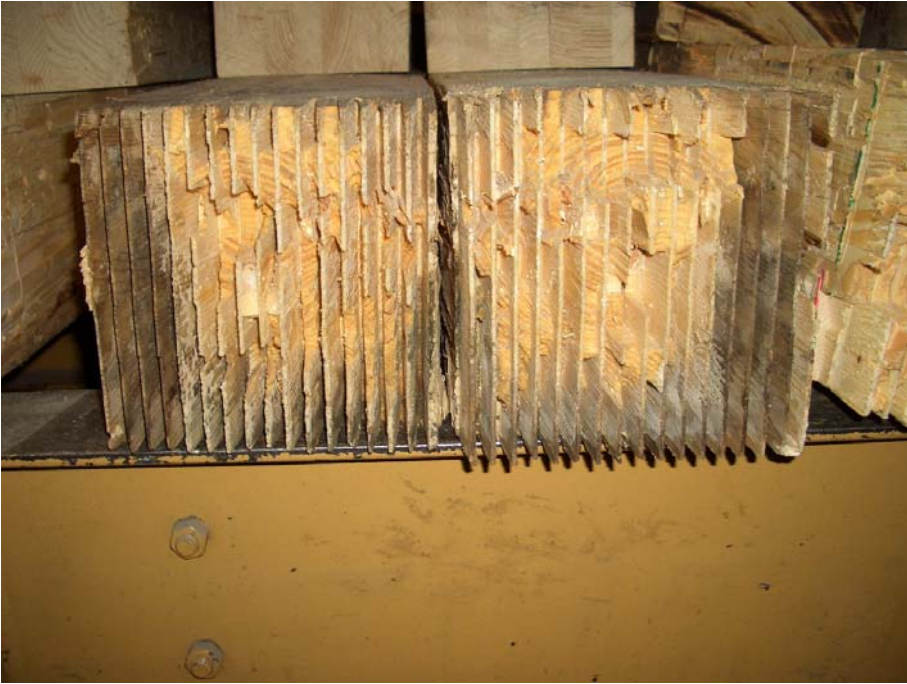
Through the humidity exposure over the years in the Bad Reichenhall ice-arena, the glue-lines carried out with urea-formaldehyde glues cause significant damage to the roof structure. This primarily affected the general finger joints on the lower girders and the bonding between the girders and the web-boards. On the general finger joint of the lower girders, there was so much damage to the glue in some cases, that it no longer had an adhesive effect to a depth of 50 mm to 80 mm.

Figure 6 Damaged general finger joint of upper glulam girder due to water penetration (figure is presented upside down!)

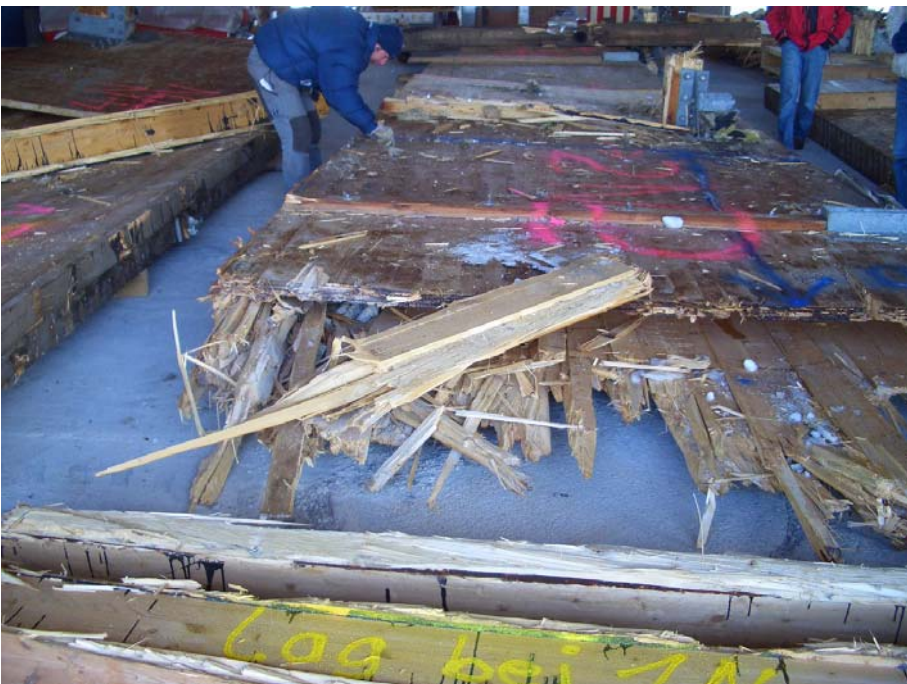
technology at the time [gluing secured by nails was and is limited to a board thickness of max. 35 – 50 mm]. The production of the vertical general finger joints of the web-boards must also be regarded as difficult and not very robust. The quality of the glue lines in these finger joints of the webs differed. Added to this was prior damage to the large-format web-boards due to changing humidity exposure. These structural defects were involved in causing the collapse of the arena.

Figure 7 General finger joint of a Kämpf web-board

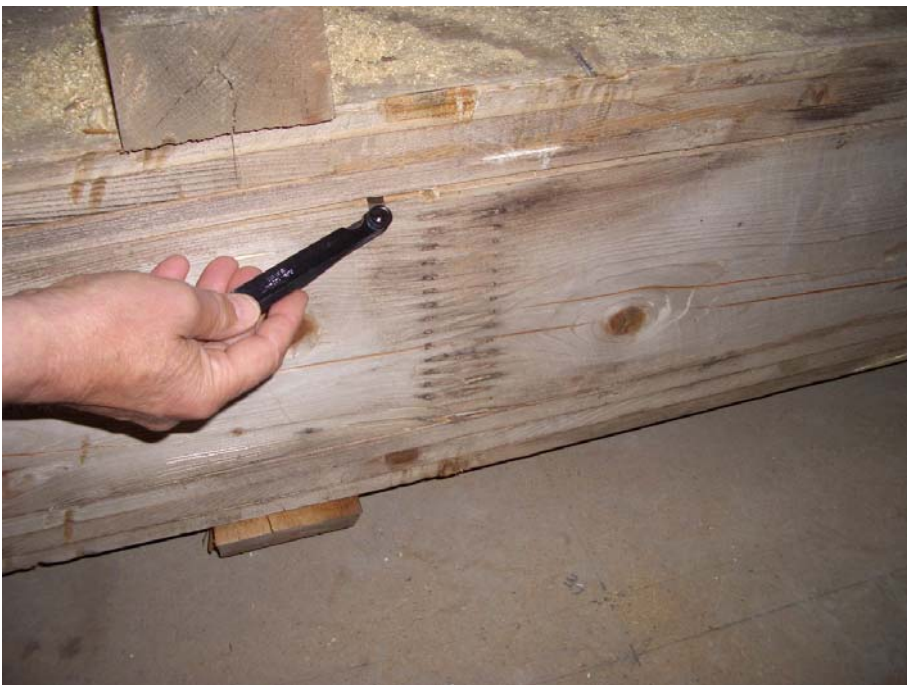
A professional examination of the structural integrity of the roof structure is not documented. With this, it should have been taken into account that it involved a special structure. Furthermore, even years ago, indications must already have existed for damage to the glue lines between glulam-girders and web-boards, as well as to the general finger joints of the lower girders and the general finger joints of the web-boards. For a professional, this should have given rise to a more detailed examination of the condition of the roof structure and the related technical documentation.

Figure 8 Damaged glulam-girder to web-board glue line
