Robustness of large-span timber structures – Two examples

Jørgen Munch-Andersen Philipp Dietsch (TUM)

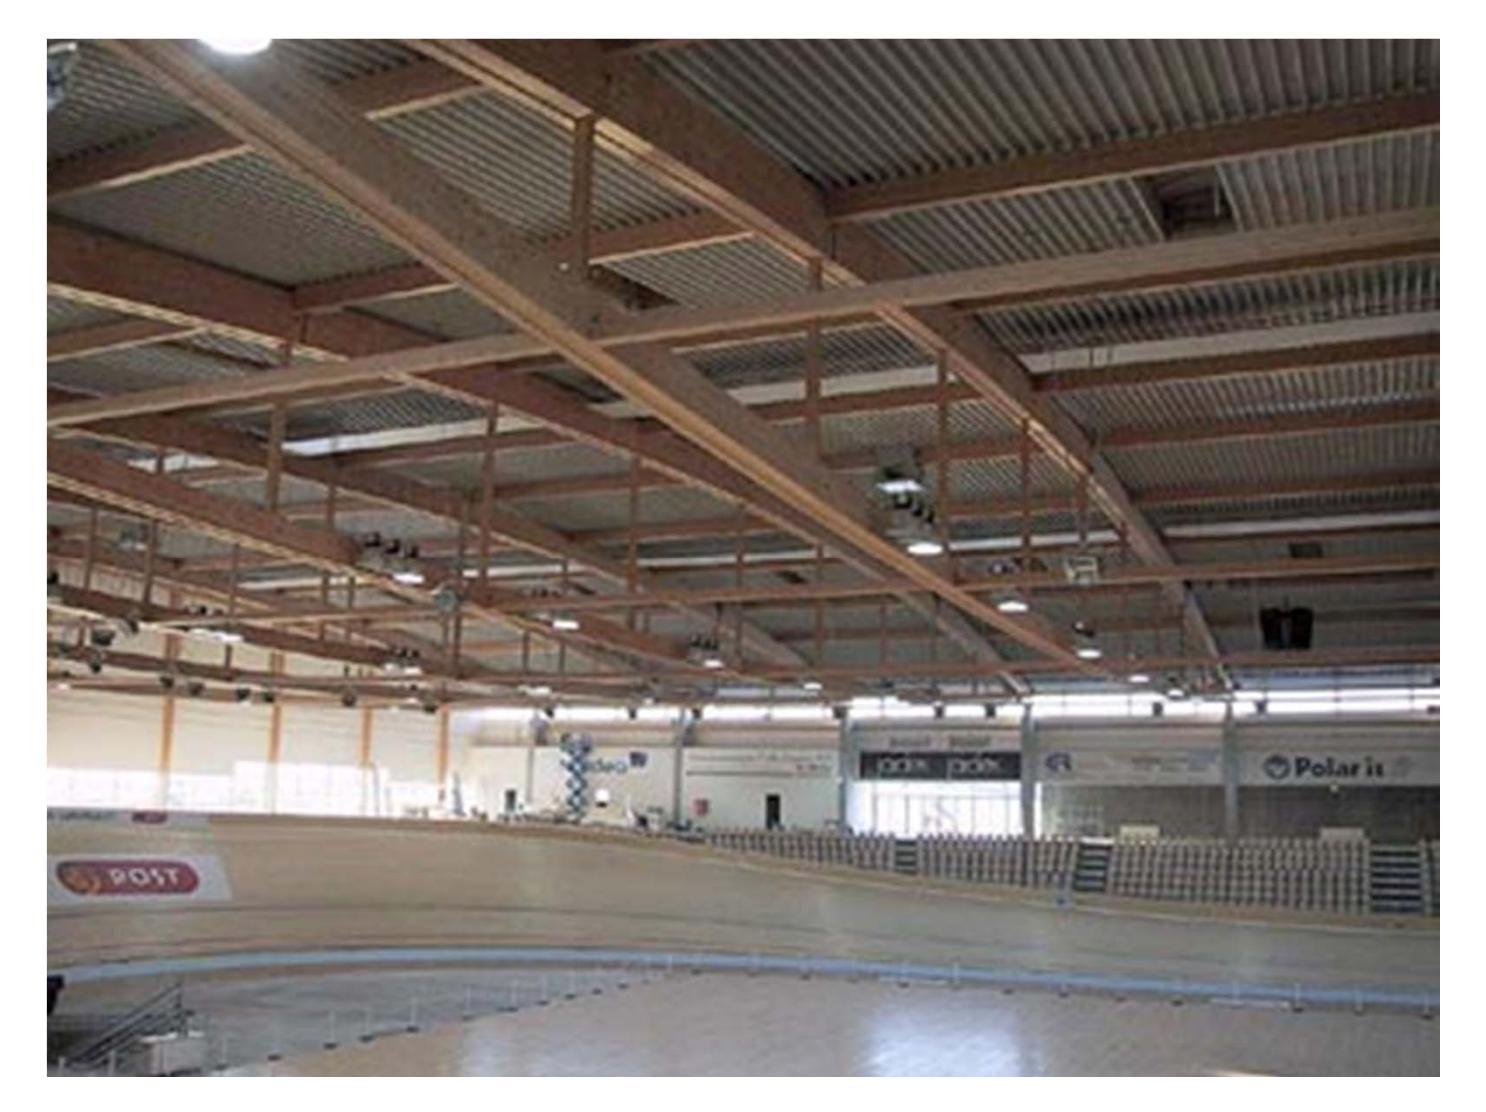
Siemens Arena, Denmark (2001) Cycling arena with glulam trusses, span 73 m Simply supported purlins, span 12 m

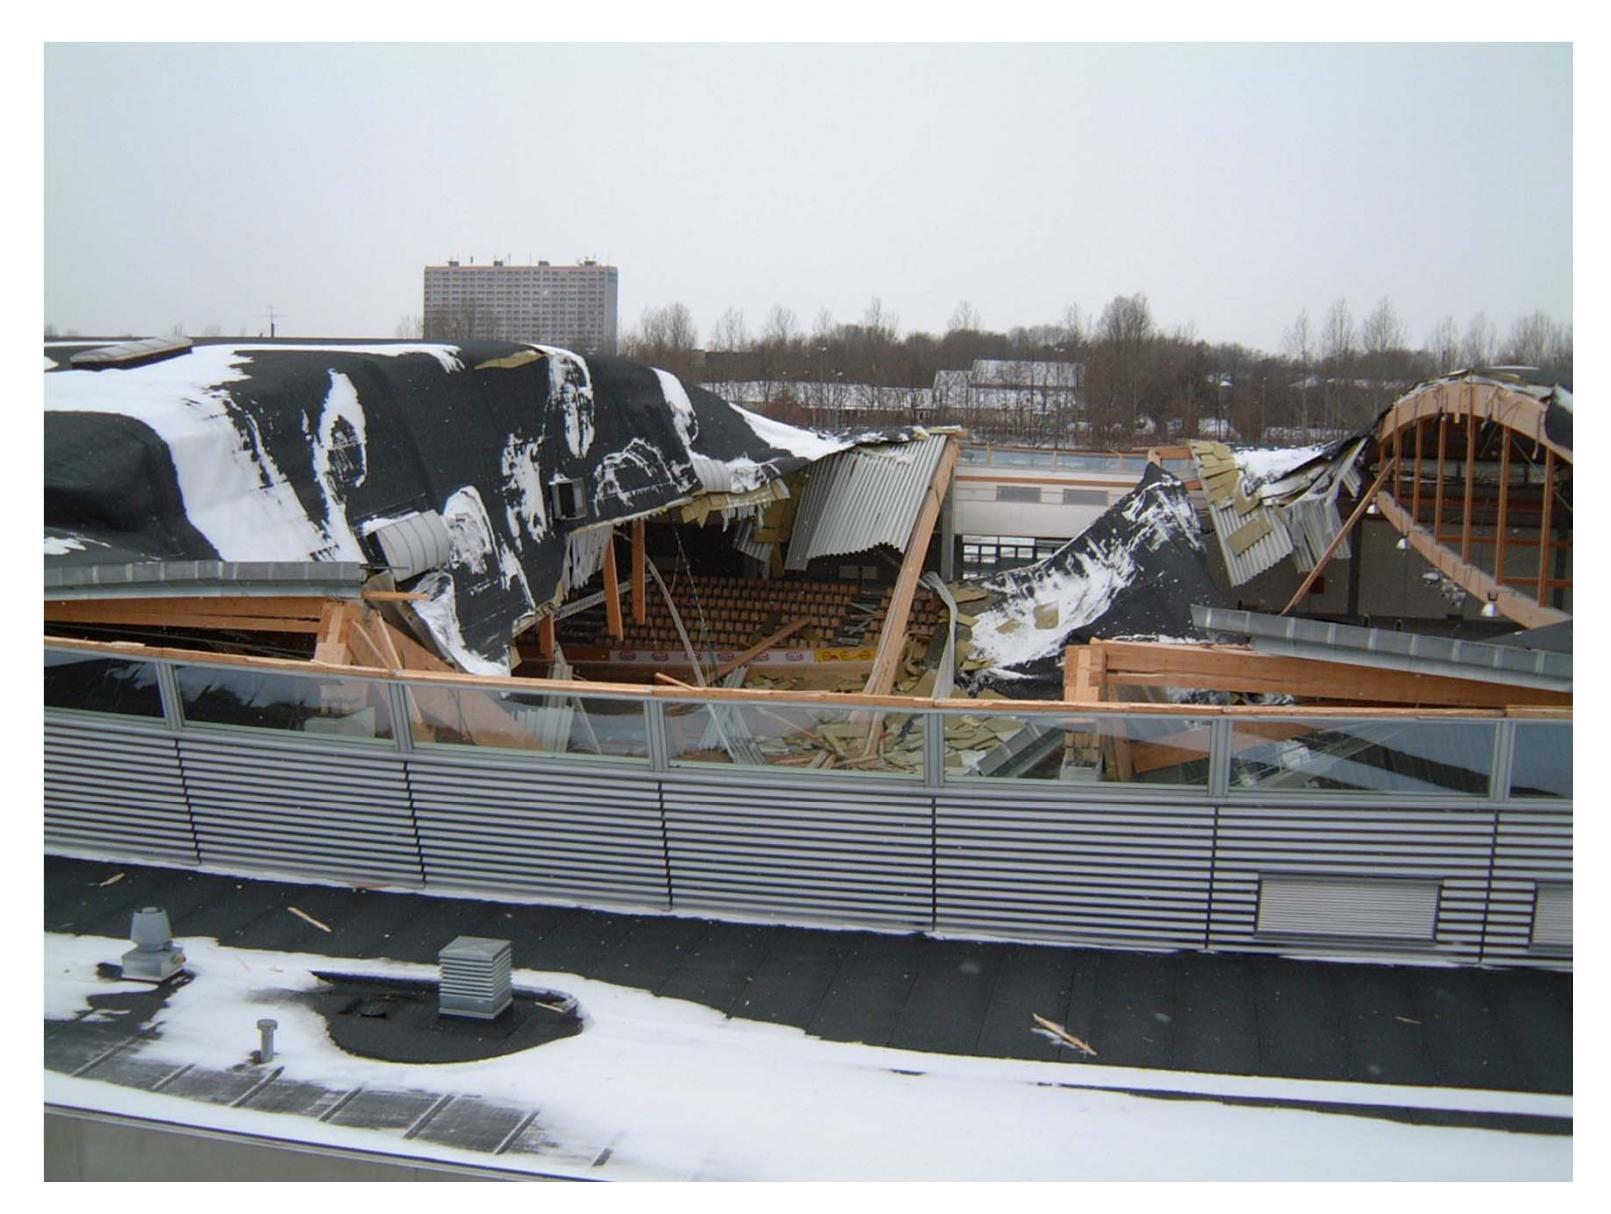
Siemens Arena - failure 2 trusses failed (2600 m²), no significant wind or snow

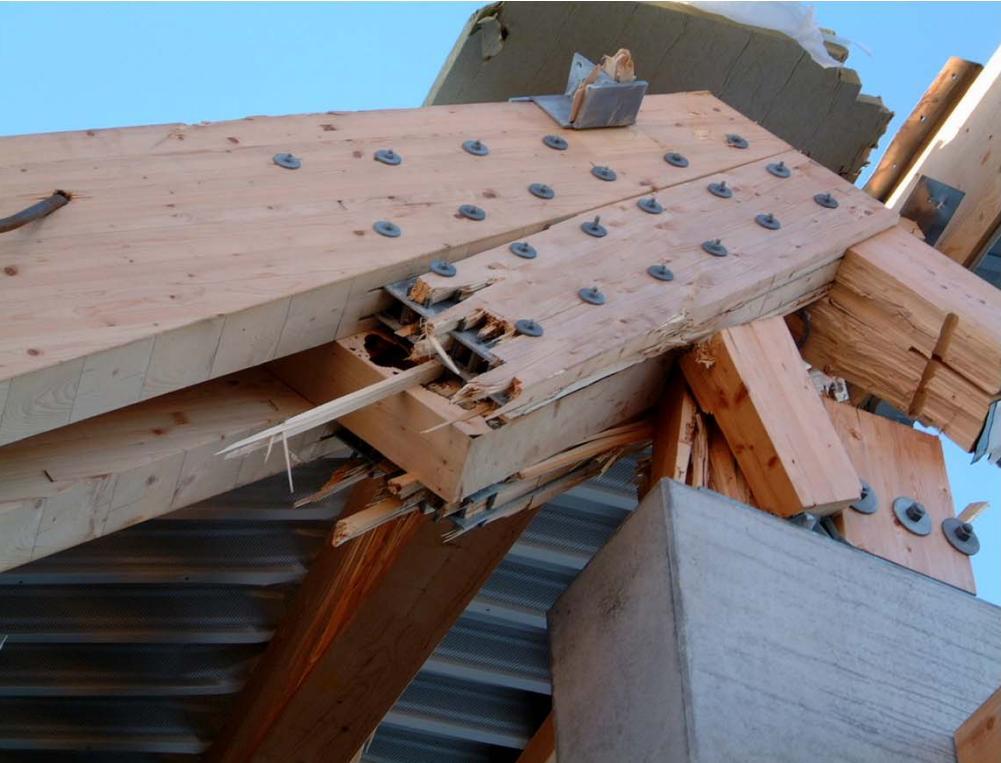
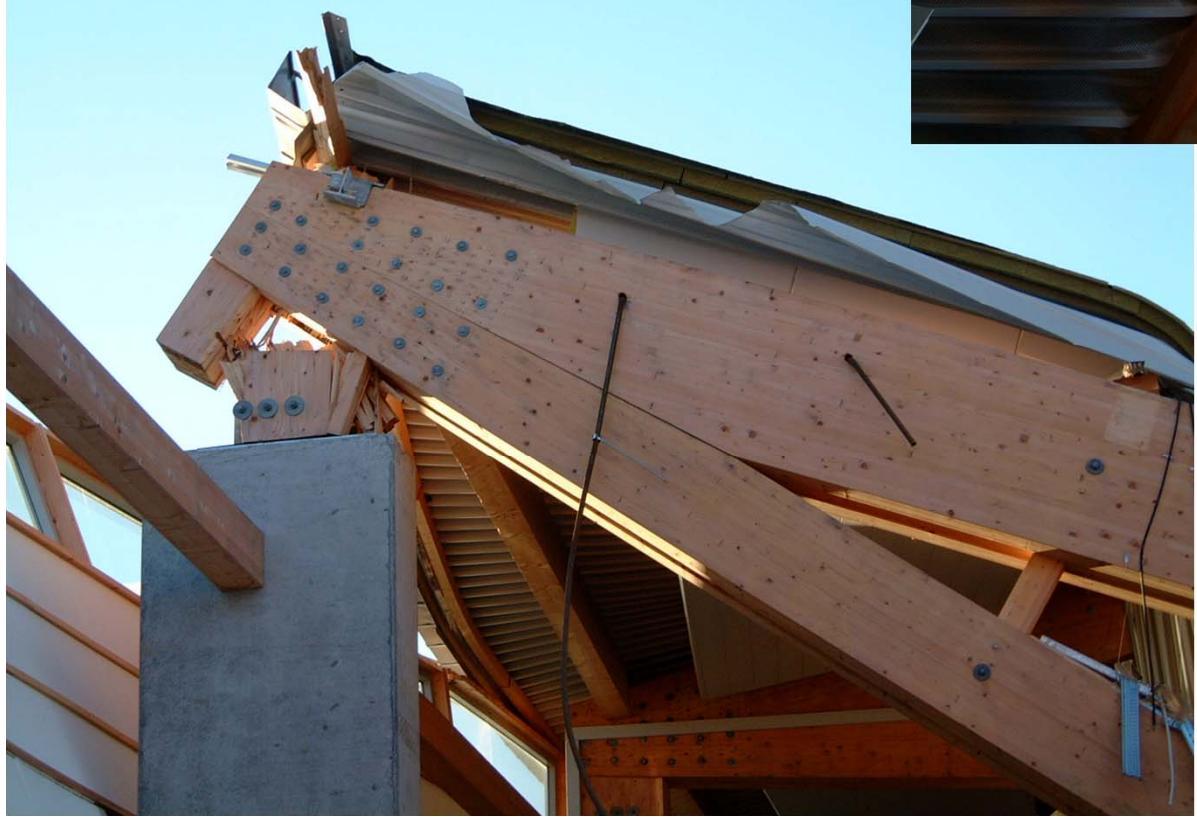
Too high design strength Reduced timber area at connection not accounted for

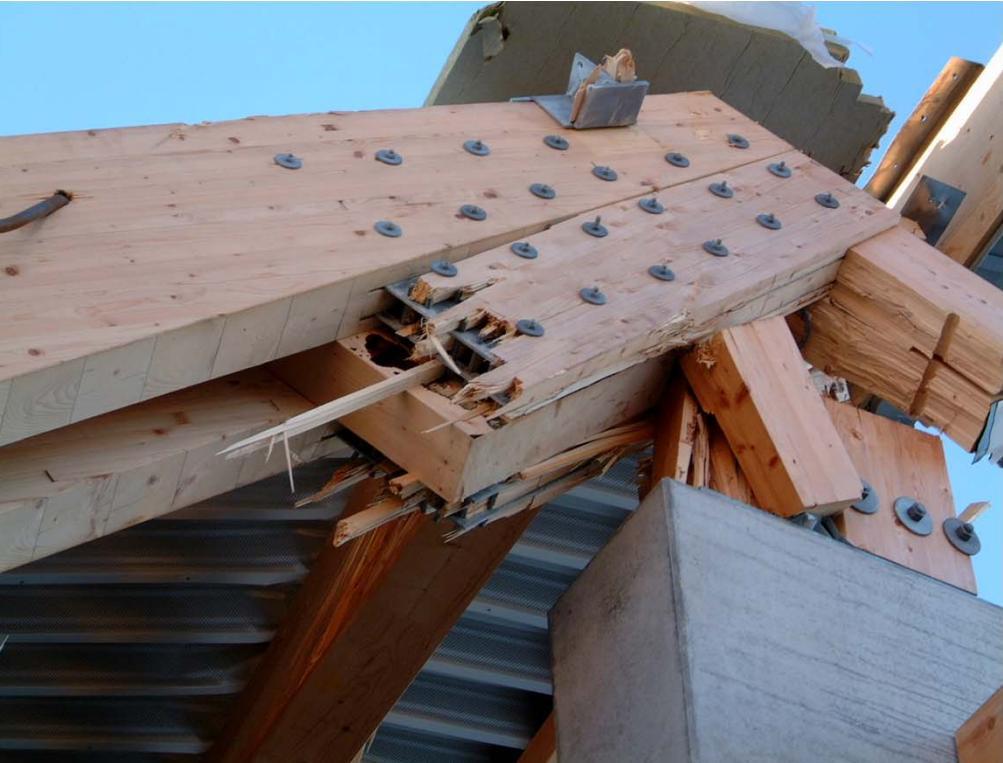
Too high design strength Reduced timber area at connection not accounted for

Load-bearing capacity only 25-30% of required Failed due to k_{mod}-effect ("static fatigue")

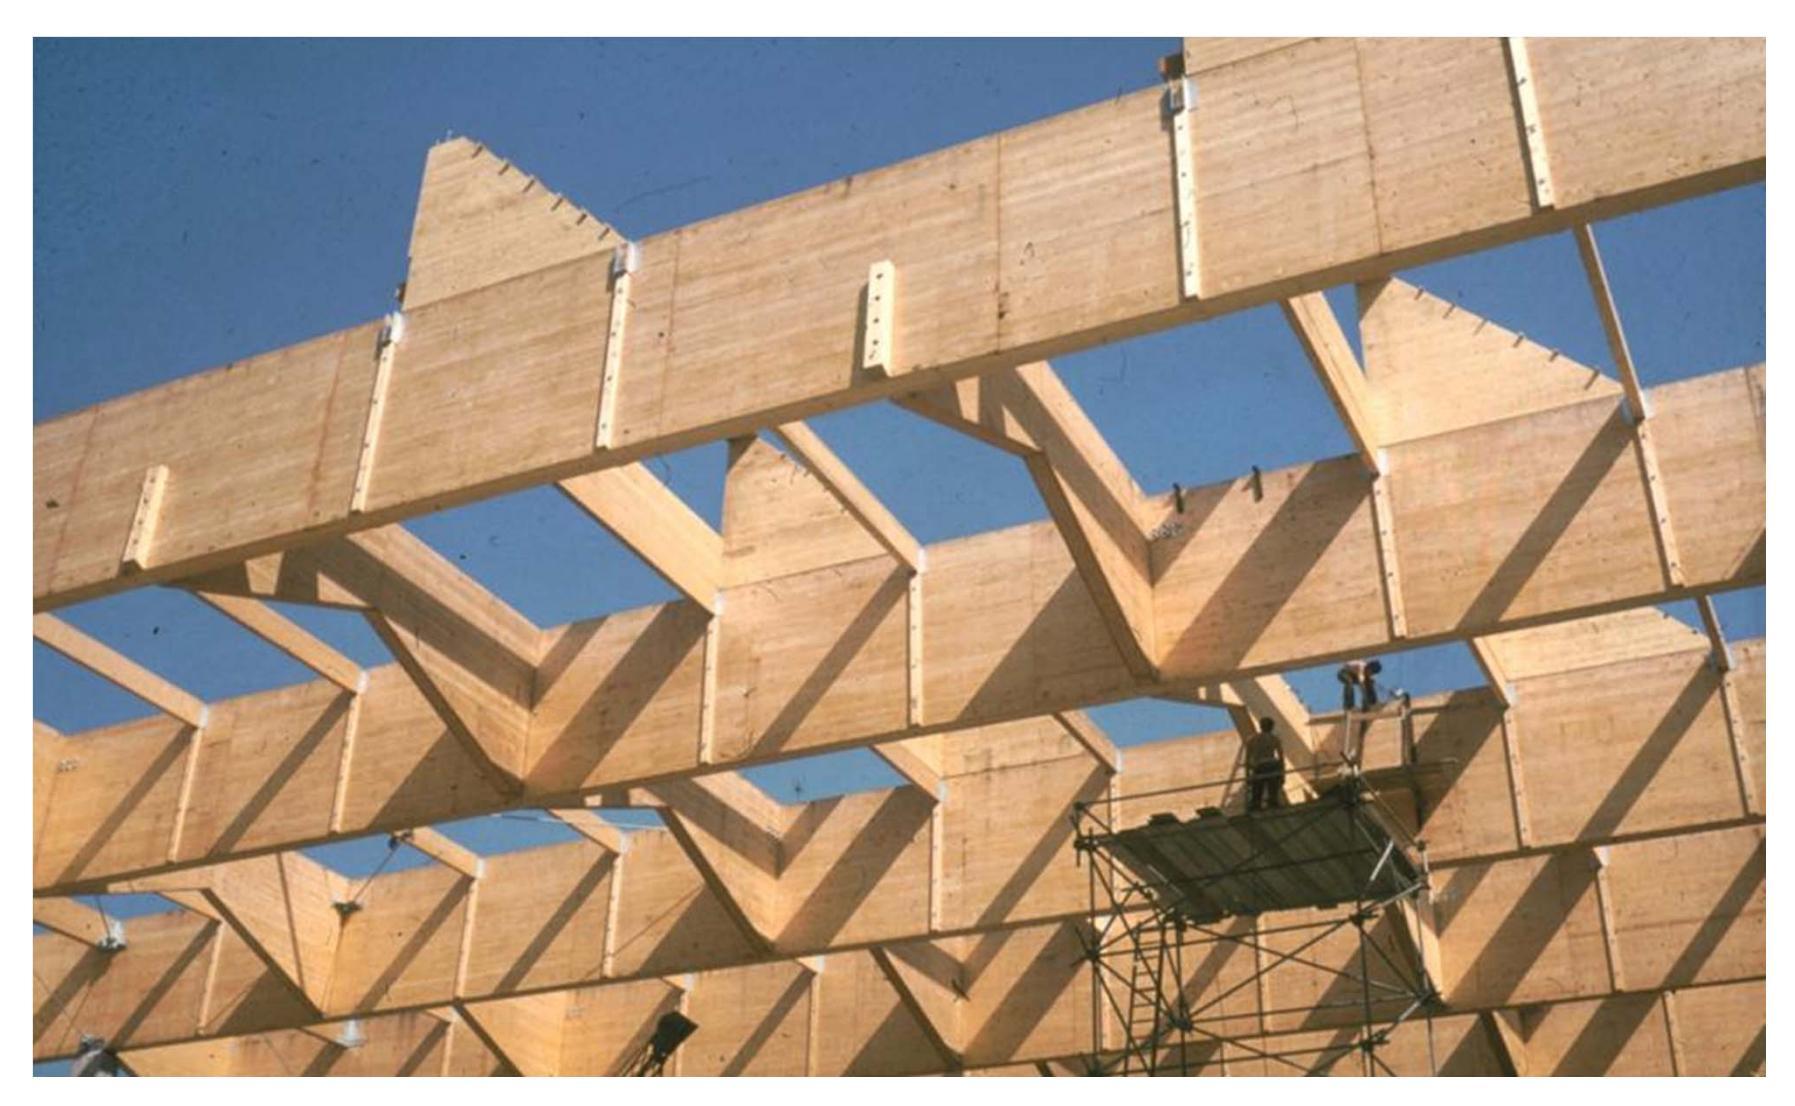
Bad Reichenhall Arena, Germany (1972) Ice-arena with 2.9 m high box-girders, span 48 m Finger joints in girders per 16 m, K-shaped bracing

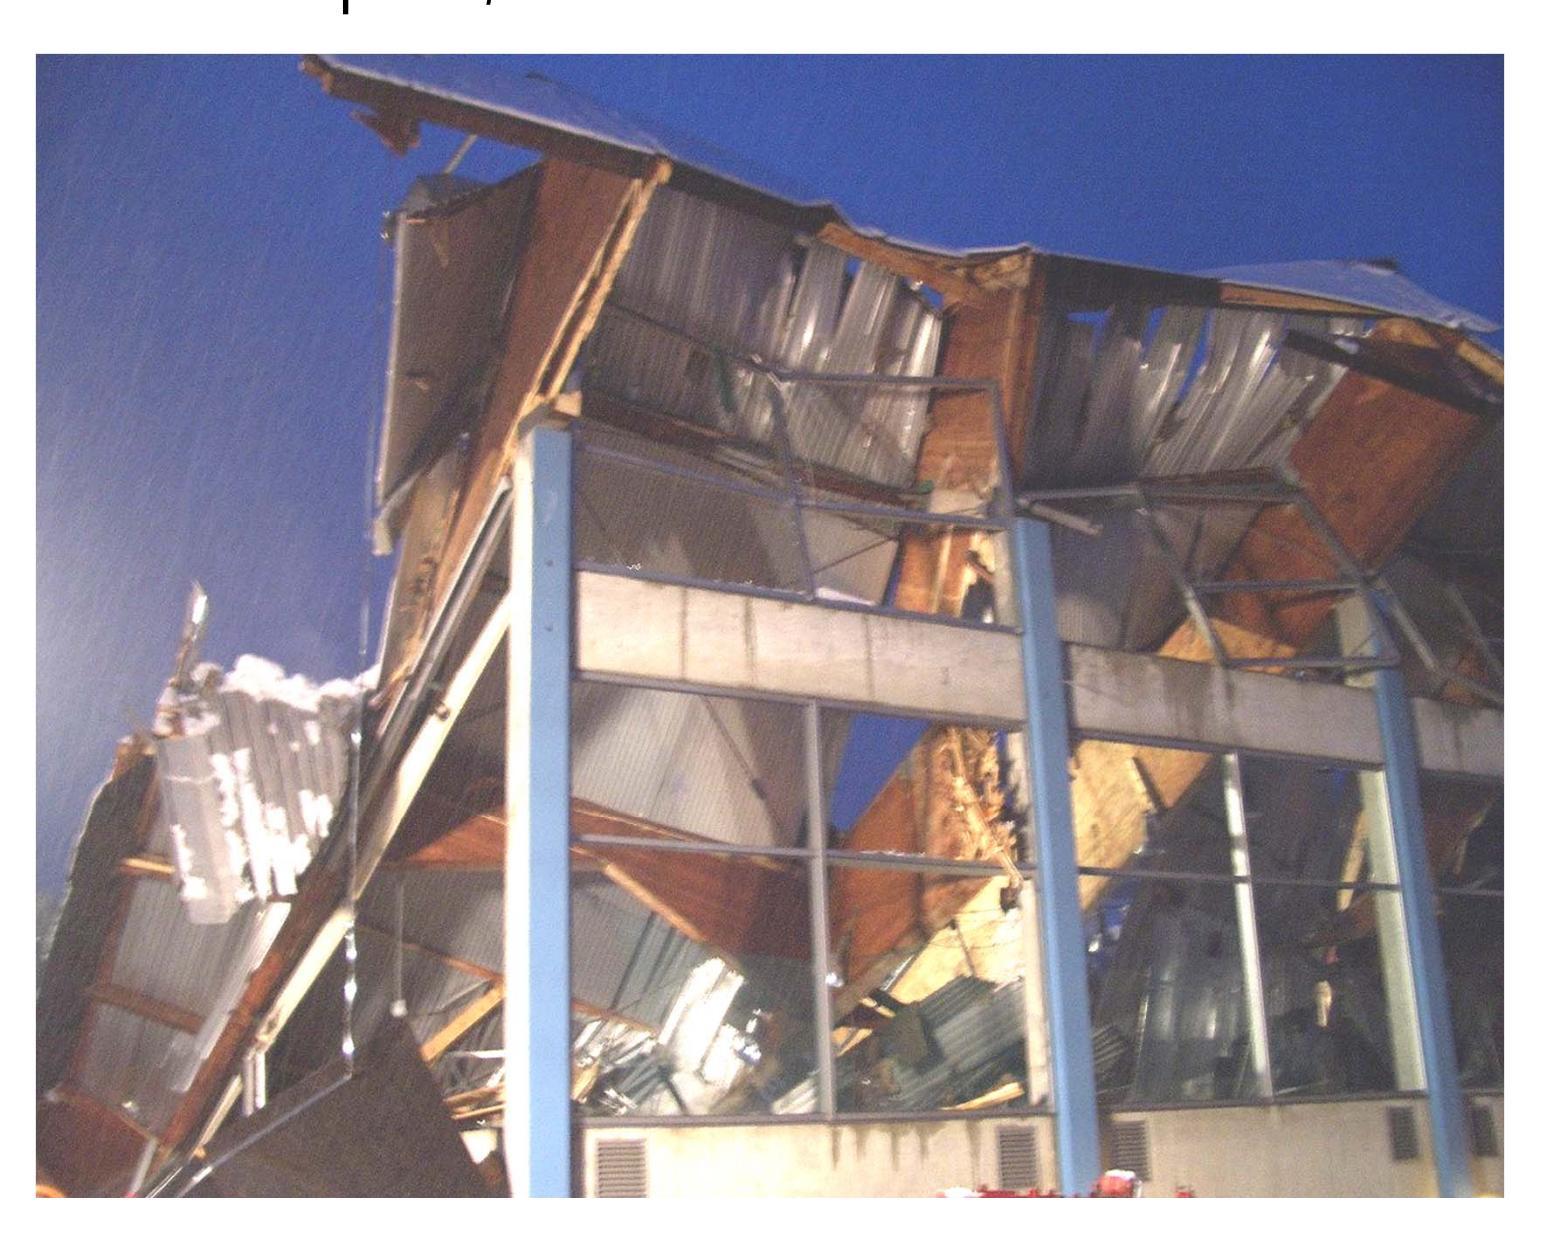
Bad Reichenhall Arena - failure Entire roof collapsed, snow below characteristic value

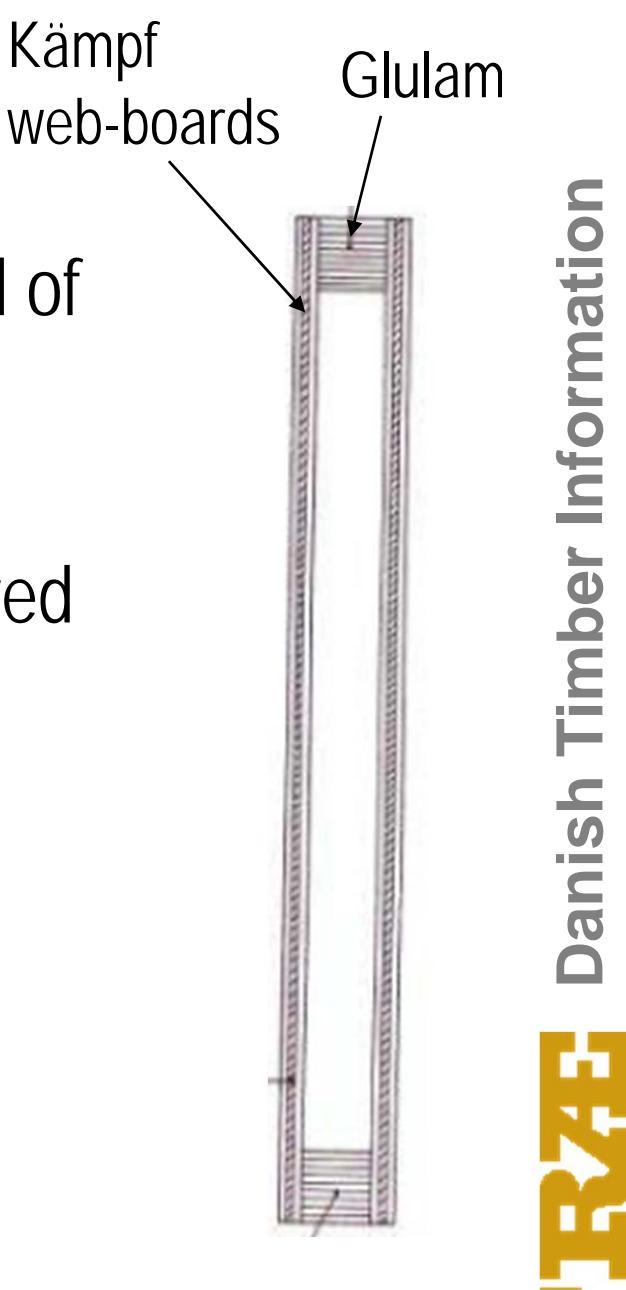
- 1. Bending strength of glulam used in stead of tensile and compressive strength
- 2. No reduction for finger joints in girder
- 1+2: Load-bearing capacity ~ 75% of required

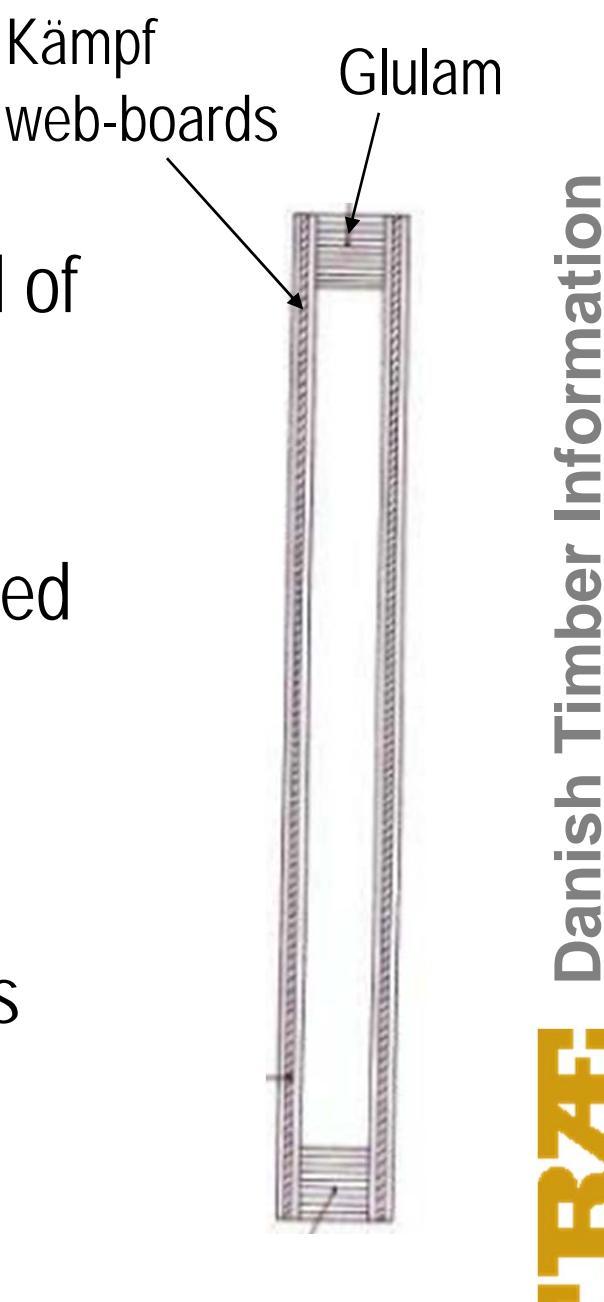
- 1. Bending strength of glulam used in stead of tensile and compressive strength
- 2. No reduction for finger joints in girder
- 1+2: Load-bearing capacity ~ 75% of required
- 3. Kämpf web-boards (~Cross Laminated Timber) only approved for height 1.2 m and provided resorcinol glue is used
- 4. Urea-formaldehyde glue used, which was and are not allowed in humid conditions

Collapse caused by degradation of glued connections over time combined with design errors

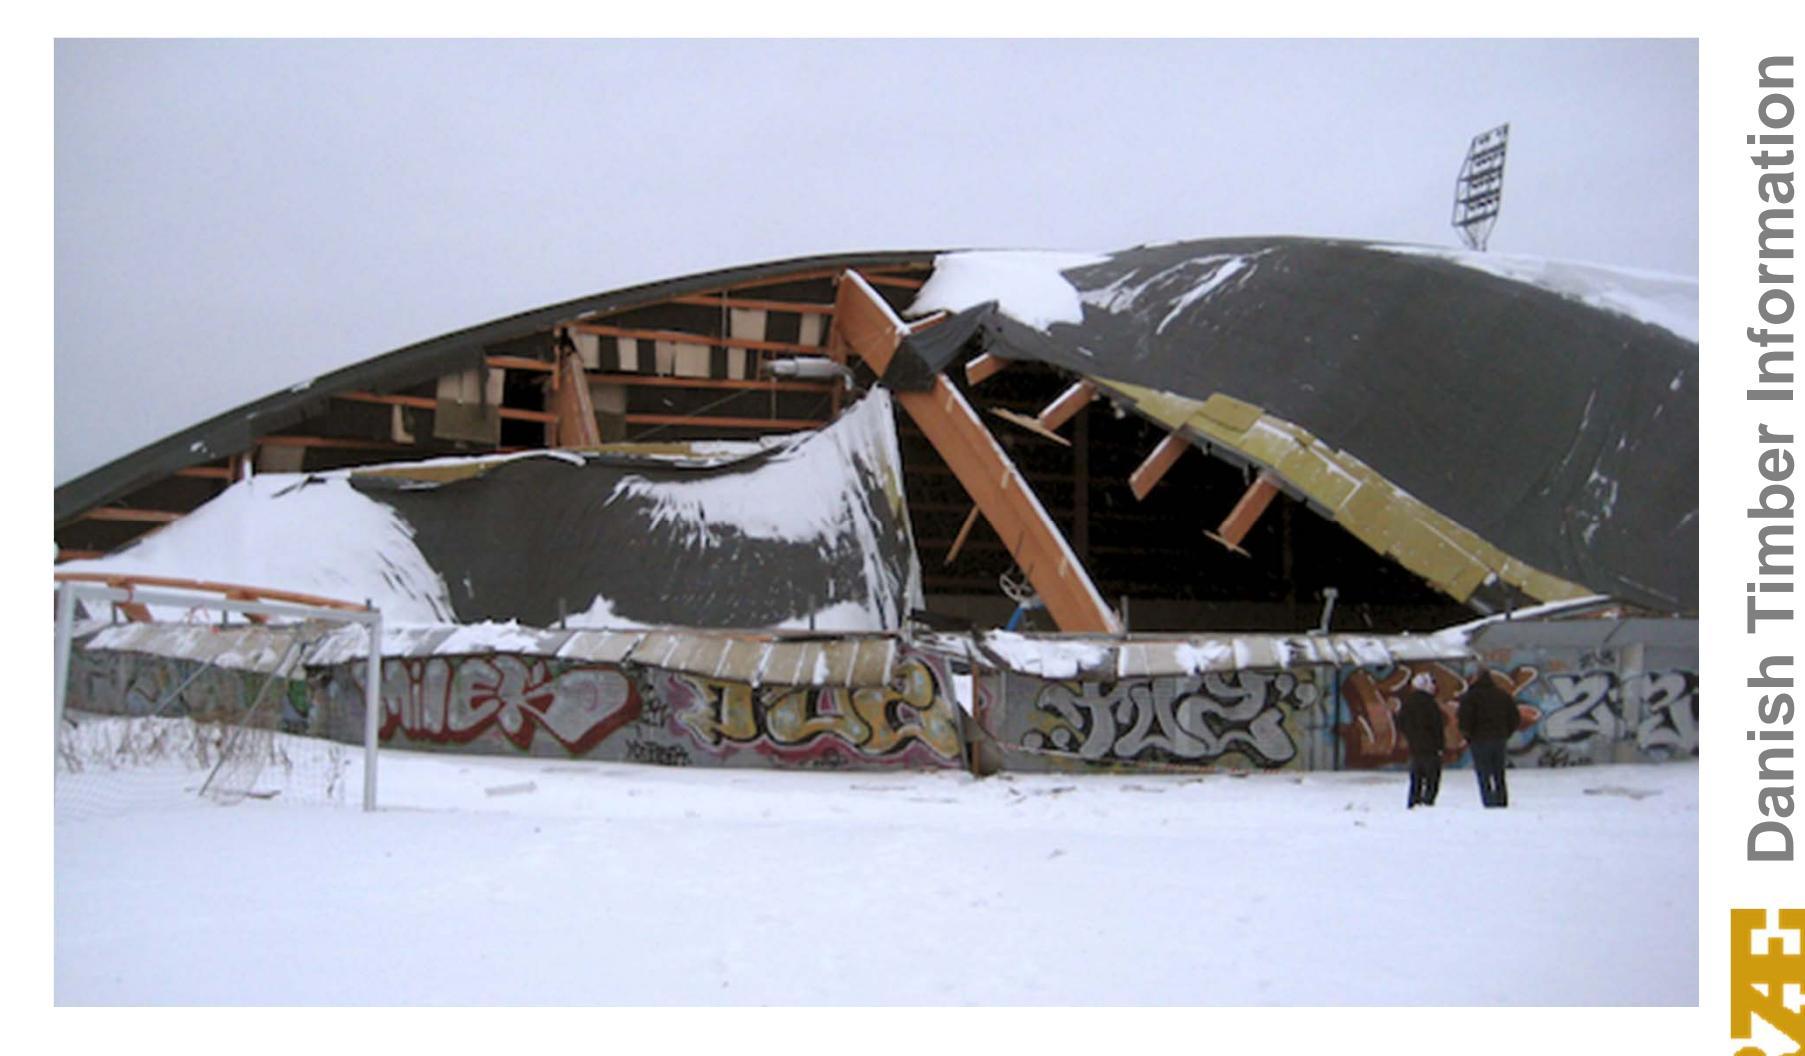
Apsis hall after collapse

- Sports hall with soccer lane
- 177 m long, 78 m wide, 16 m high
- Apsis halls with large curved glulam beams (32 m)
- Apsis hall towards SSV collapsed on Christmas eve 2010

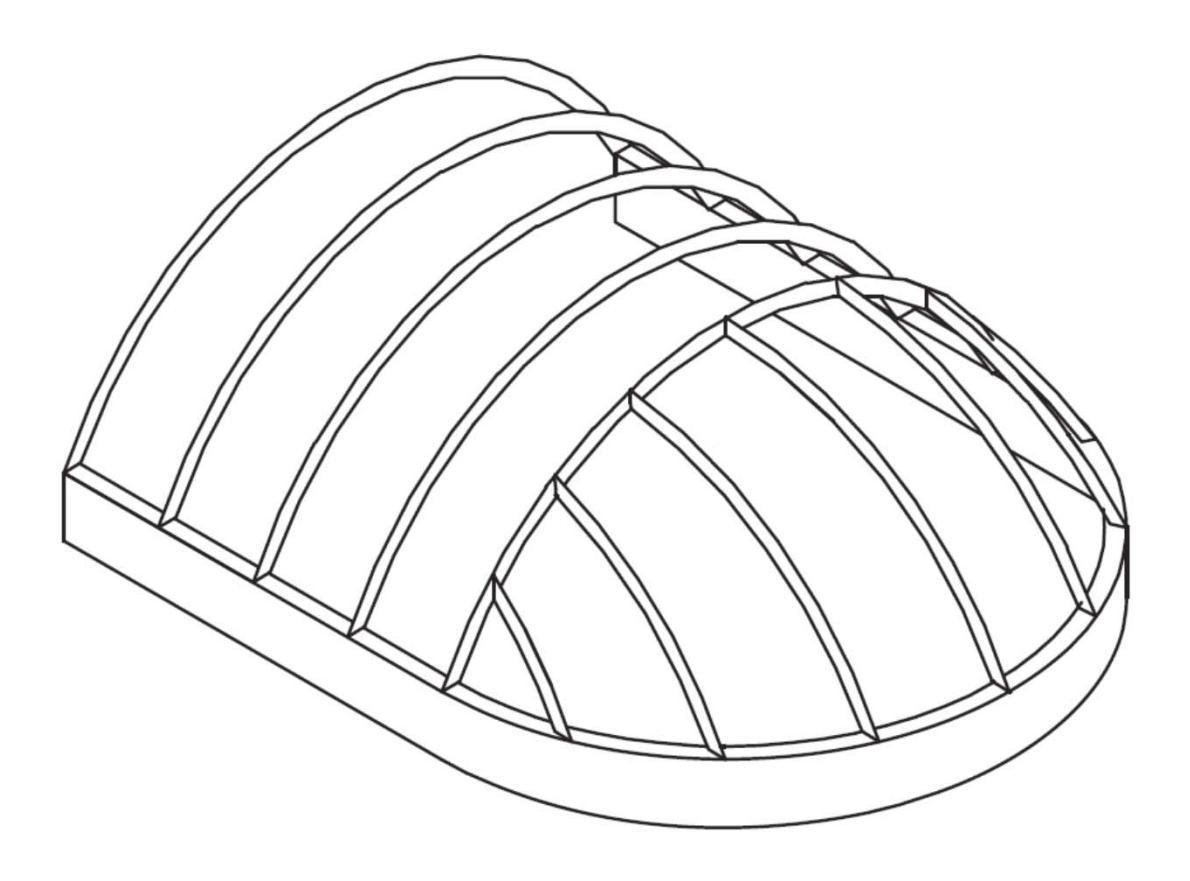
- Only designed for shape factor 0,8 (as normal roofs)
- Curved beams designed as normal beams
- · Non-considered shell effect due to edge beam

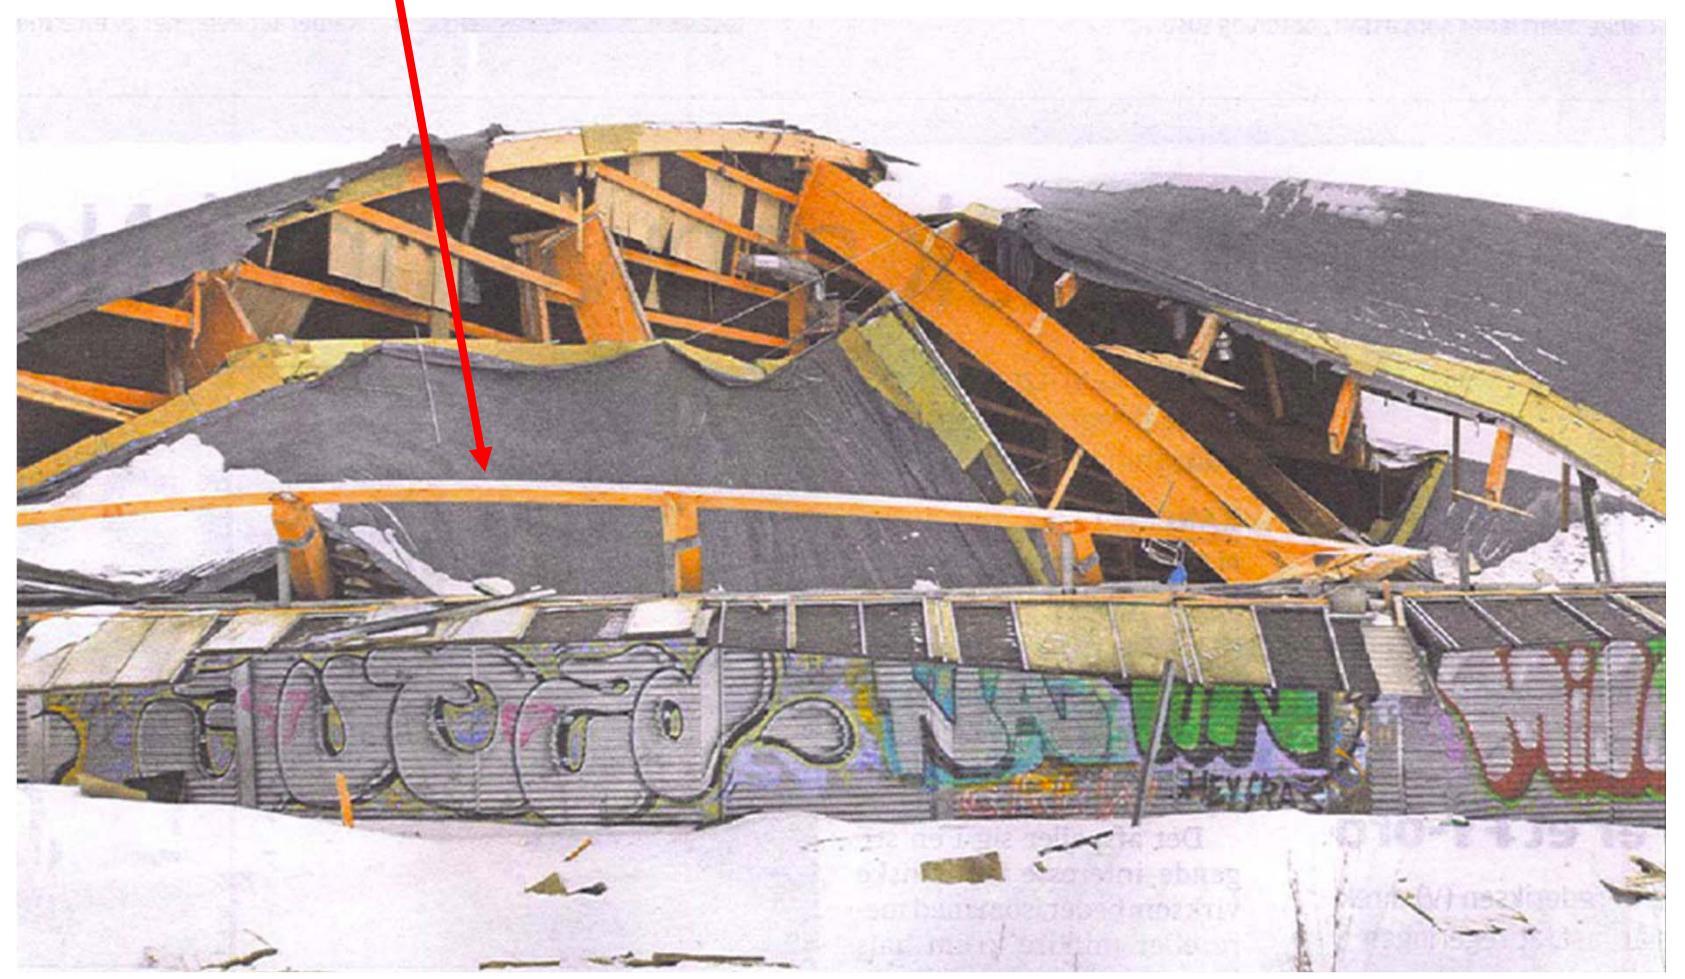
Curved edge beam serves as tension cord
