Modelling of the Performance of Timber Structures

COST Action E55

Reliability of timber trusses under eccentric loads

Luís Neves & Jorge Branco

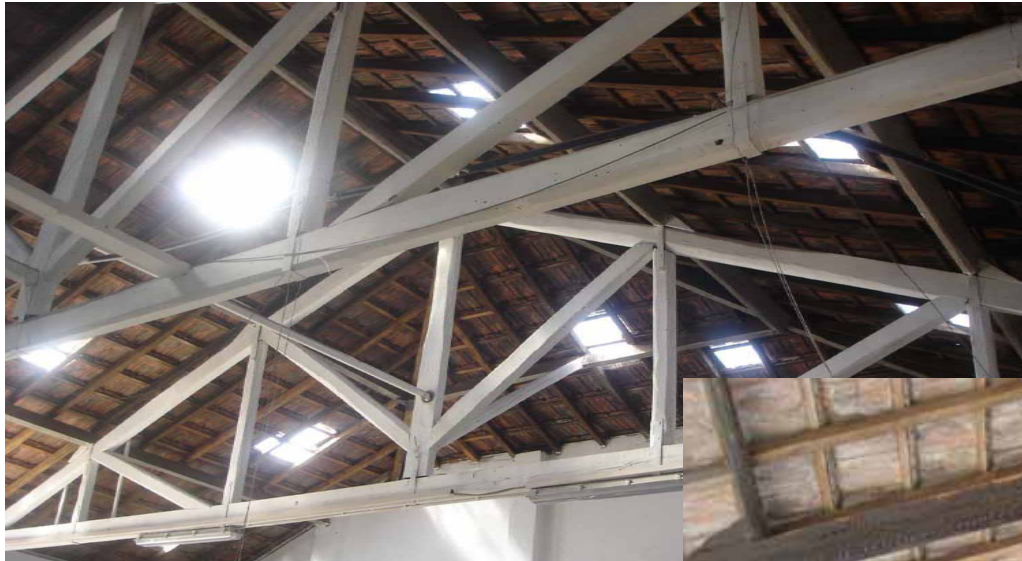
Howe truss
 $7\text{m} < L < 12\text{ m}$

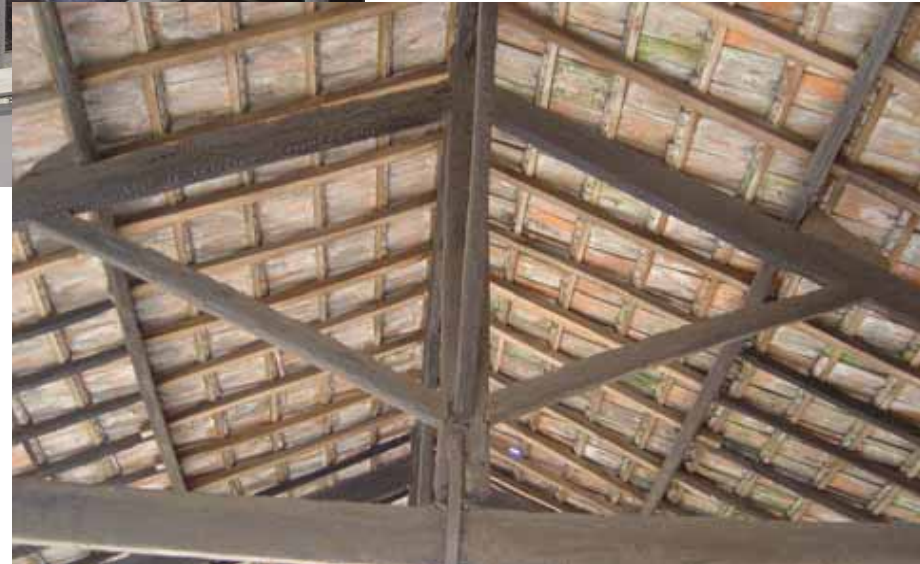
King post truss
< 7 m

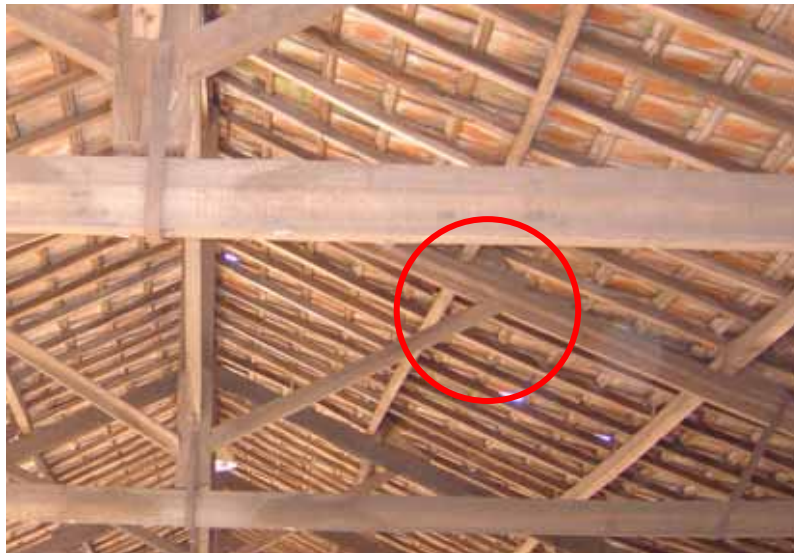
Increase in bending moments
in main rafters

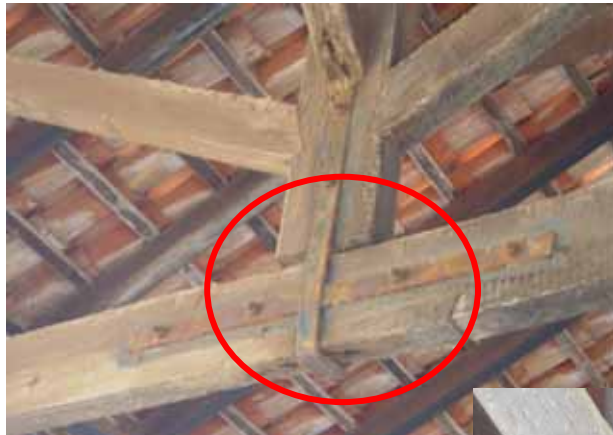
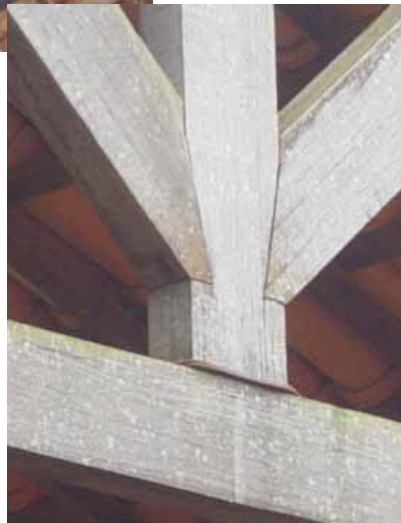
Increase in moments in tie-beam

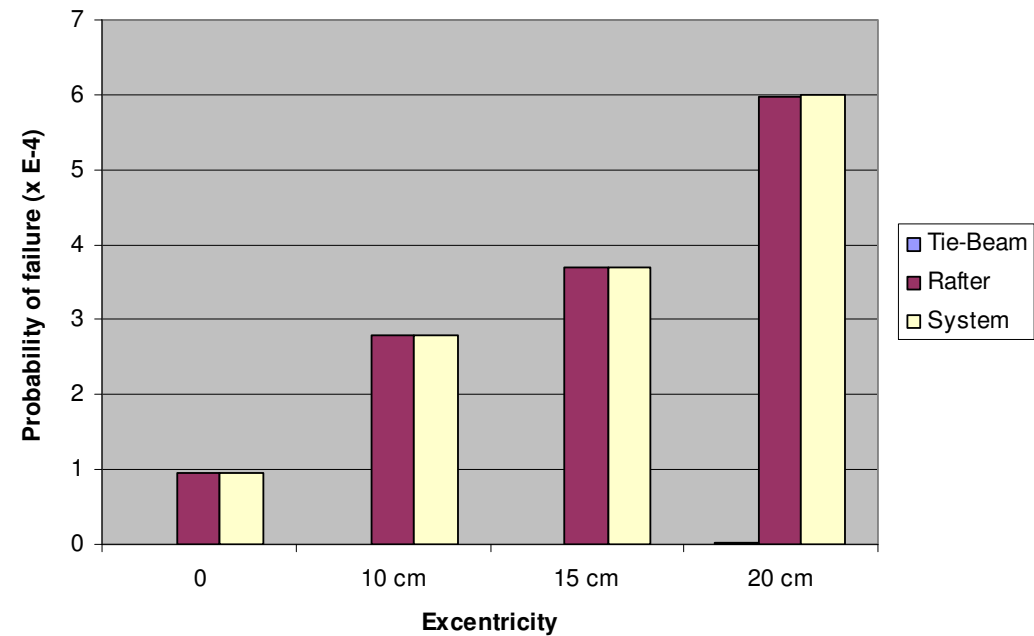
Strong tie-beam

PURLINS ECCENTRICITY

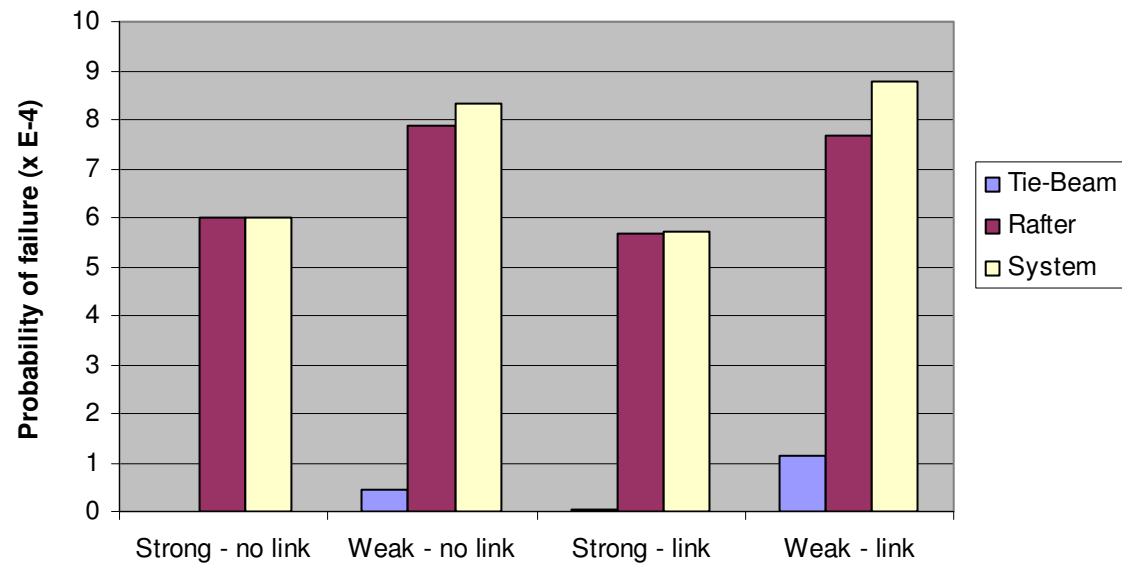
Excentricity = 20 cm
