# Failure analysis on timber structures in Germany

A contribution to COST Action E55

M. Frese, H.J. Blaß

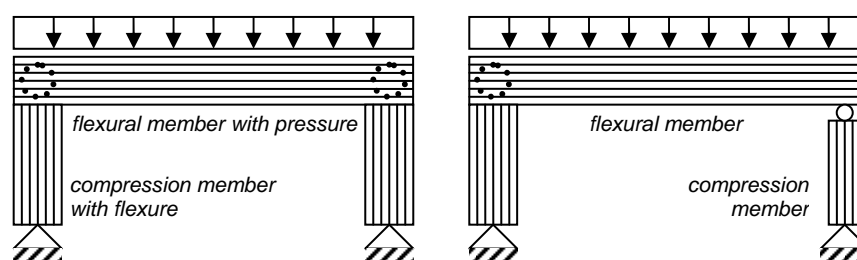
Fig. 1 Exemplifying keywords for components

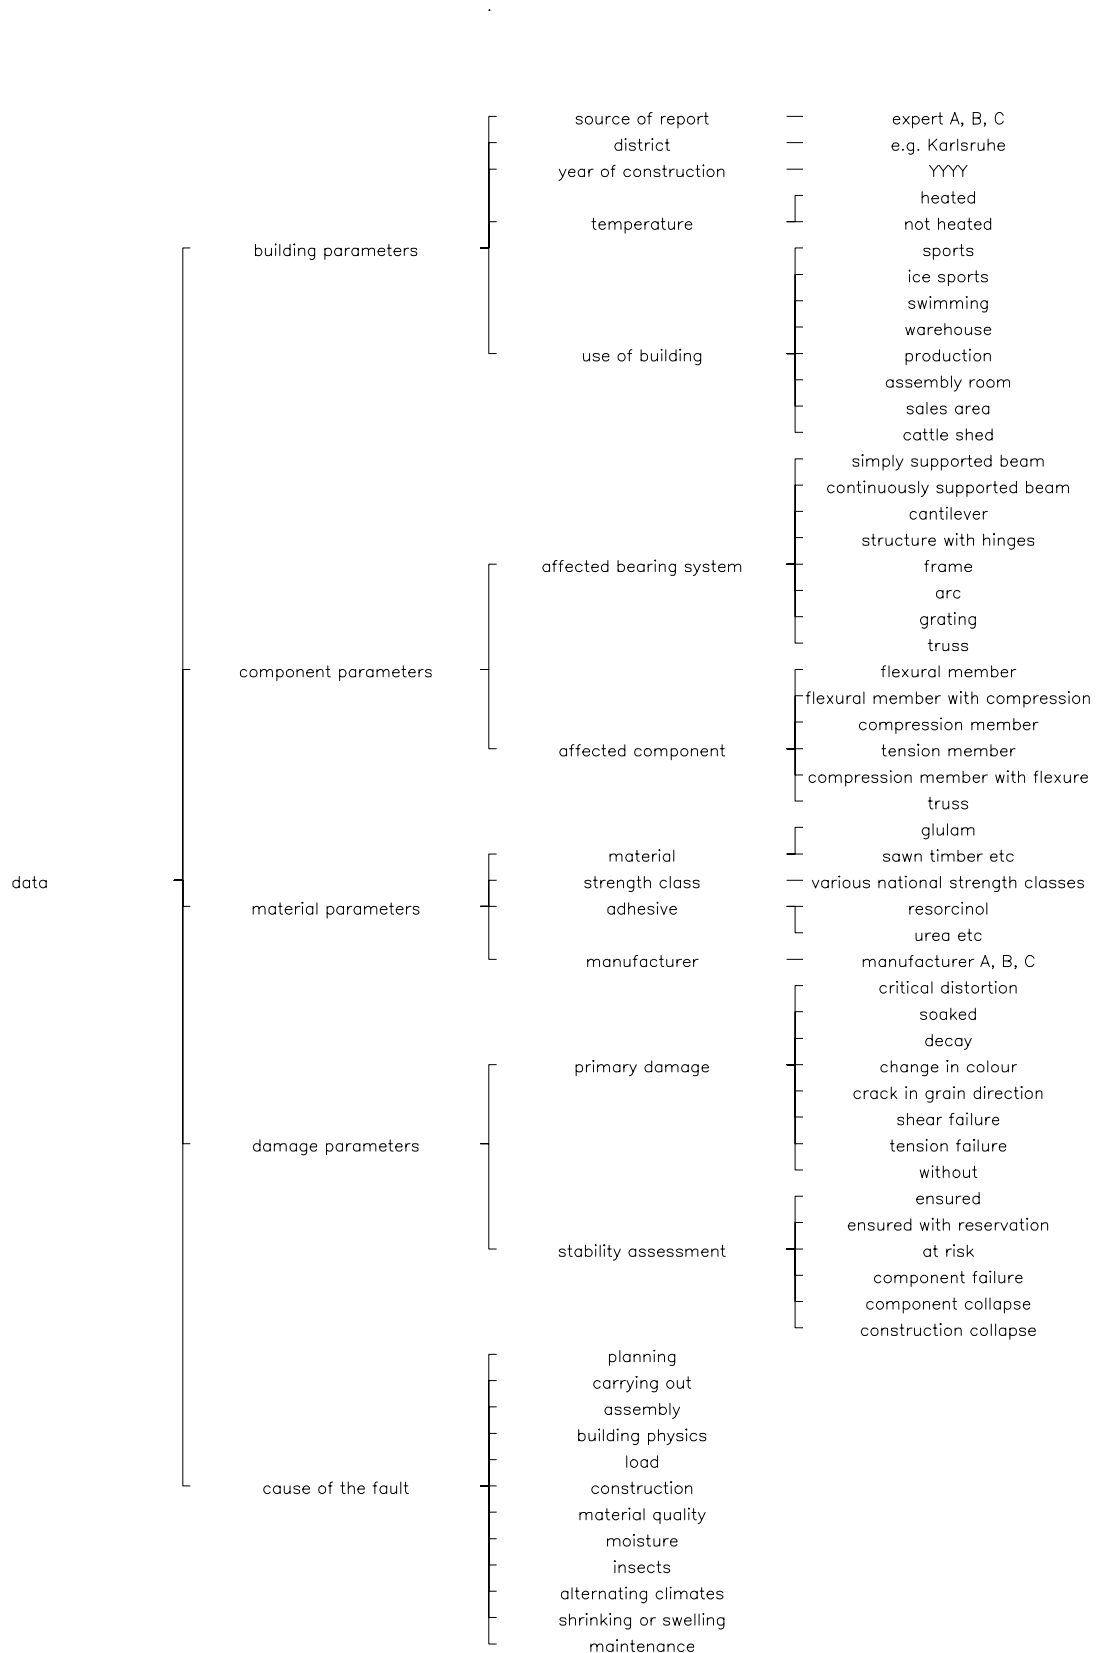
Fig. 2 Data structuring and small selection of keywords repeated at the end of the branches at a time

The data capture works with parameters which can only take on different keywords. The scheme is shown in Fig. 2. Therein the parameters and an easily understand-

able selection of the most important keywords are repeated. Keywords can be found at the end of the branches in the treechart.

The data are divided into five groups: parameters concerning

- the building,
- the components,
- the material,
- the damage and failure
- and the cause of the fault.

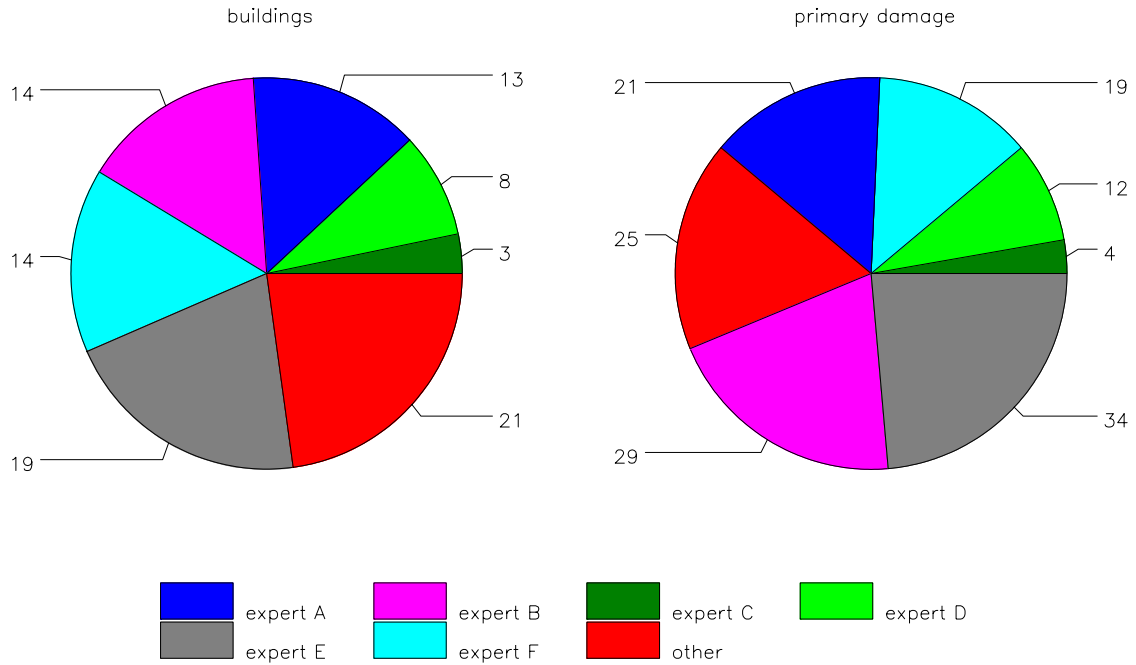
Fig. 3 Distribution of expert's reports and examined buildings, respectively (left) and detected primary damage (right)

Fig. 3 shows both the number of buildings about which expert advice was given and the number of detected primary damage. Hence 144 (140 explainable) cases of primary damage are apportioned to 92 buildings. The year of construction ranges from 1965 to 2006. The locations are scattered all over the former West German states (Fig. 5). An important statement is that data concerning failures in the former East German states was almost not available. Hence it can not be concluded that timber hall structures in the former East German states are free from failure. It is Sports or ice sports halls being frequently affected by damage (Fig. 4). Damage was mainly observed in simple or continuously supported beams (Fig. 6). This pie chart also shows clearly the frequency of the structural components referring to the different bearing systems. In most cases damaged components consist of glulam belonging to the national strength classes Güteklasse II and I (comparable with GL24 and GL28). Many different glulam manufacturers produced the material. Accumulations concerning particular manufacturers therefore can be excluded with certainty. The span of the bearing systems ranges from 6 m to 48 m. A histogram is given in Fig. 7 showing that large span is rare.

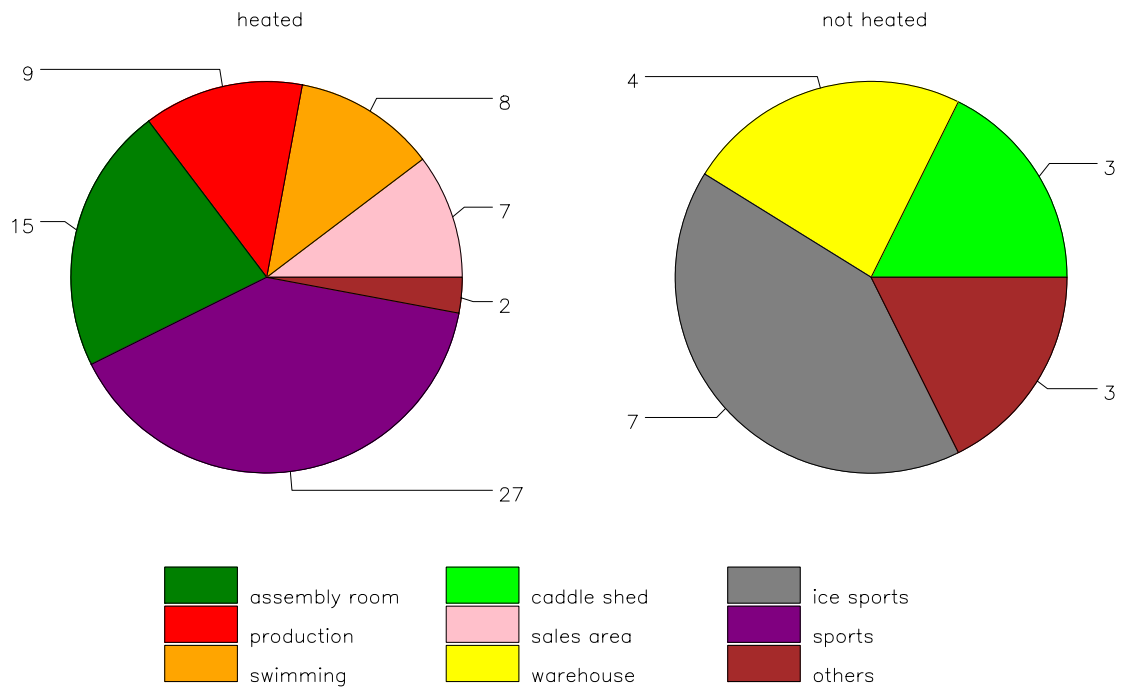
Fig. 4 Distribution of building use grouped according to heated and not heated constructions

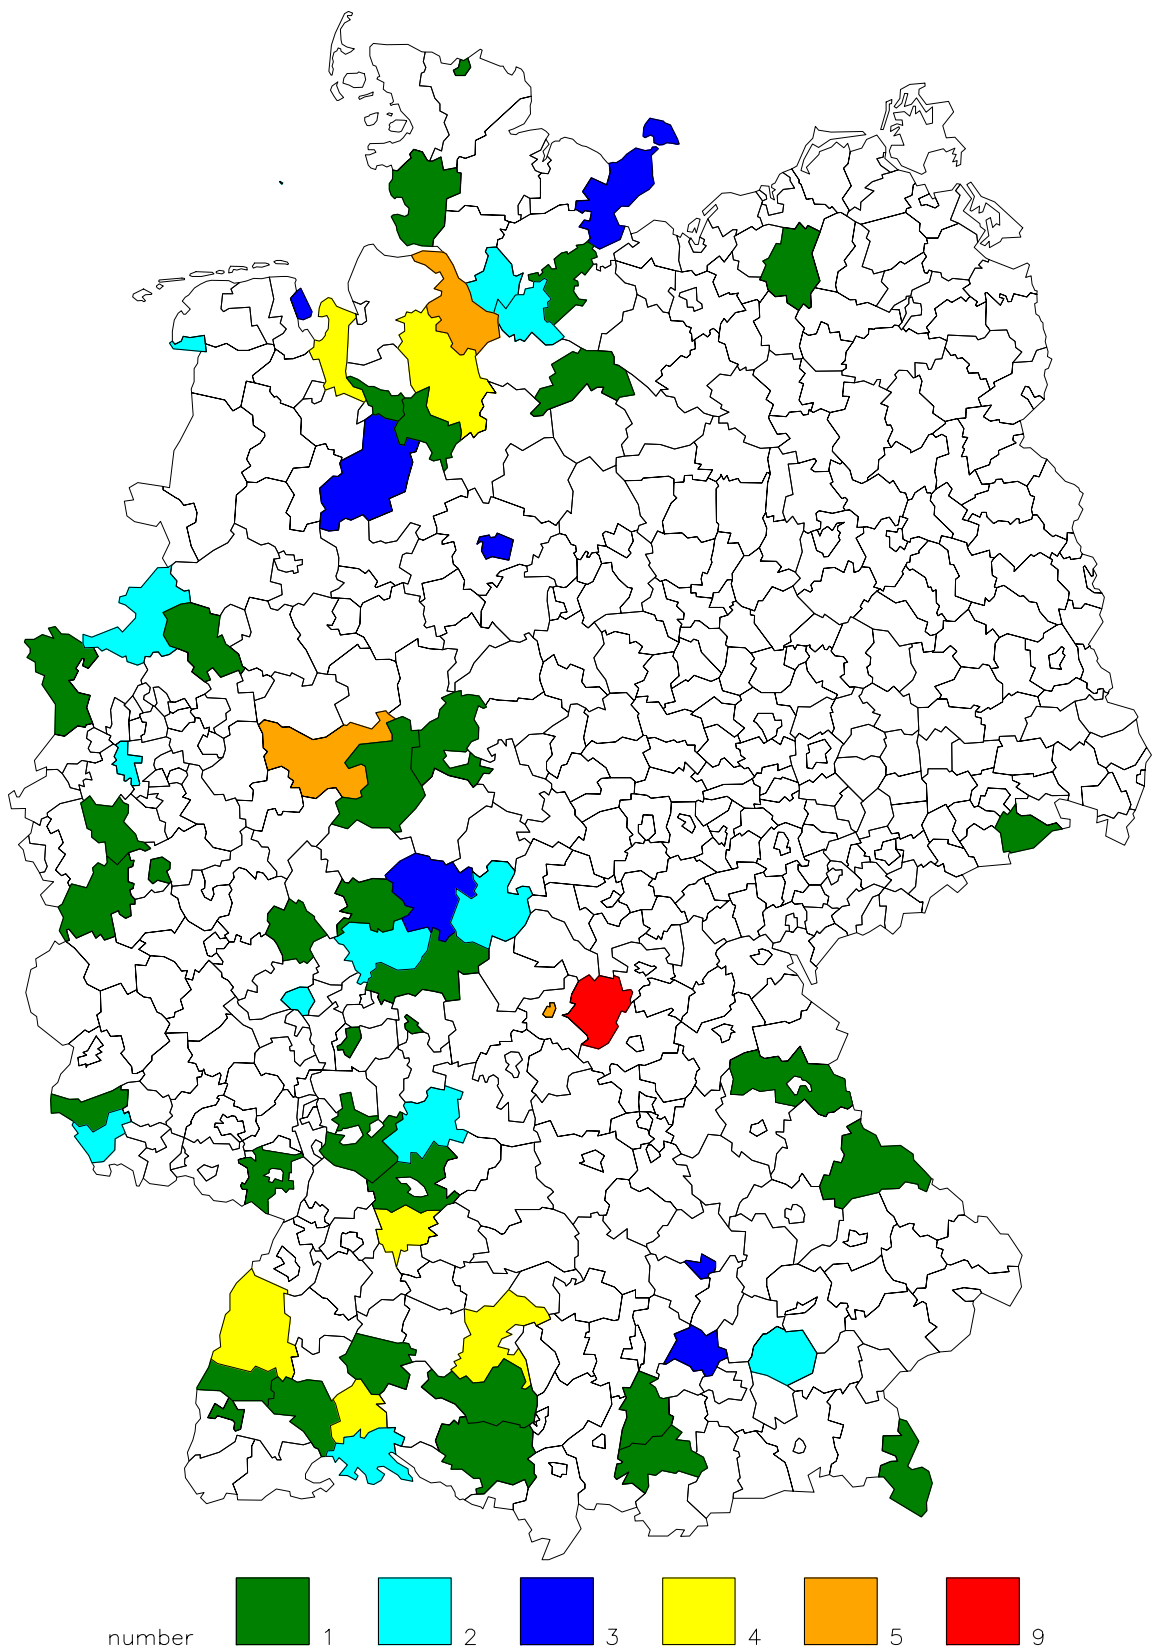
Fig. 5 Number of primary damage related to districts

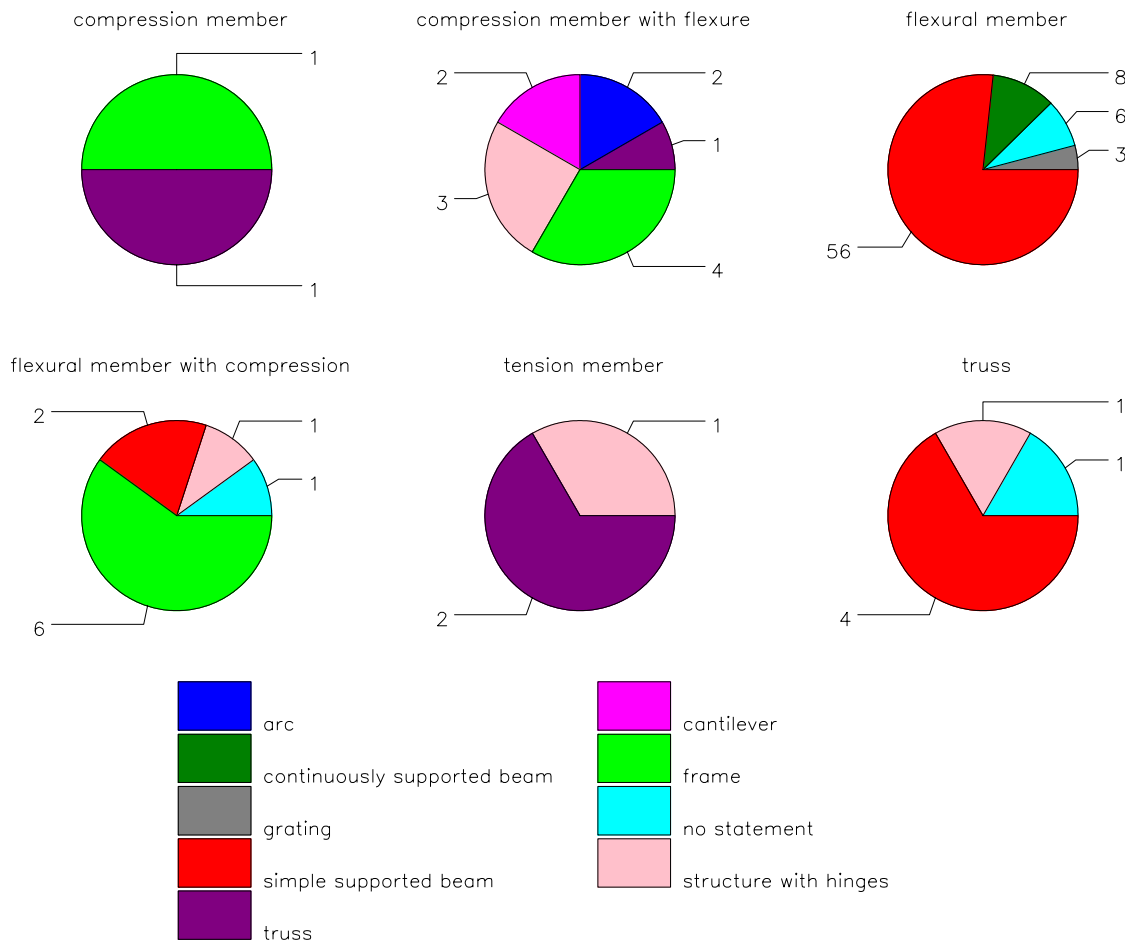
Fig. 6 Distribution of bearing systems grouped according to affected components; components with more than one case of damage are repeated once

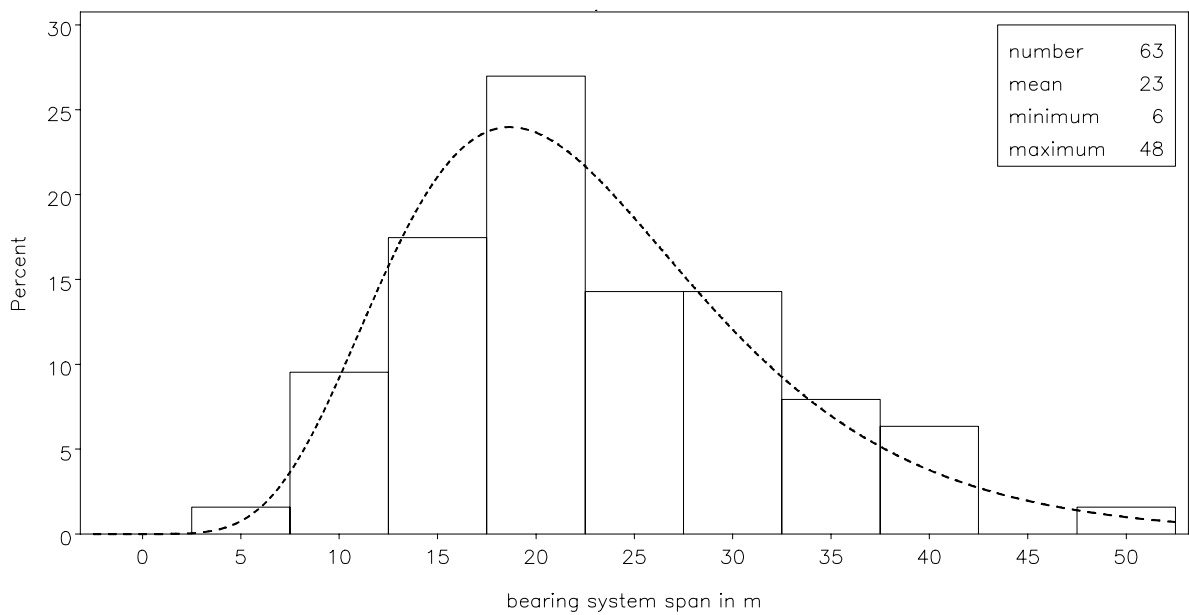
Fig. 7 Histogram and fitted lognormal density of the bearing system span

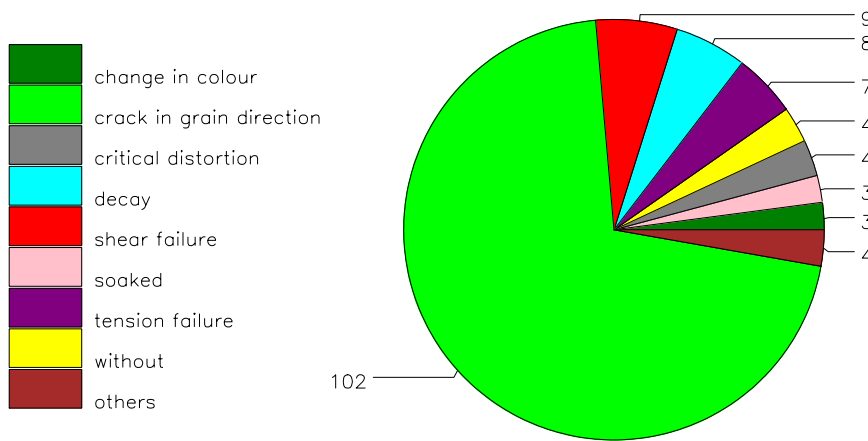
Fig. 8 Primary damage distribution

70% of the damage is allotted to cracks in grain direction. 6% each belong to shear failure, decay and tension failure (Fig. 8). The rest of 12% concerns serviceability and appearance of the components, which does therefore not affect the stability. The distribution of failure time indicates an accumulation in the months January to March.

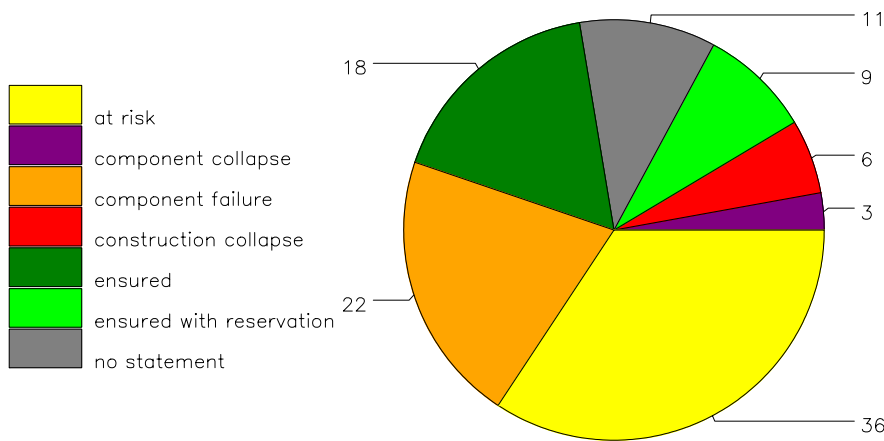
Fig. 9 Distribution of stability assessments; not only related to whole constructions but also to single components within a construction

According to the expert's assessments of stability one third of the constructions or components are at risk. Just under one third collapsed or failed. One quarter had an ensured stability. About the rest no statements were available (Fig. 9). This pie chart has a close connection to way of looking at life of construction. The great portion of constructions having stability at risk is striking (yellow slice). It is obviously possible to detect signs for stability at risk when a construction is inspected. Through it, it is timely possible to take steps to ensure stability and prolong construction life. A pie chart without the yellow slice would be a serious problem: That means constructions will lose their stability without any announcement. Hence the preventive maintenance (inspection and restoration) is very important.

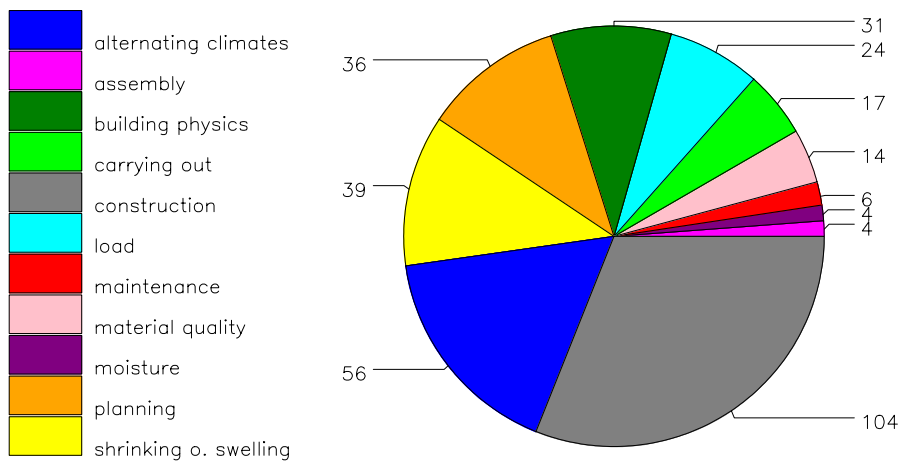
Fig. 10 Cause of the fault distribution; The total amounts to 335 due to multiple naming of cause of the fault with regard to a single damage.

Fig. 10 shows that individual constructions (hindrance of shrinking, curved beams or connections of cross girders) are the main cause of the fault. In addition alternating climates are of importance for cracks in grain direction. The influence of shrinking or swelling and causes of the fault concerning planning, building physics, load, carrying out and material quality is moderate. Undesirable consequences in terms of poor maintenance and assembly as well as moisture are rare.
