Failure analysis on timber structures in Germany

Recording data and pointing the way statements

Matthias Frese

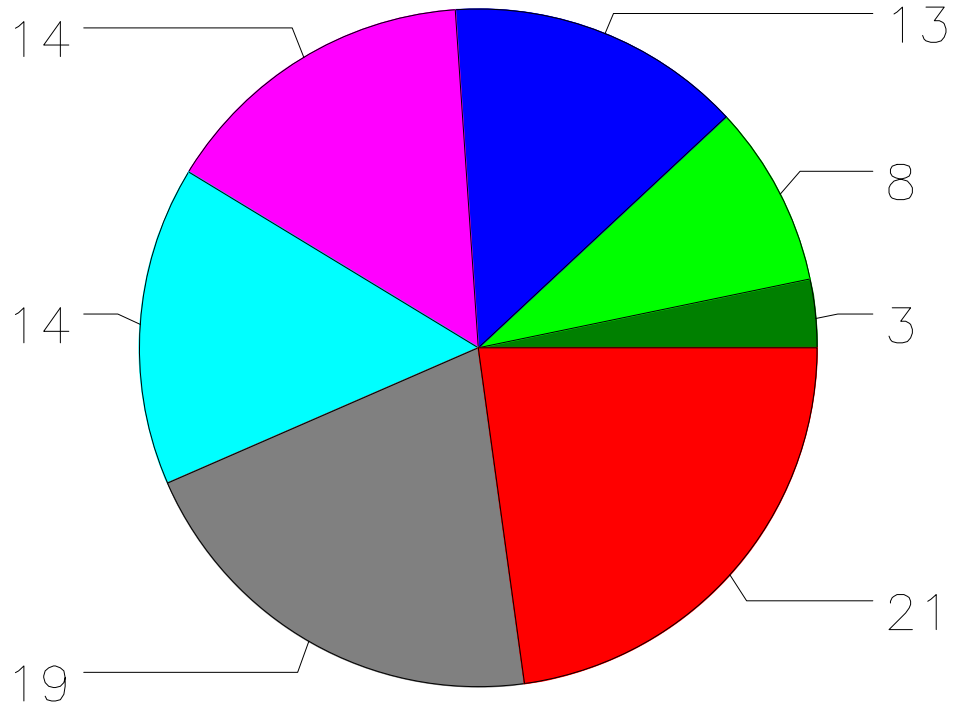
buildings, total 92

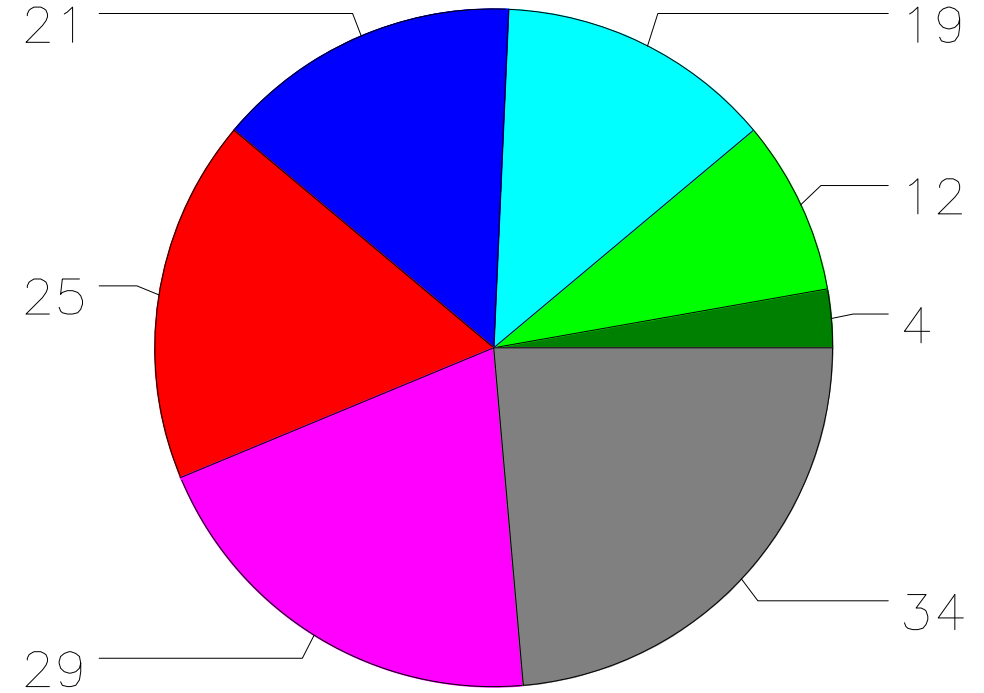
primary damage, total 144

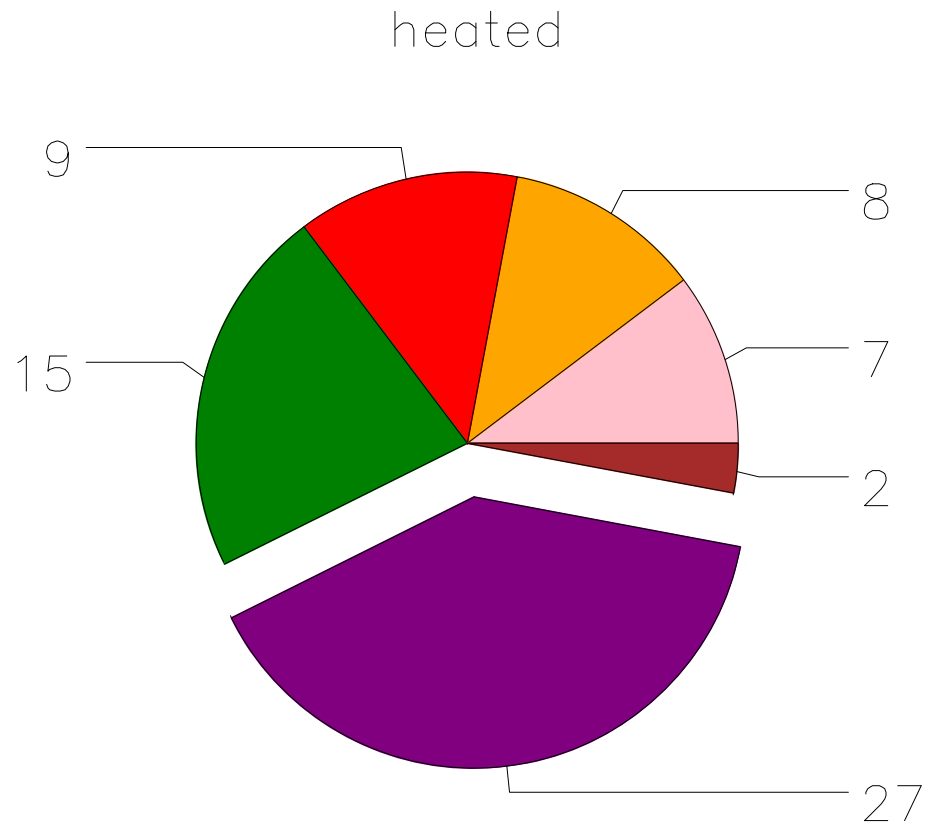
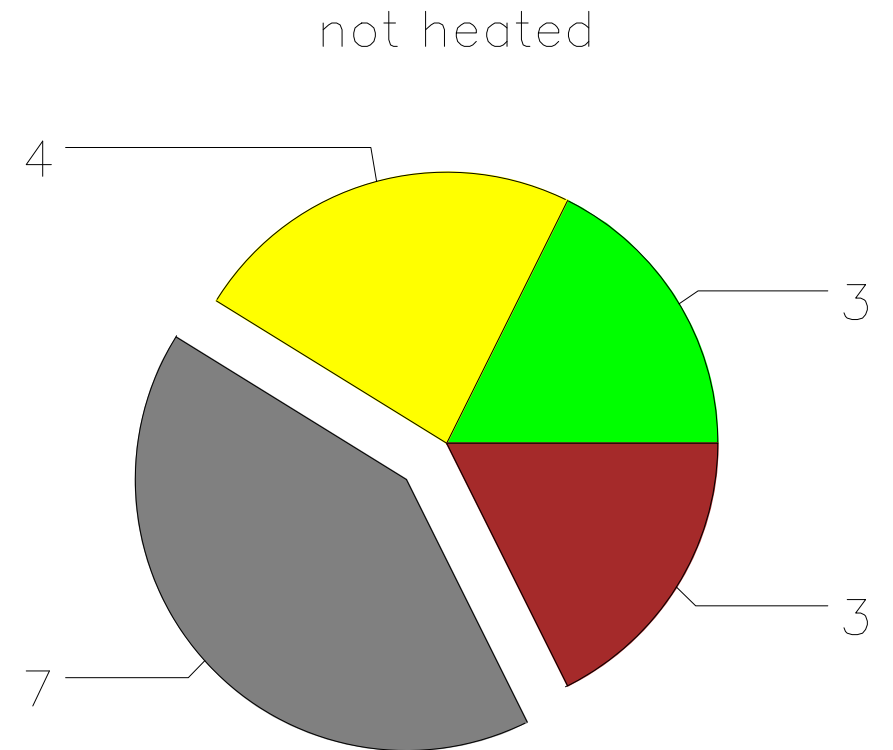
Use of building grouped according to heated and not heated constructions

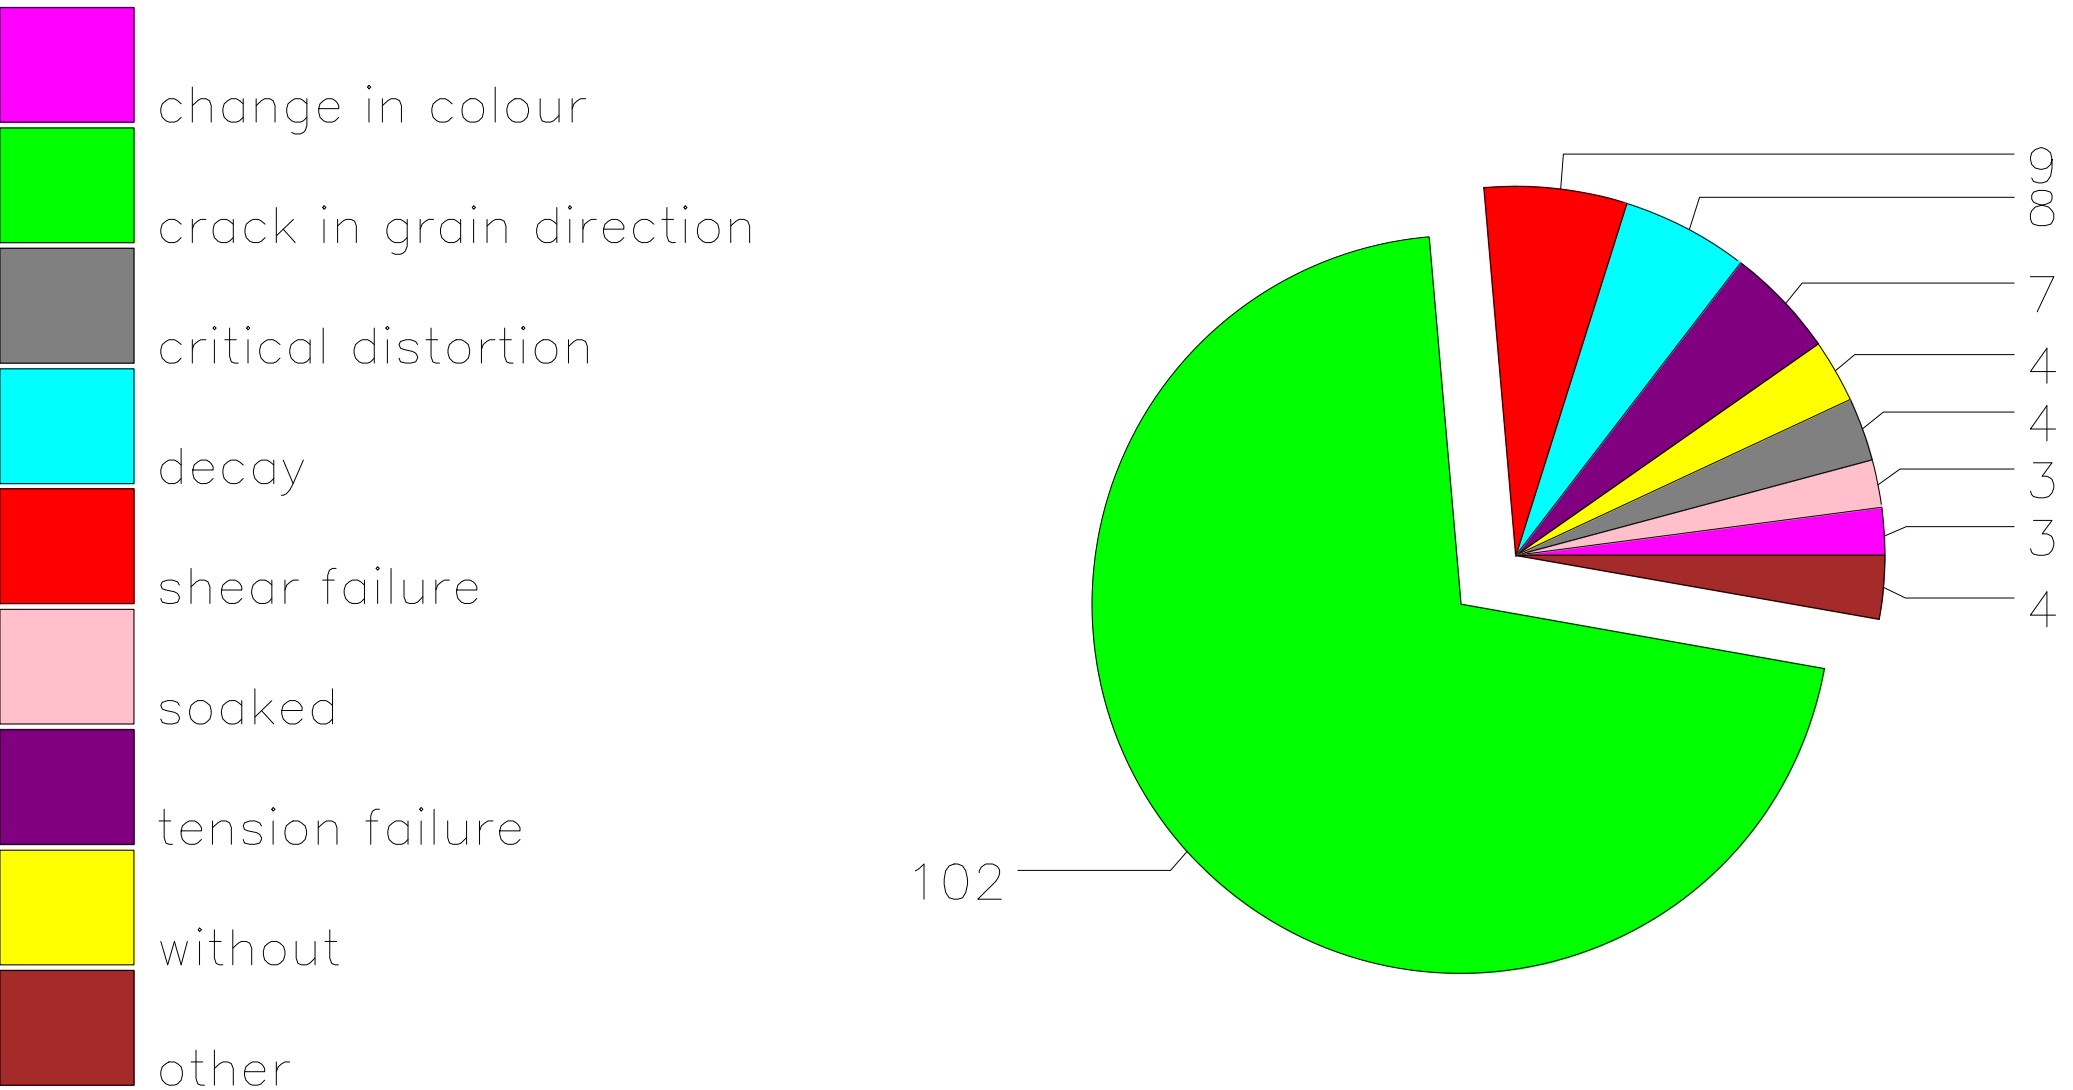
Primary damage distribution, total 144

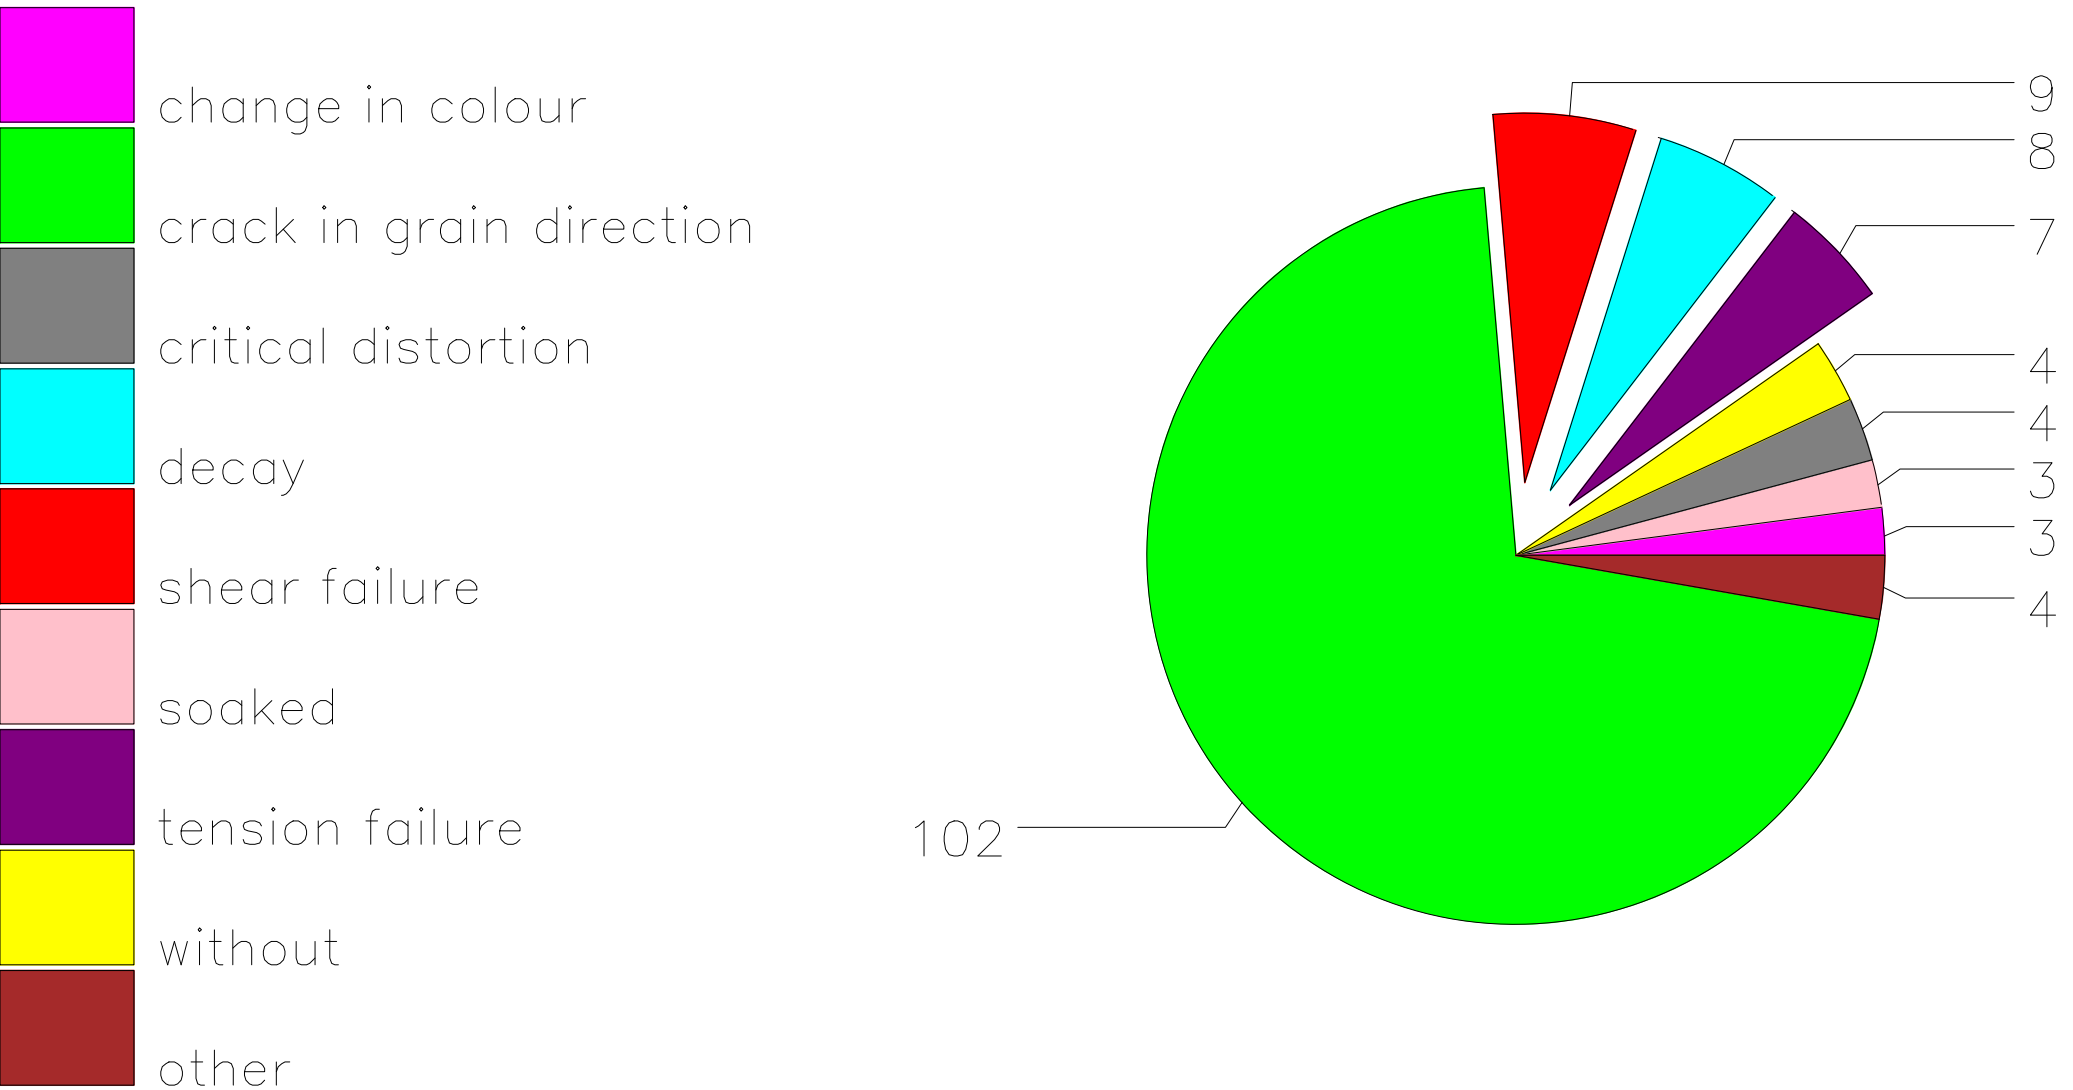
Primary damage distribution, total 144

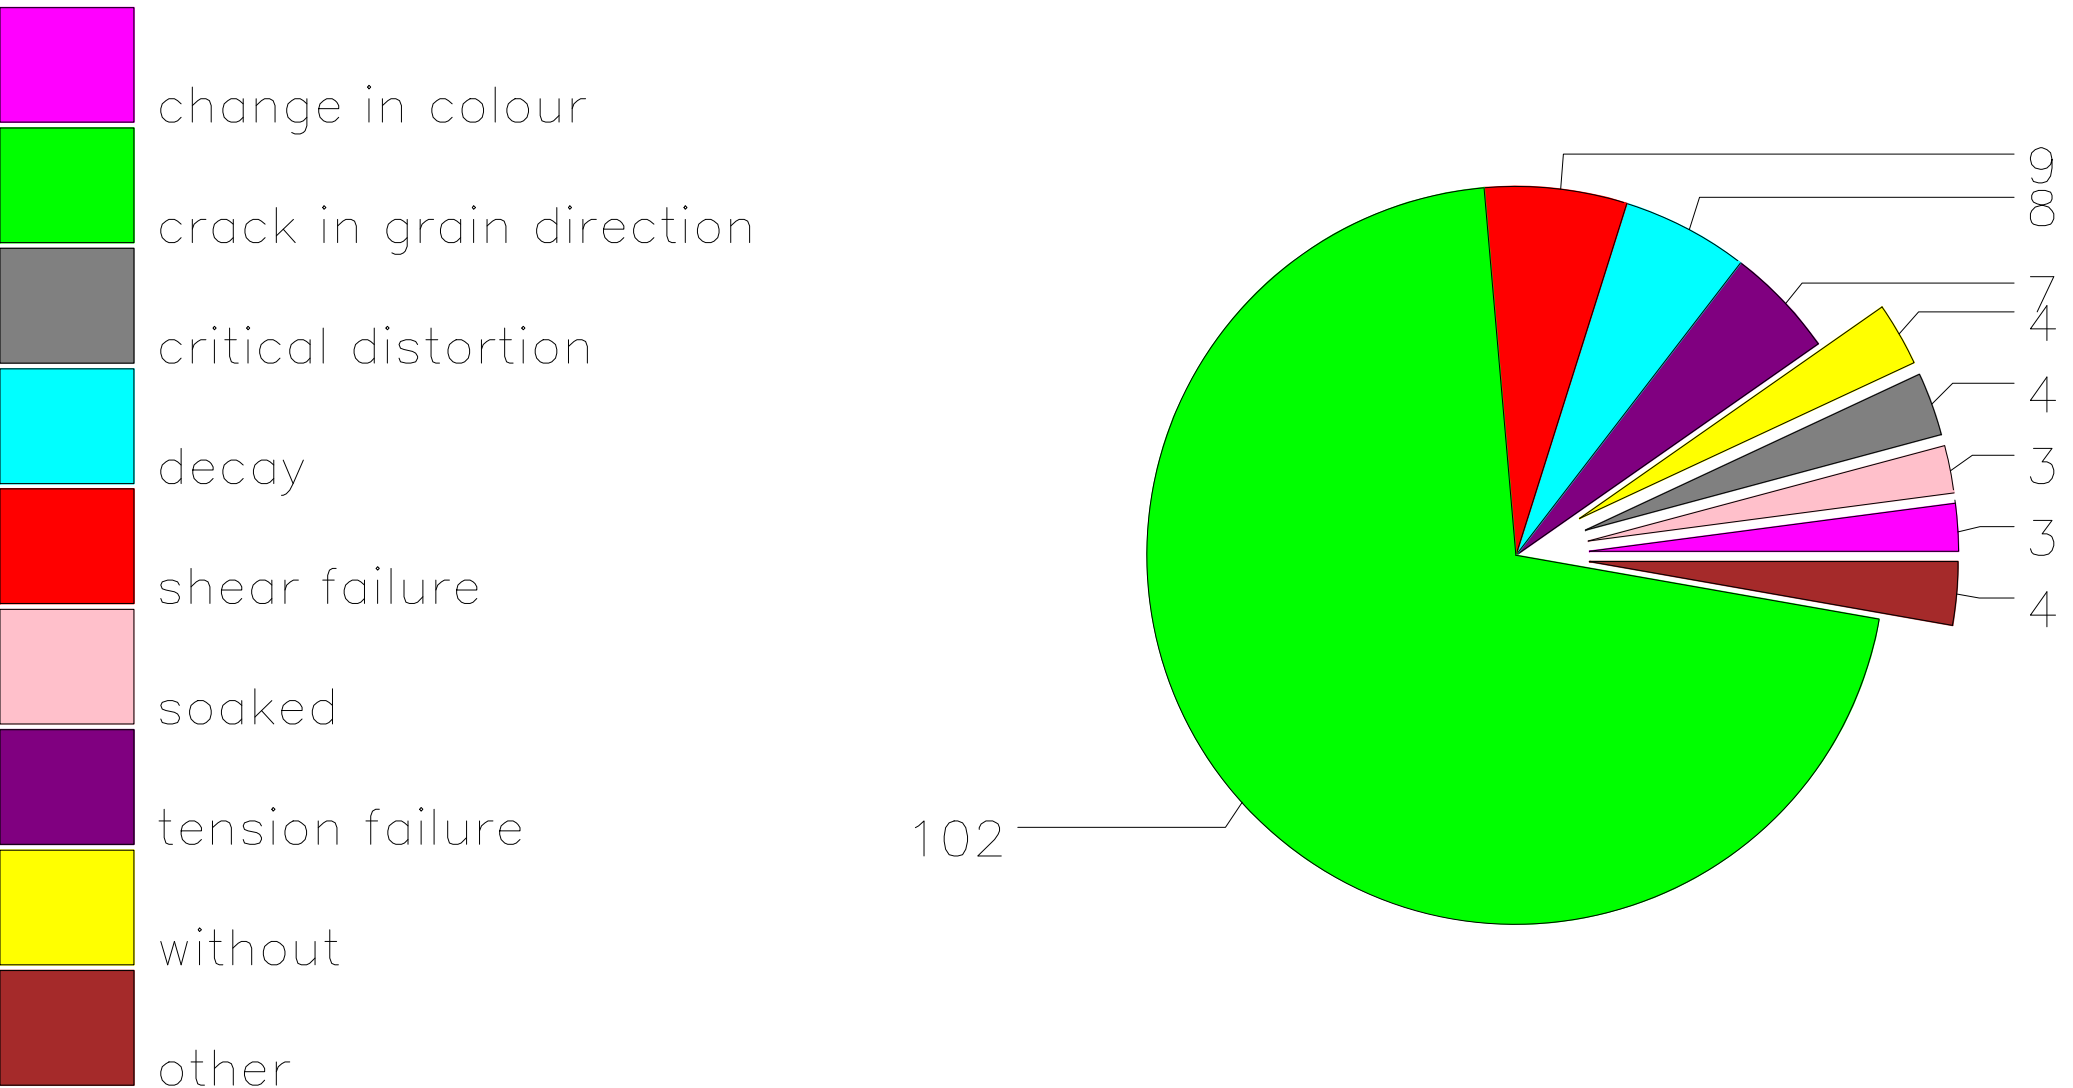
Primary damage distribution, total 144

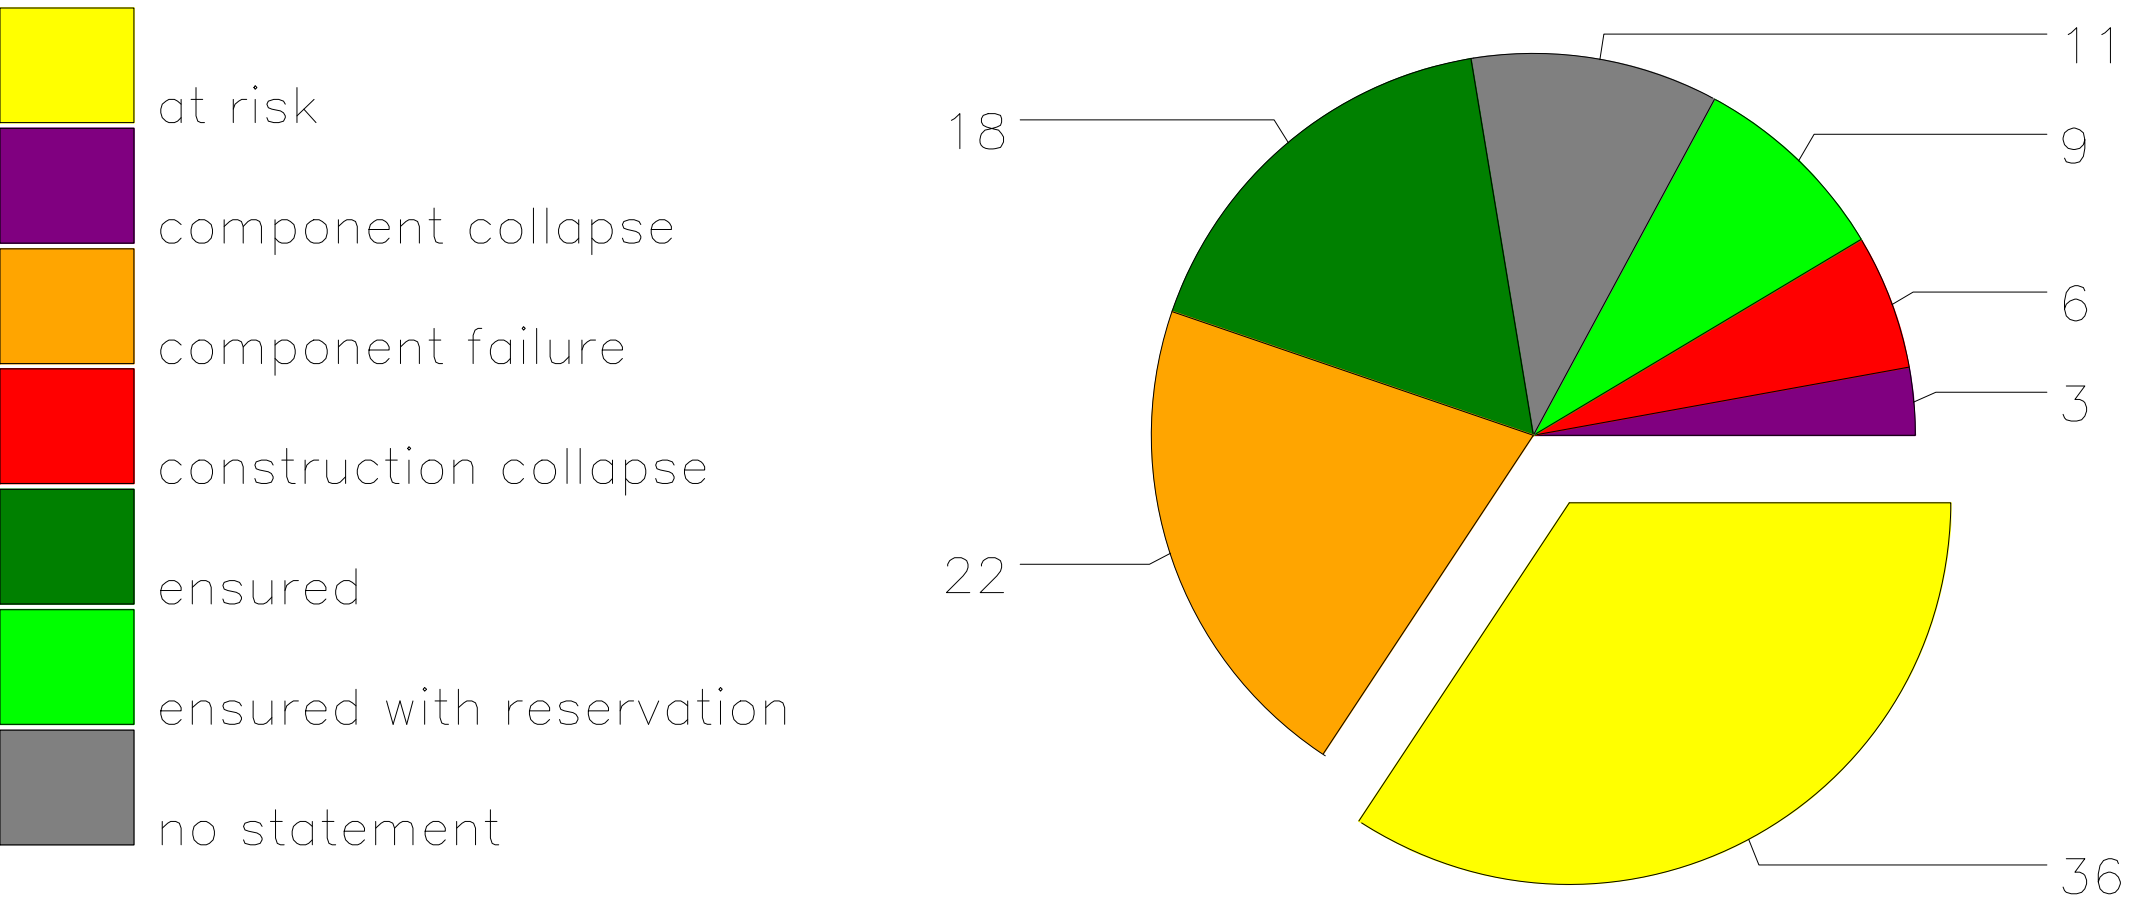
Distribution of stability assessments

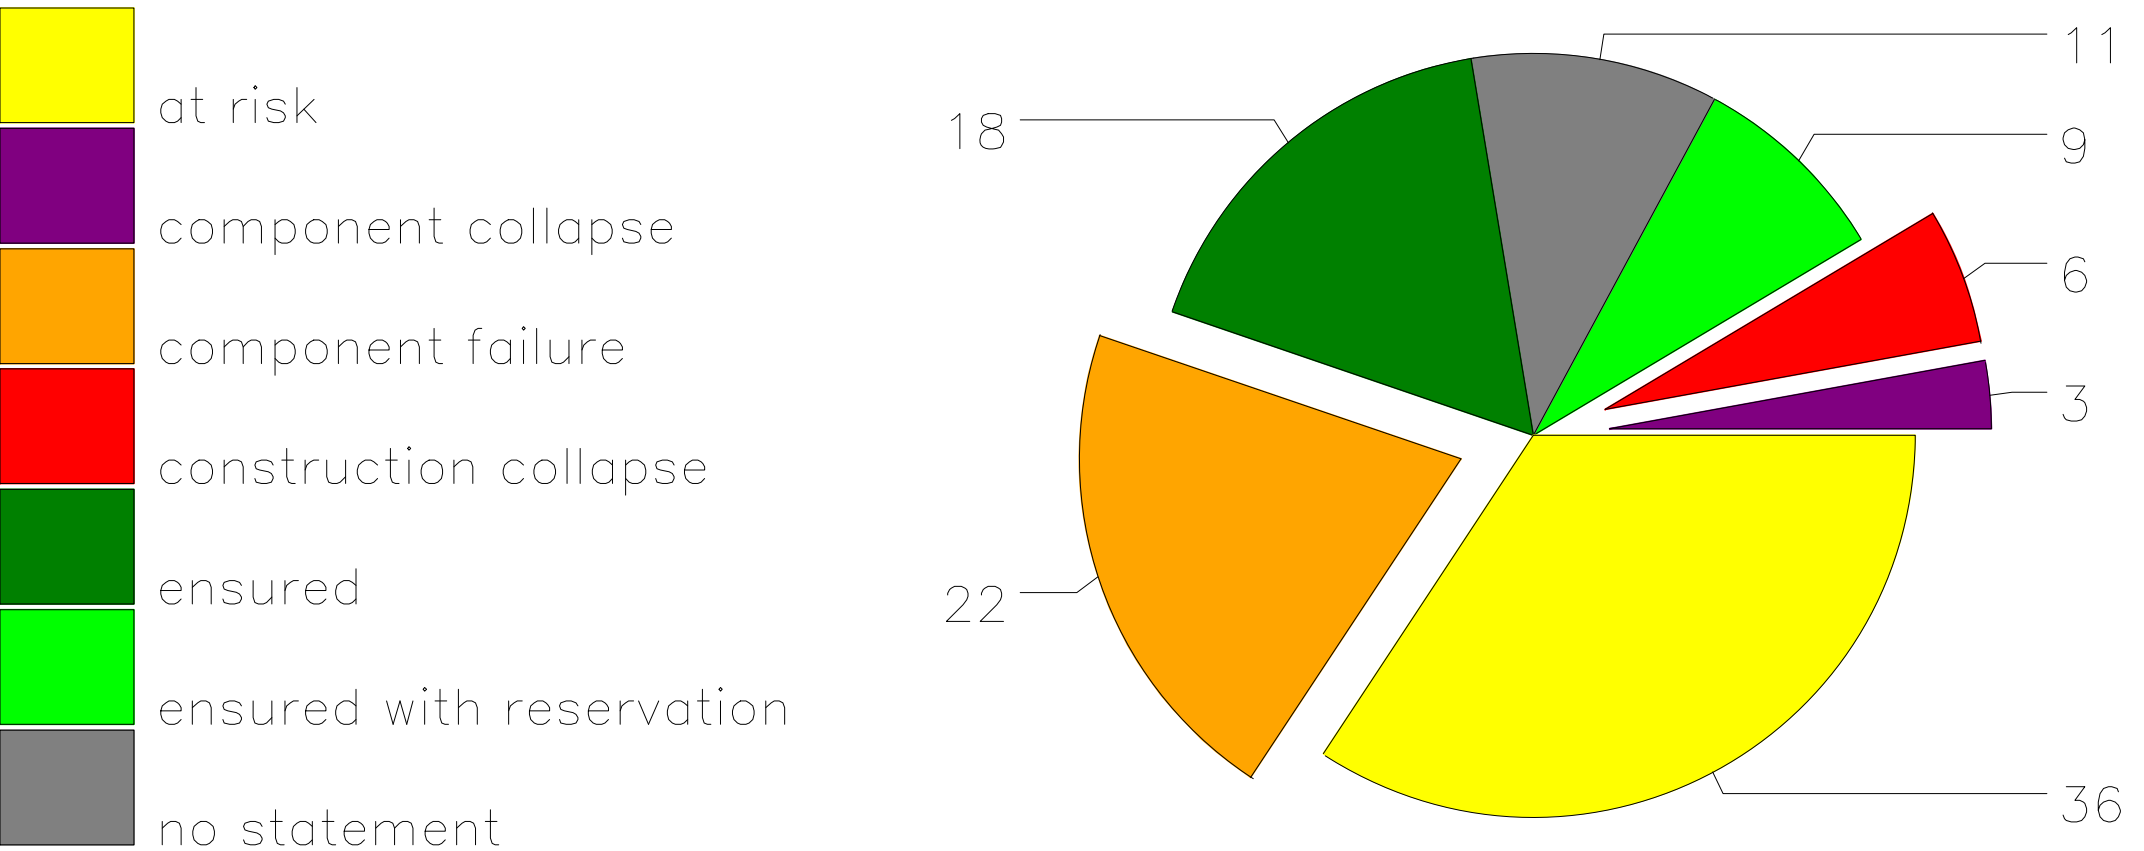
Distribution of stability assessments

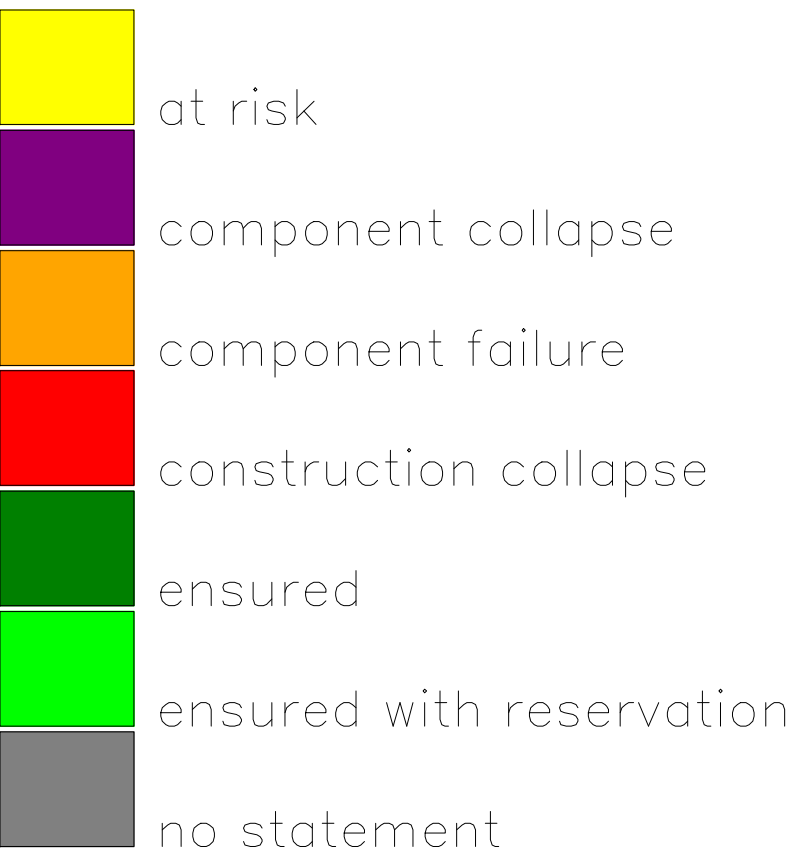
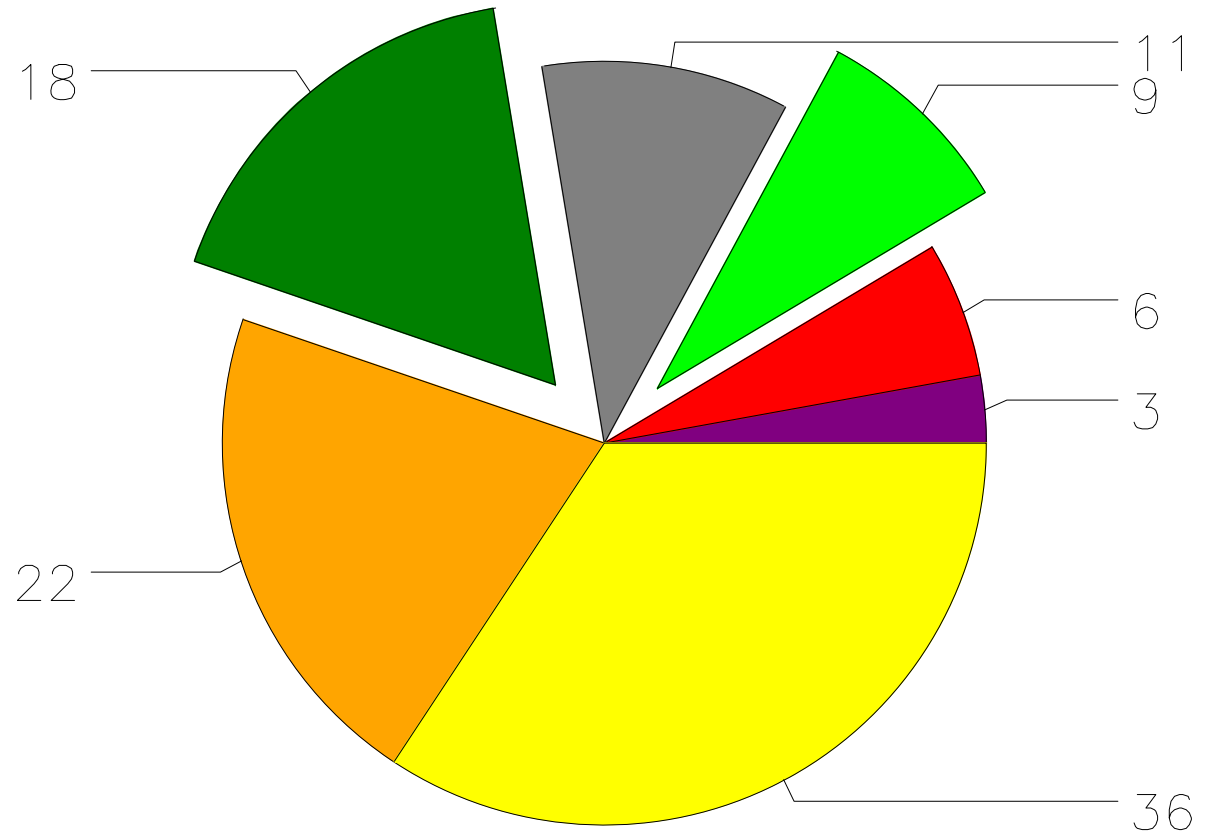
Distribution of stability assessments

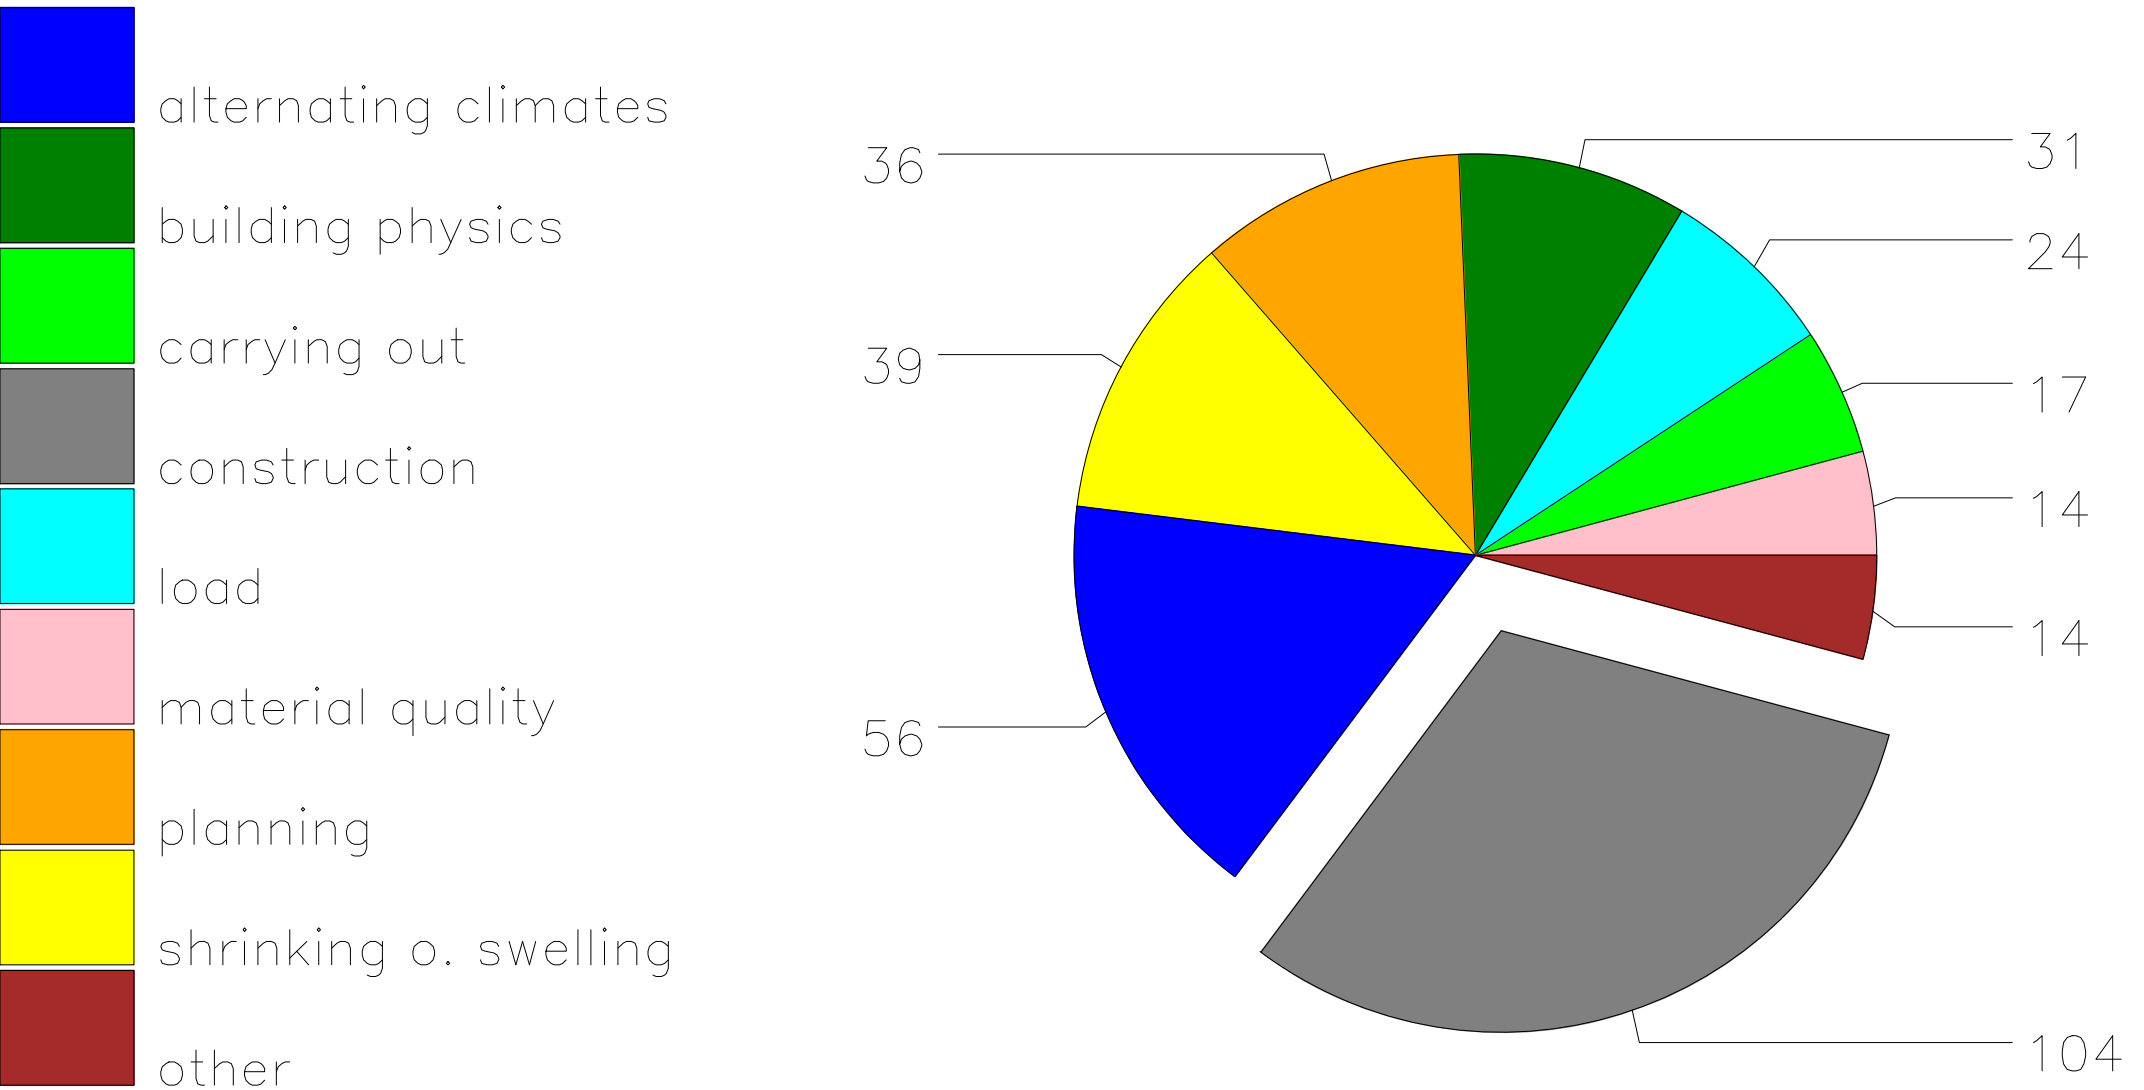
Distribution of causes of the fault, total 335 relations

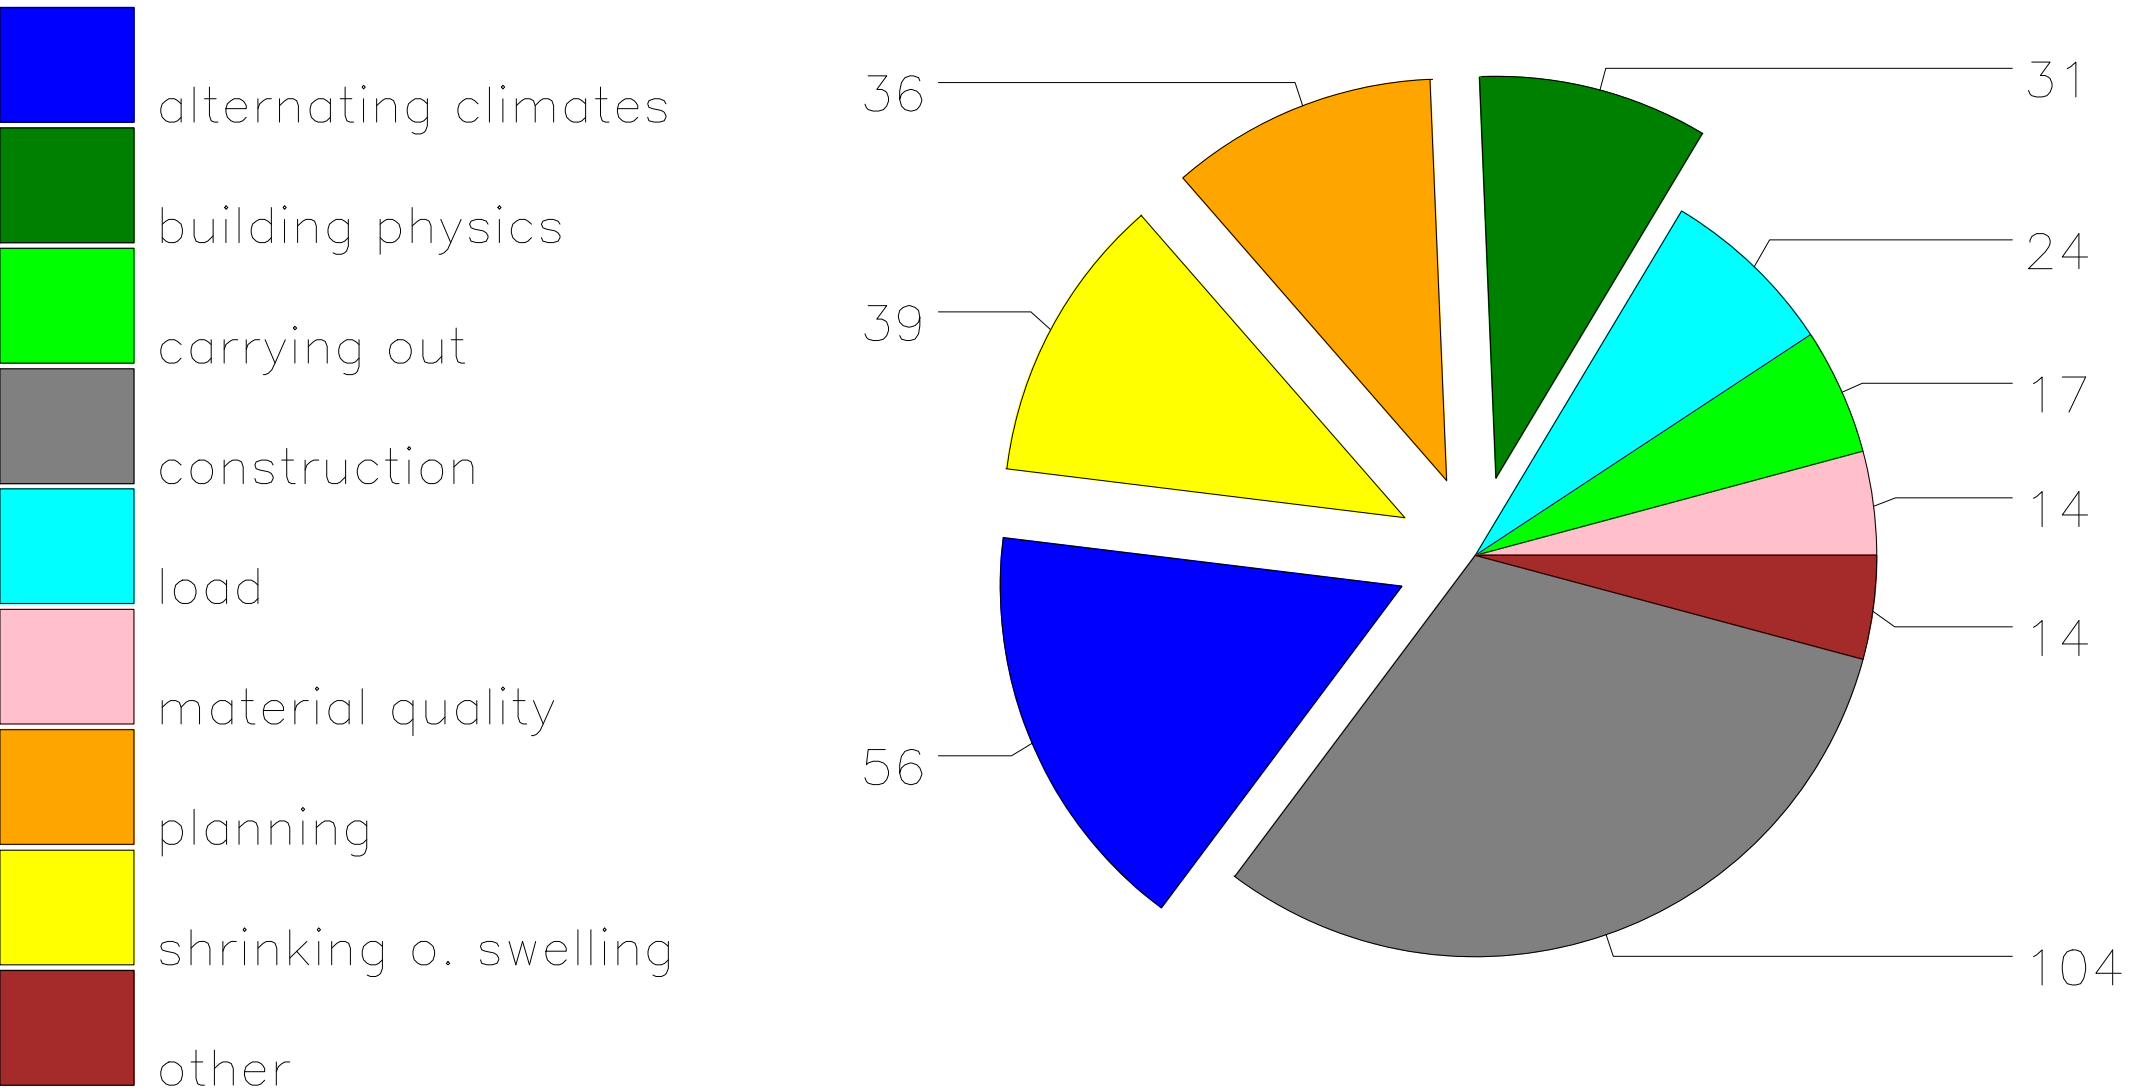
Distribution of causes of the fault, total 335 relations

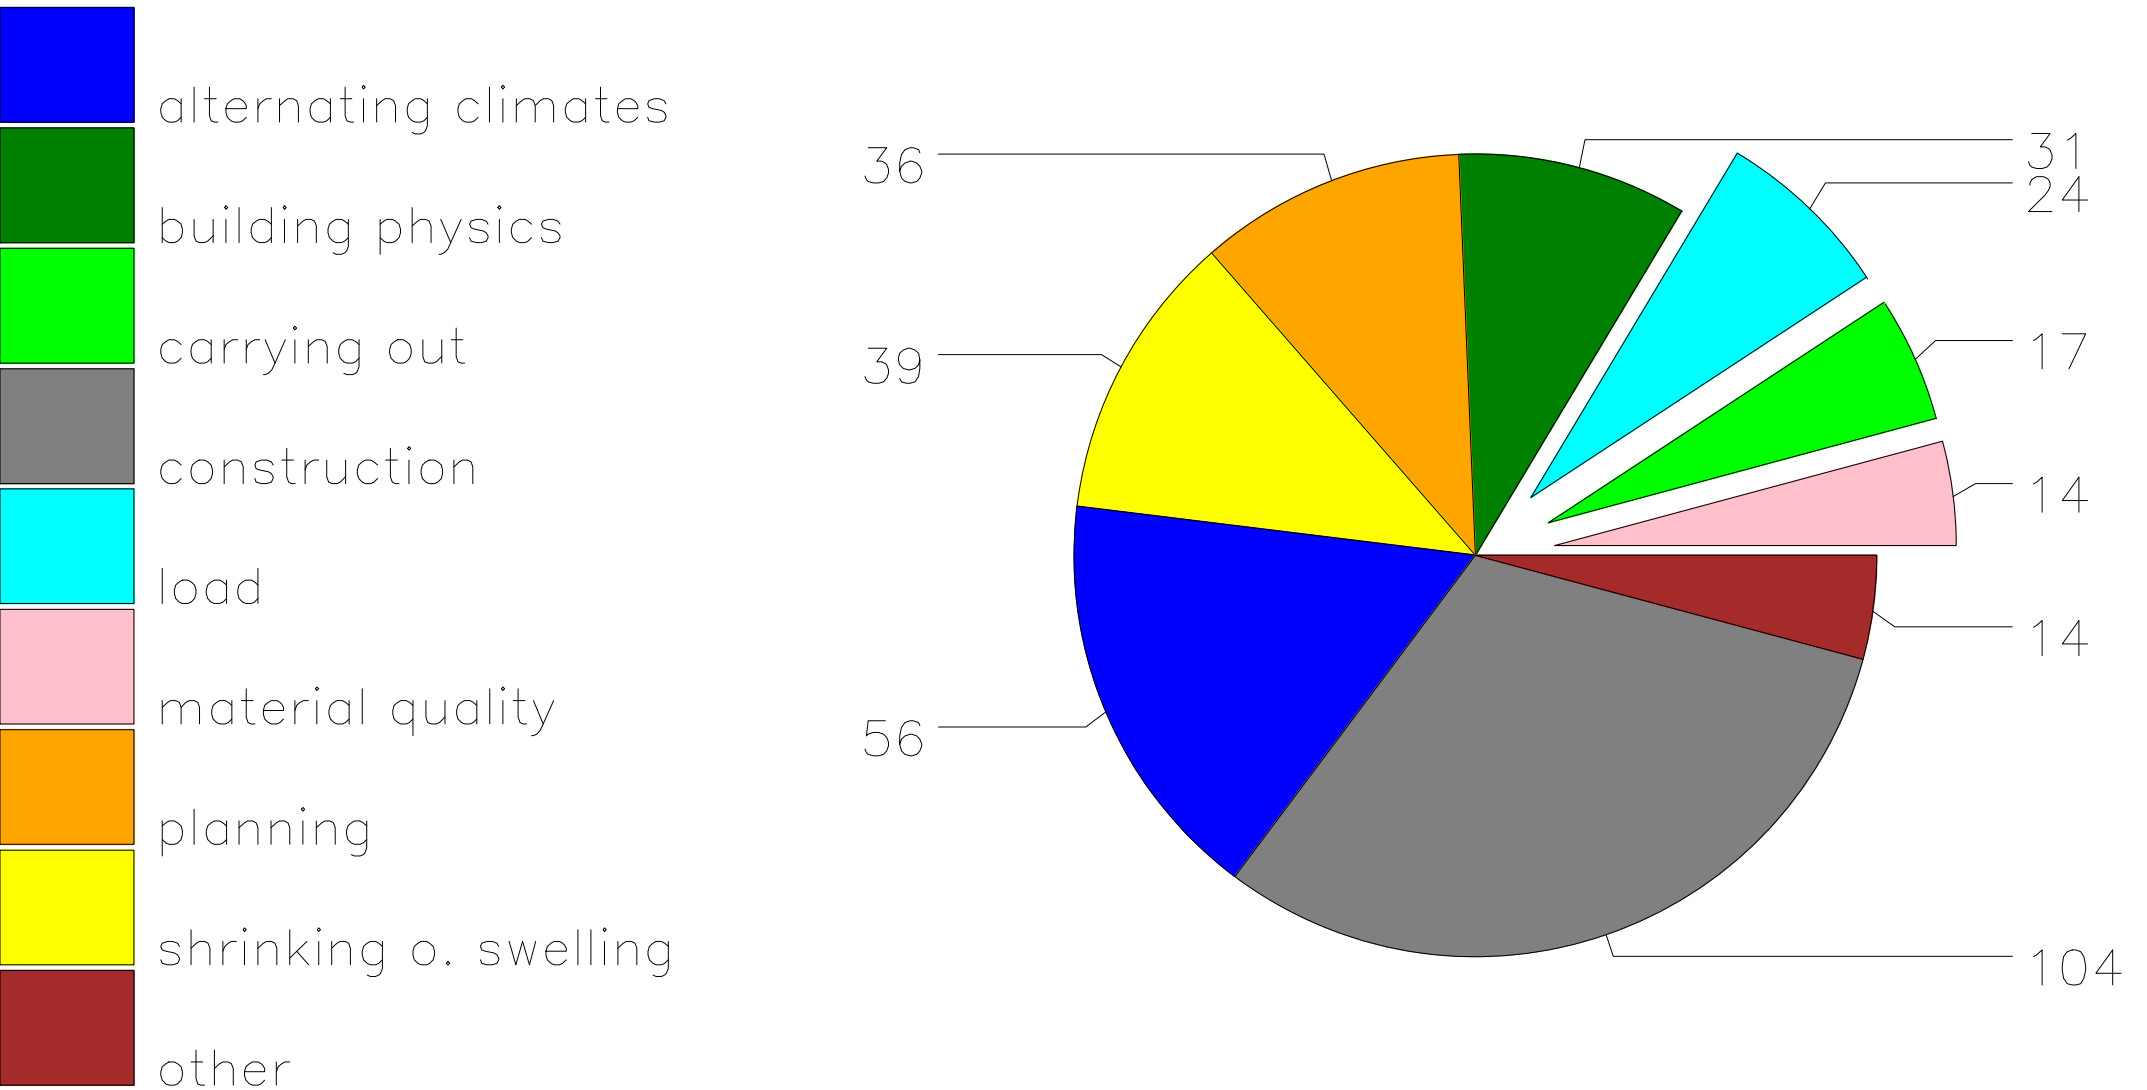
Distribution of causes of the fault, total 335 relations
