Design of safe timber structures – how can we learn from structural failures?

Collapses in Sweden 2010

Eva Frühwald Hansson
Division of Structural Engineering, Lund University

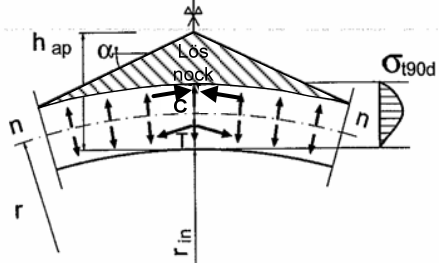
<p>Urtag SNEDSKURNA LAMELLER</p>
Tension perpendicular to grain in special beams	<p>Loose ridge</p>

<p>Screw Reinforcement</p>
