Robustness of large-span timber structures – Two examples

Jørgen Munch-Andersen Philipp Dietsch (TUM)

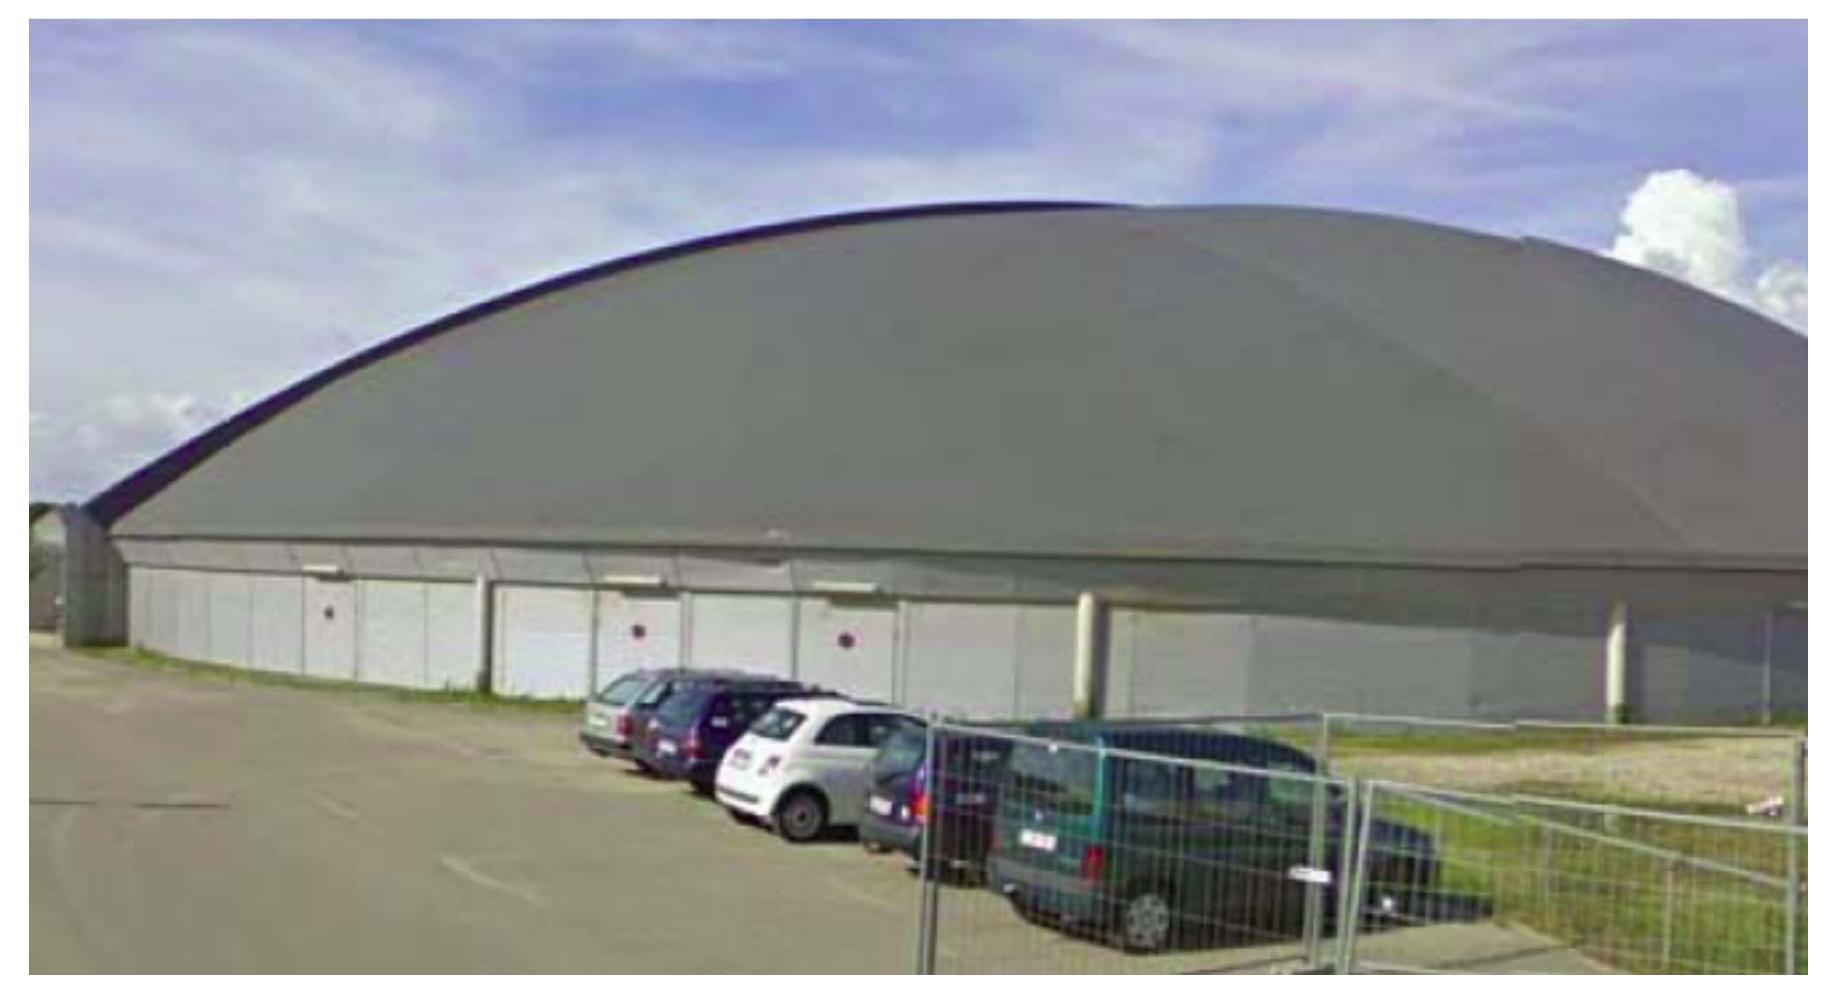
Apsis hall after collapse

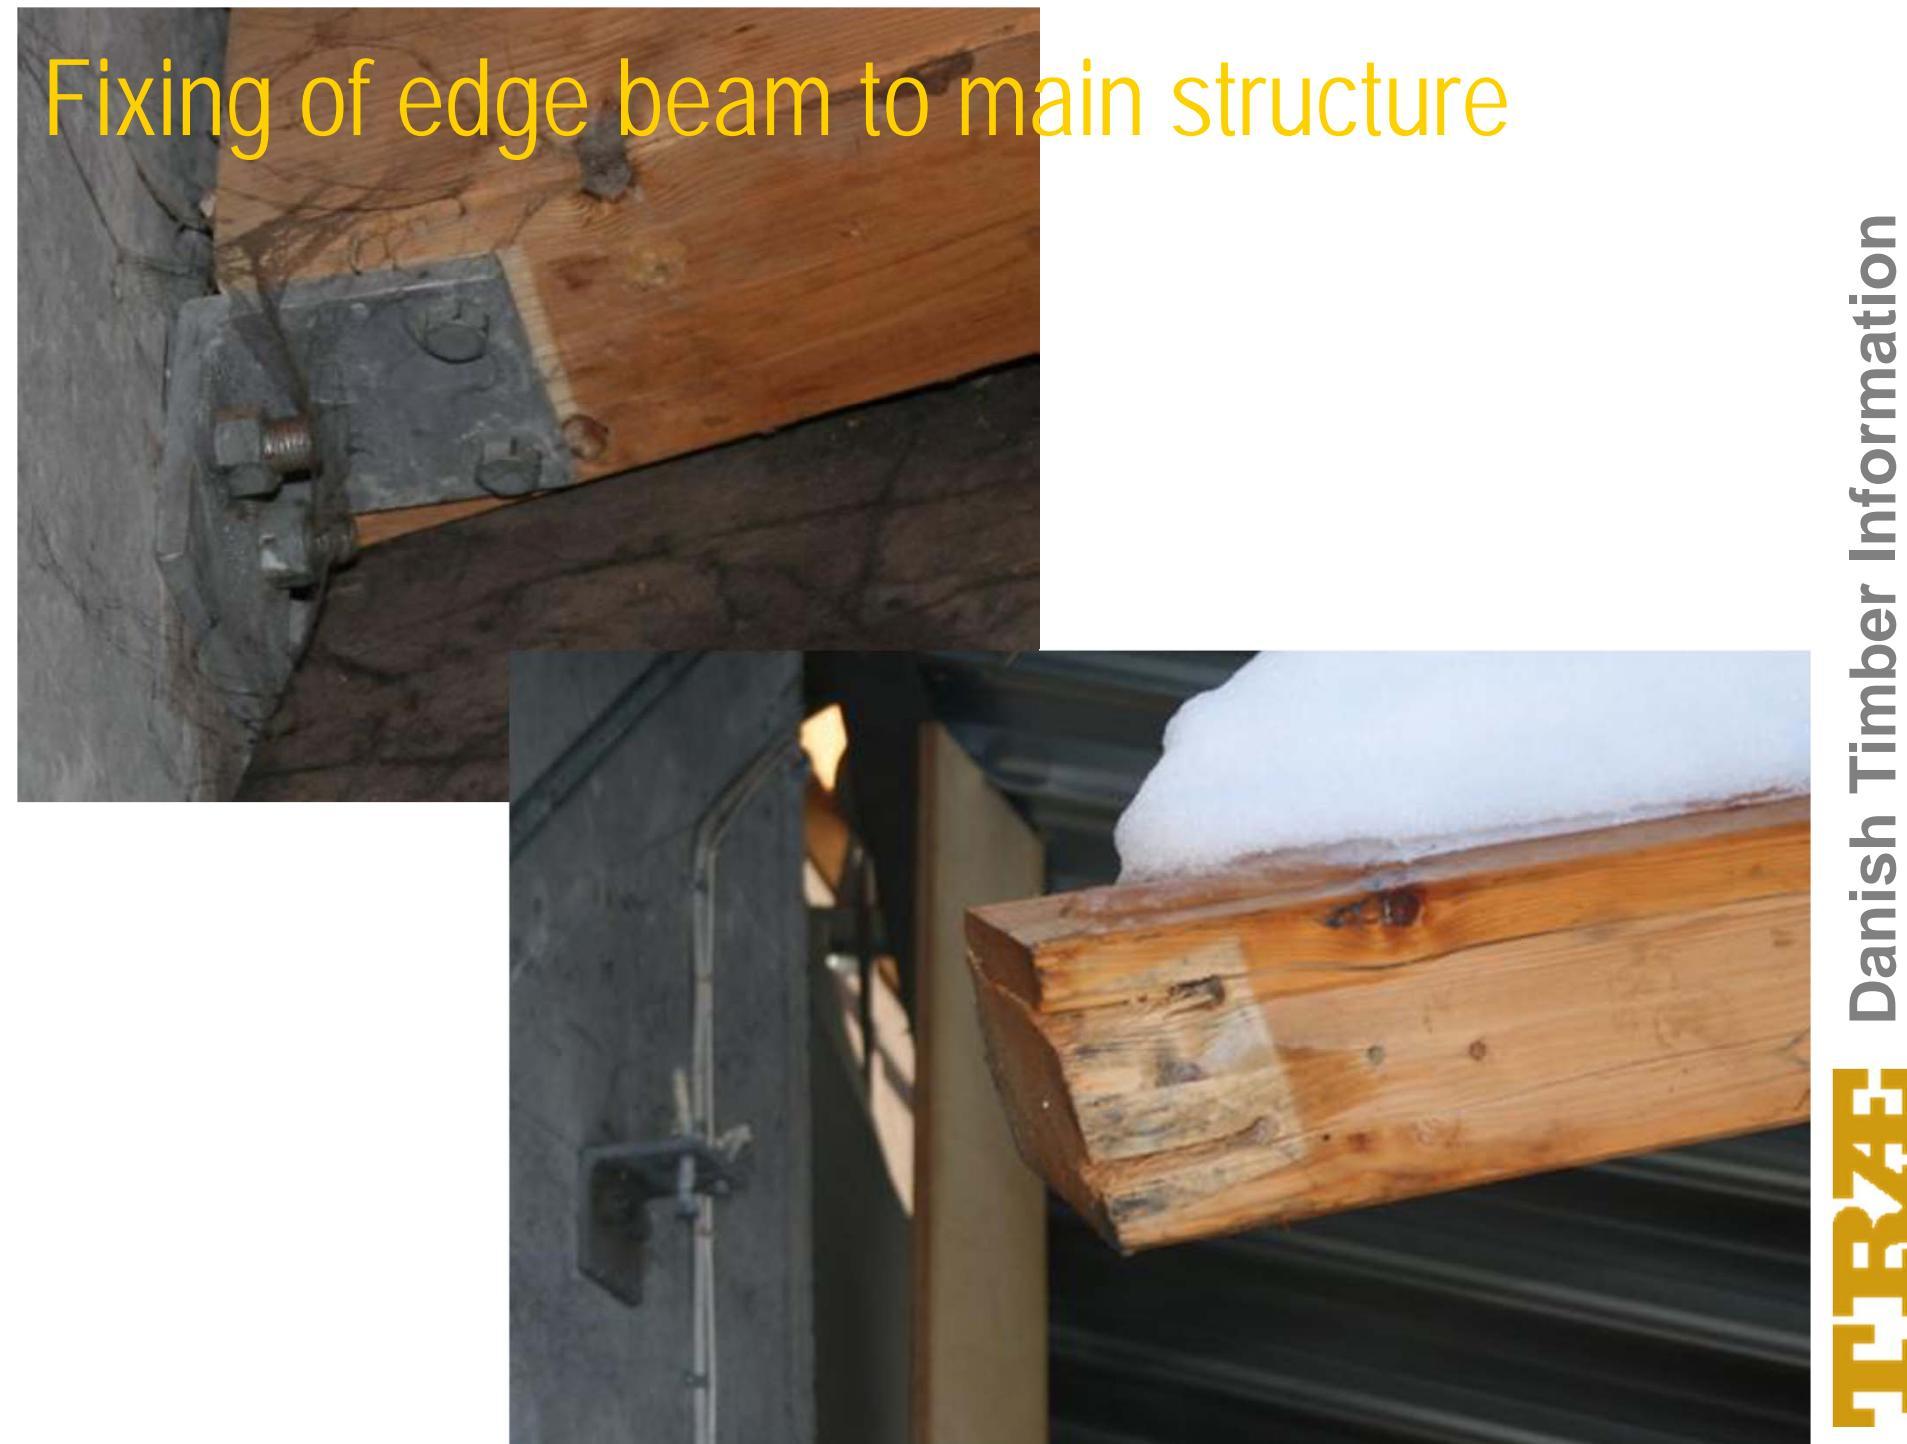
- The edge beam is a secondary structure not designed as tension cord
- Tension in edge beam converts the roof to a shell
- Failure of the edge beams fasteningincreases suddenly the actions on the main beams =>
 - 1 cracks devellops
 - 2 the curved main beams are opened a bit and moves perpendicular to the curved facade which causes torsion
- So: secondary load-carrying capacity might be dangerous! (no warning, impact load on main structure when it fails)

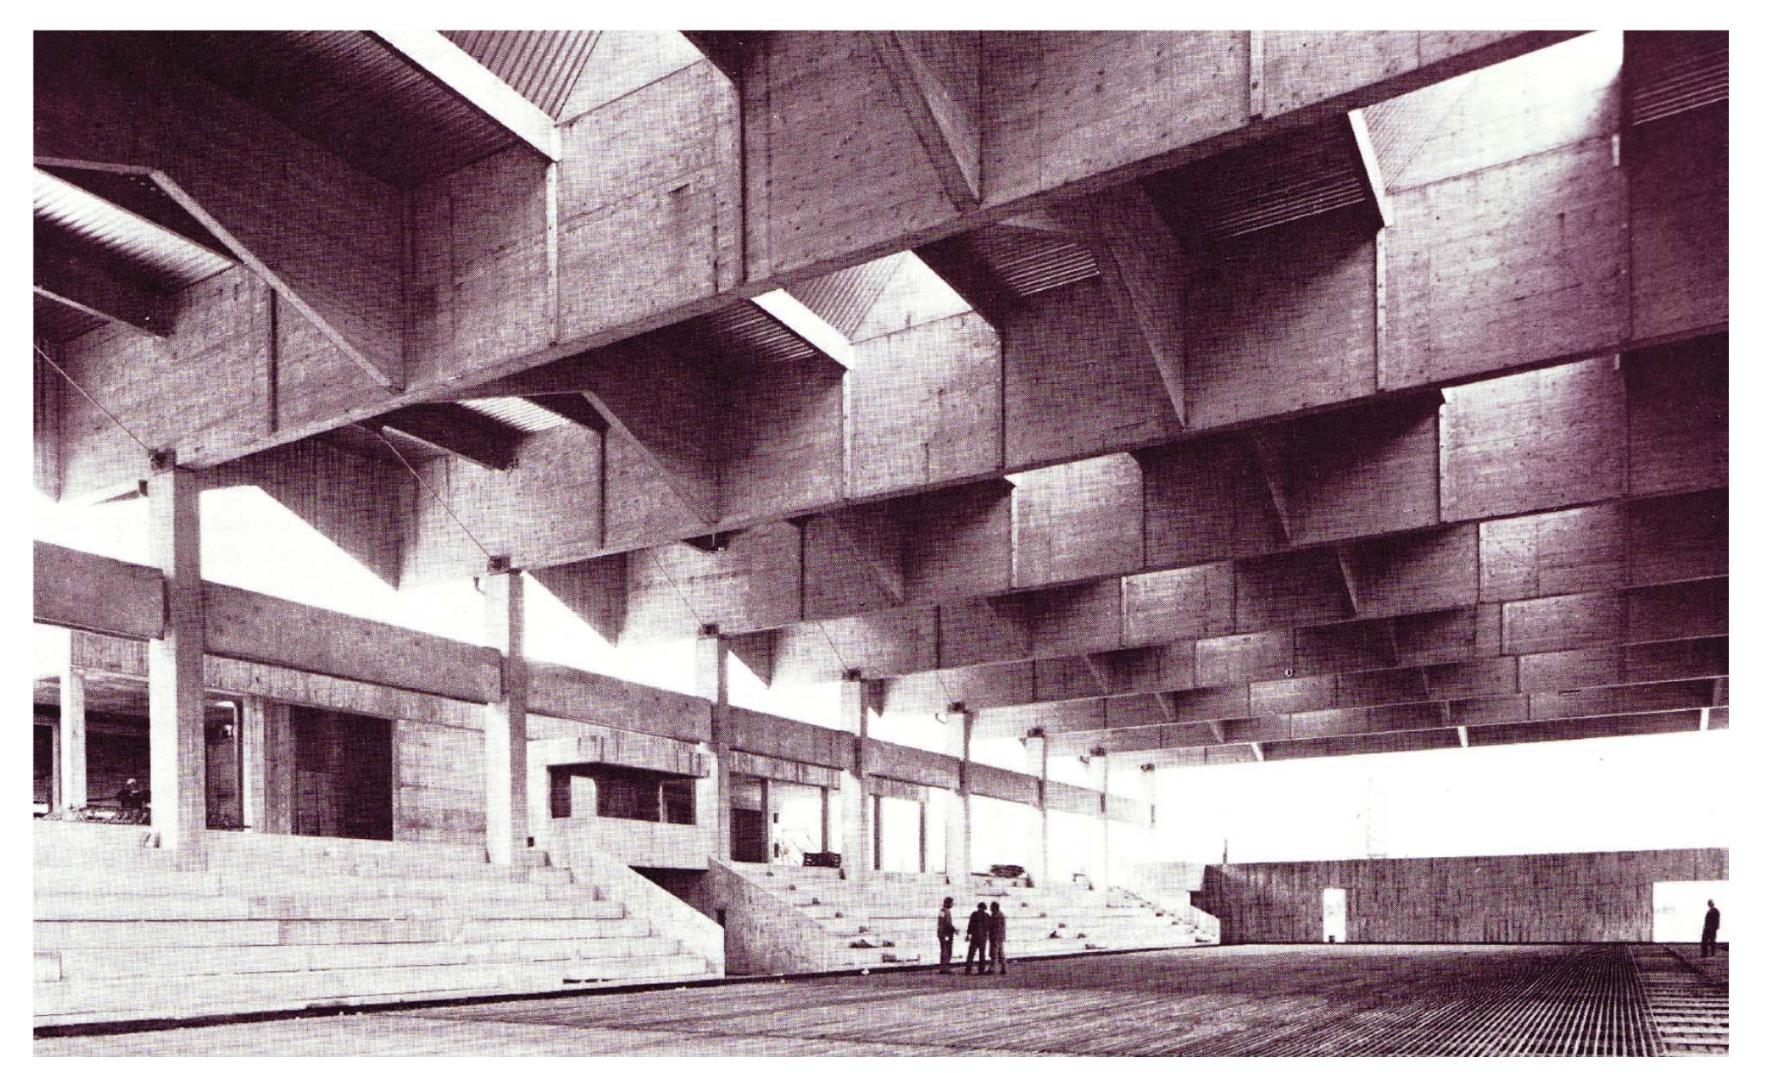
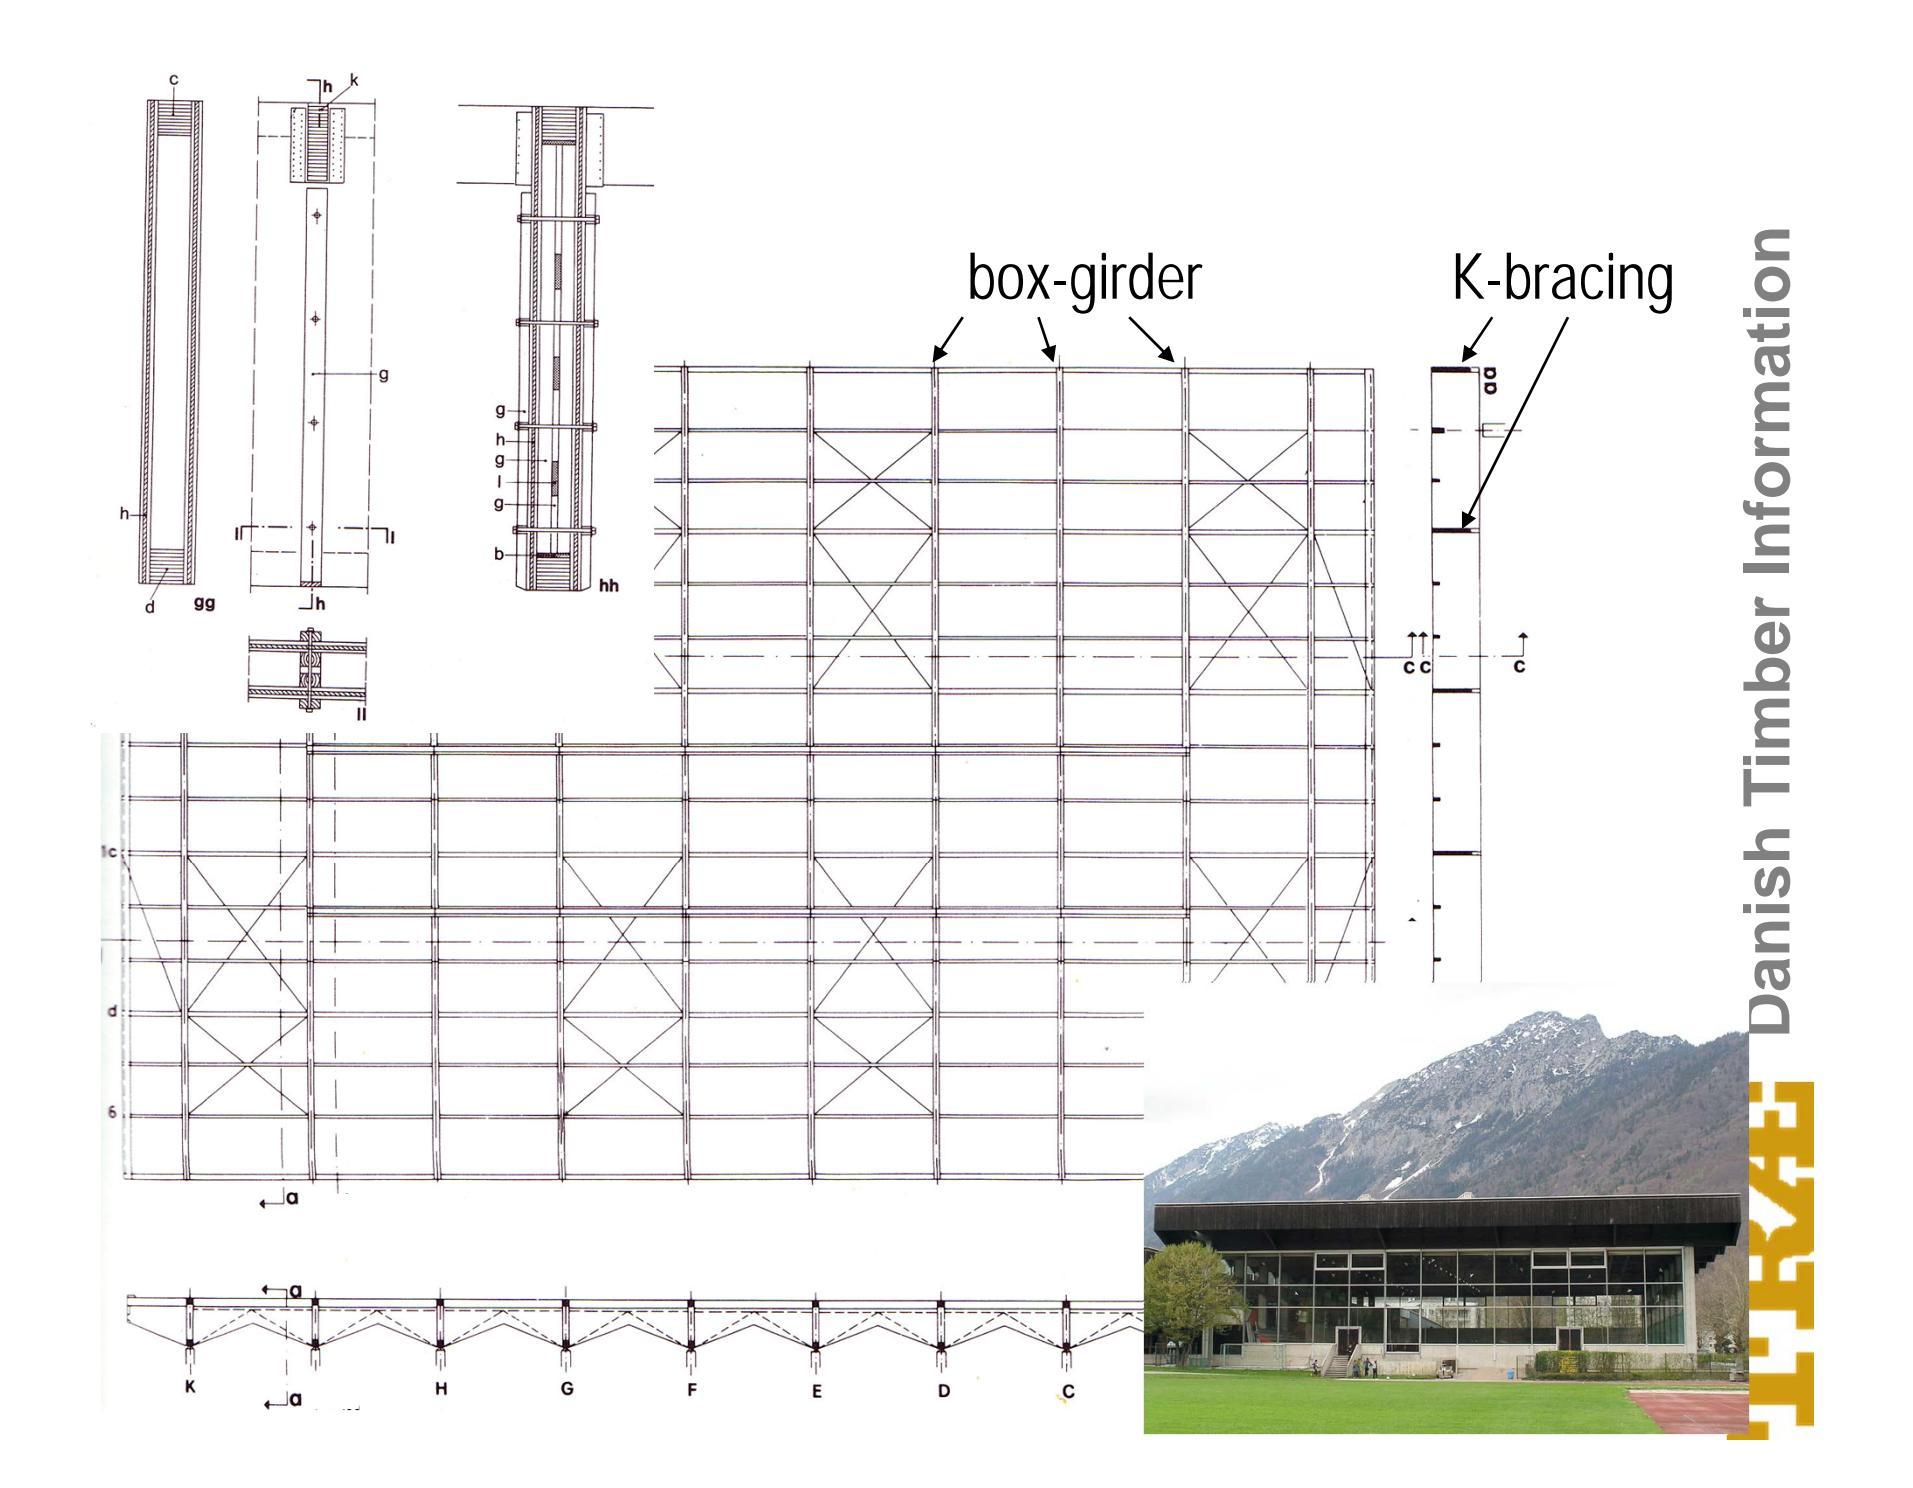
Bad Reichenhall Arena, Germany (1972) Ice-arena with 2.9 m high box-girders, span 48 m Finger joints in girders per 16 m, K-shaped bracing
