Snow storm damage in Denmark

22 February 2007

Jørgen Munch-Andersen,
Danish Timber Information Council
Jørgen Nielsen & Erik Steen Pedersen,
Danish Building Research Institute

COST E55, Helsinki 13-14 March 2008

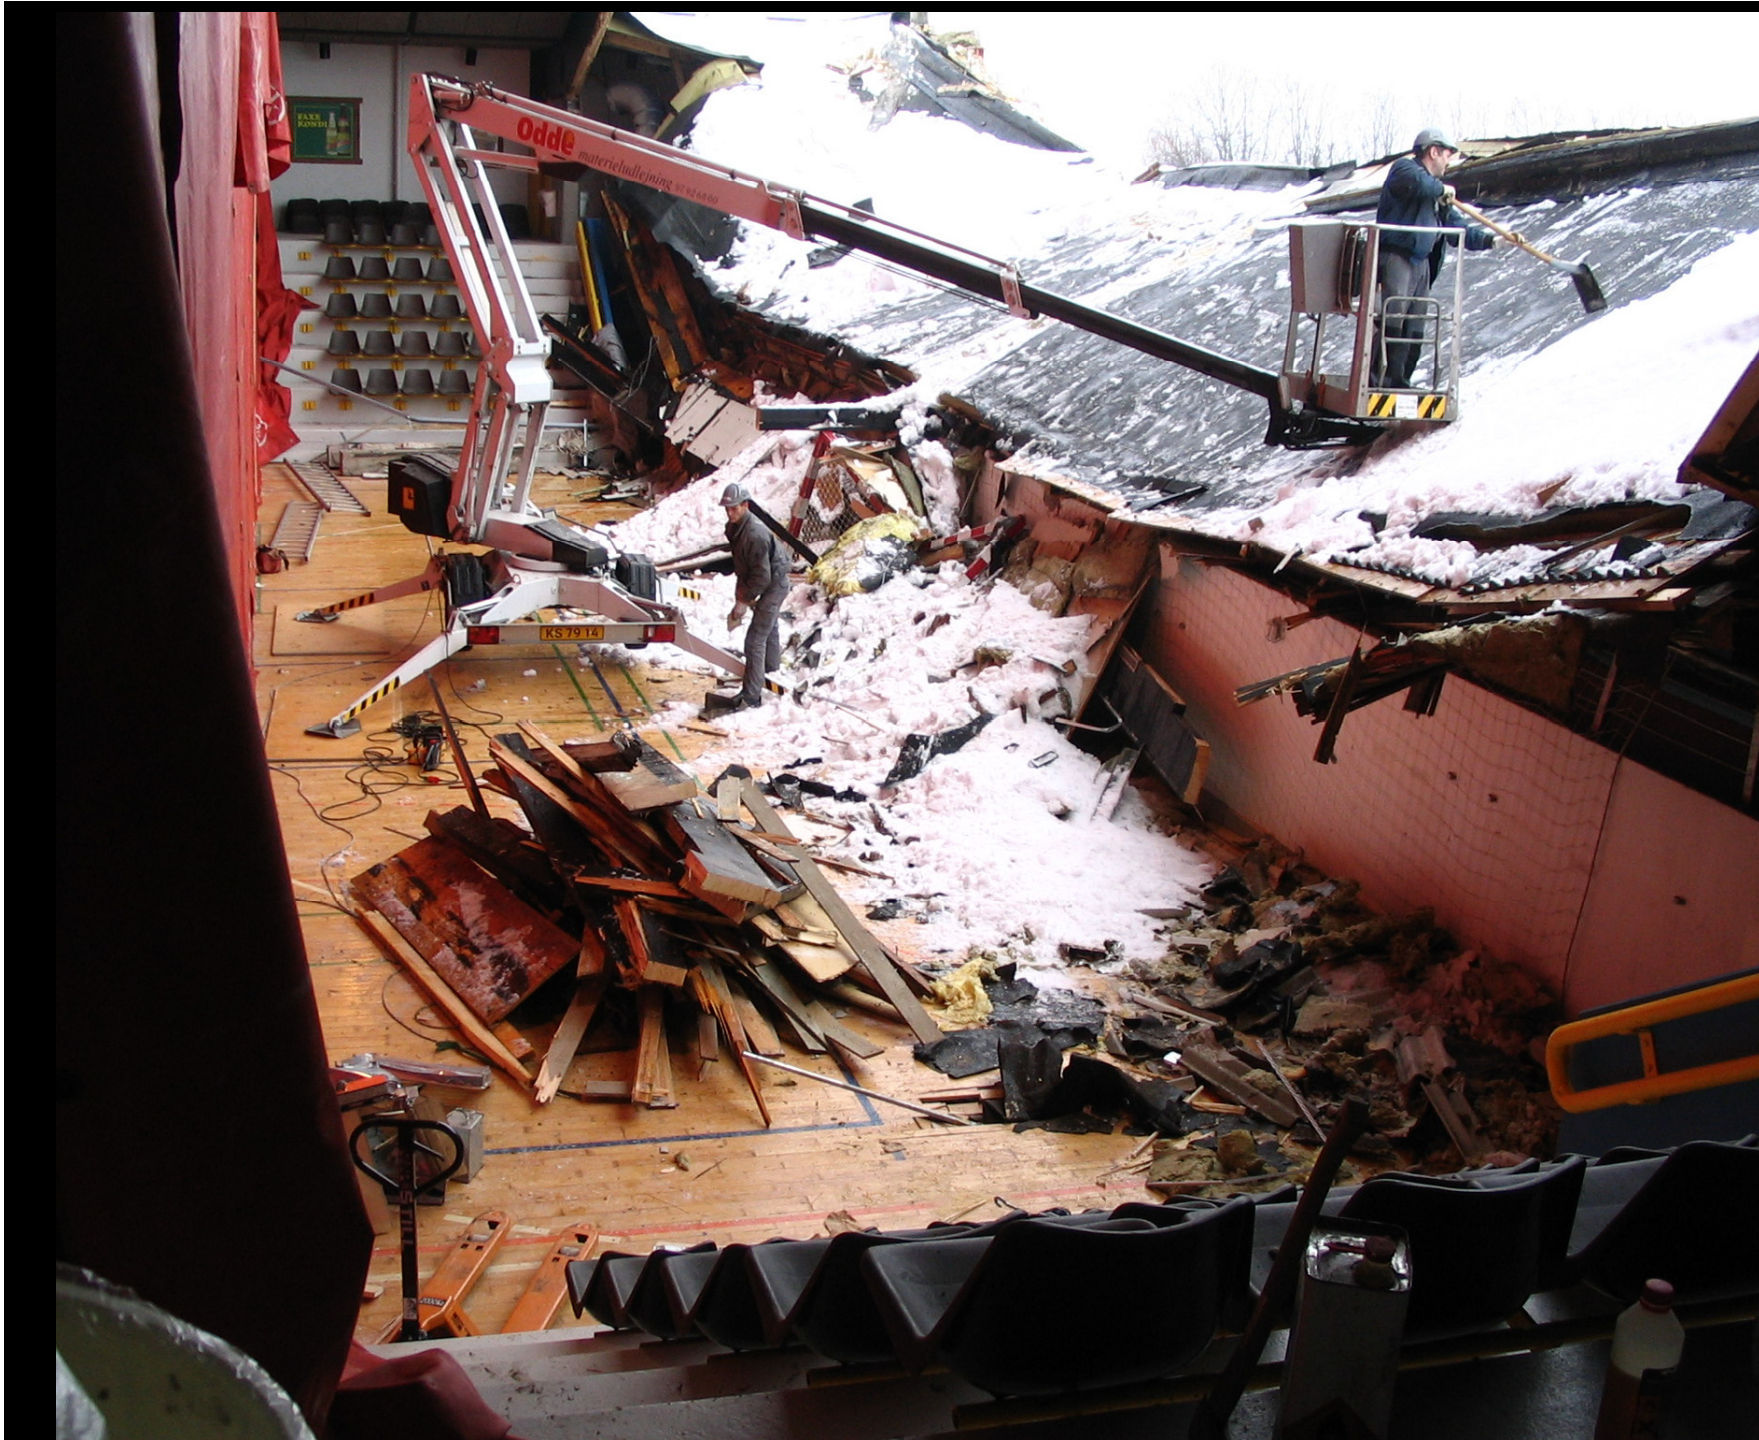
TERZÆ

Stable placed on west-side of a (later) barn

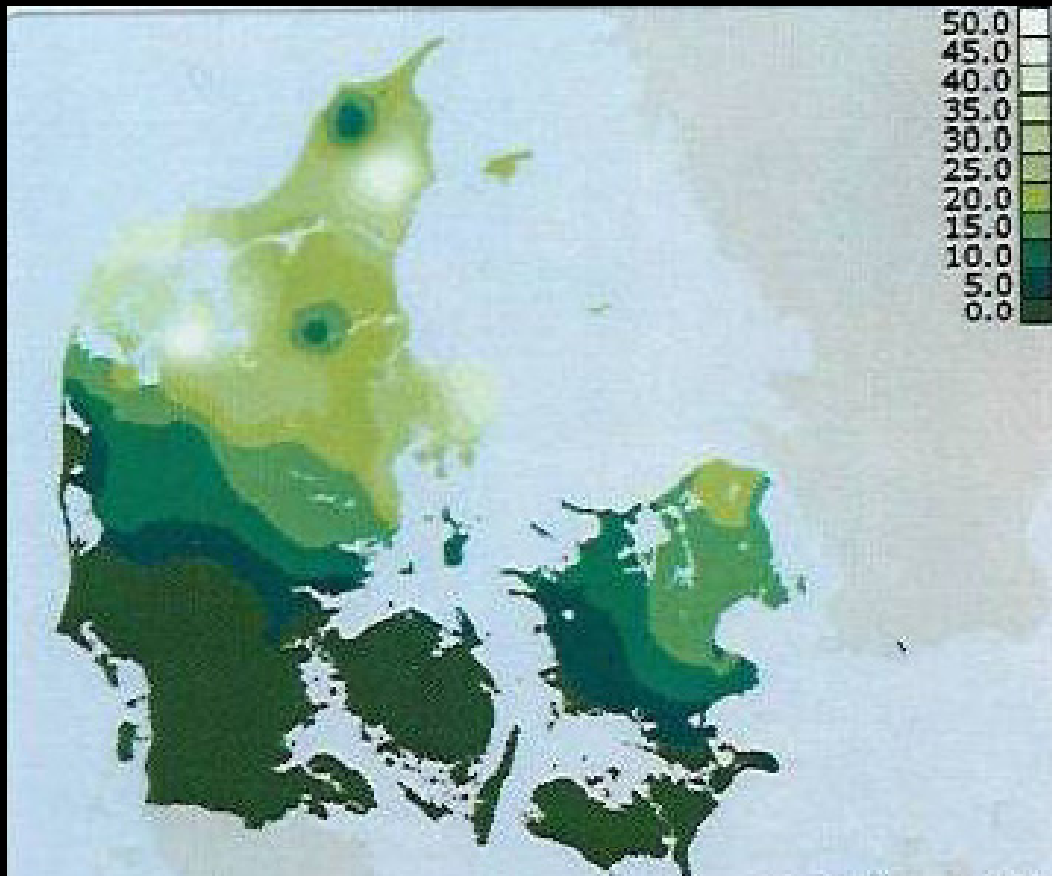
- Characteristic ground snow load in code, 0.9 kN/m^2 , might have been slightly exceeded in some places

$50 \text{ cm} \times 200 \text{ kg/m}^3$
 $\sim 1 \text{ kN/m}^2$

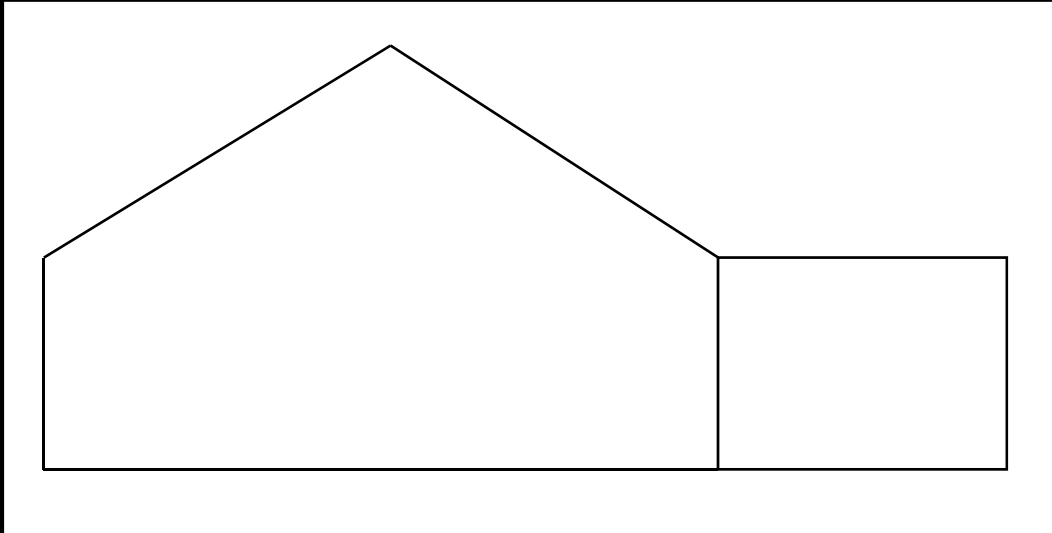
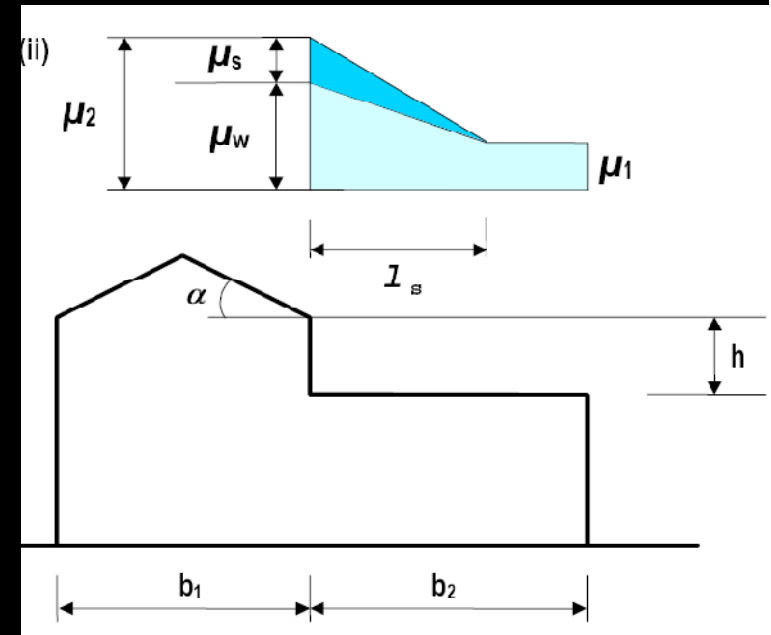
$h = 0$ and $\alpha > 0$

- Ridge height has no influence
- $h = 0 \Rightarrow$ no surcharge on either roof from drifting

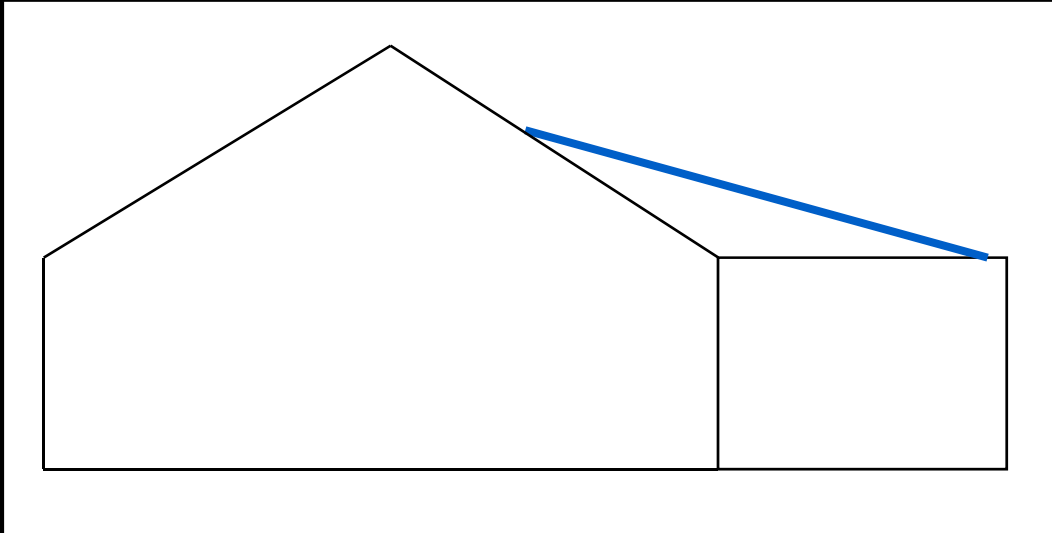
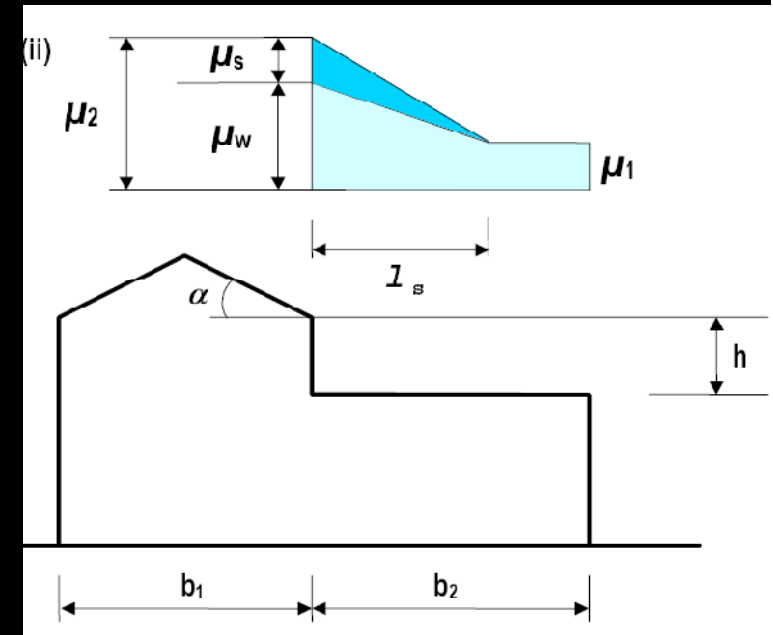
$h = 0$ and $\alpha > 0$

- Ridge height has no influence
- $h = 0 \Rightarrow$ no surcharge on either roof from drifting
- Reality: significant surcharge depending on ridge height
