# Analysis of failures in timber structures based on a Nordic project

Eva Frühwald, LTH

# project title: Innovative design, a new strength paradigm for joints, QA and reliability for long-span wood construction

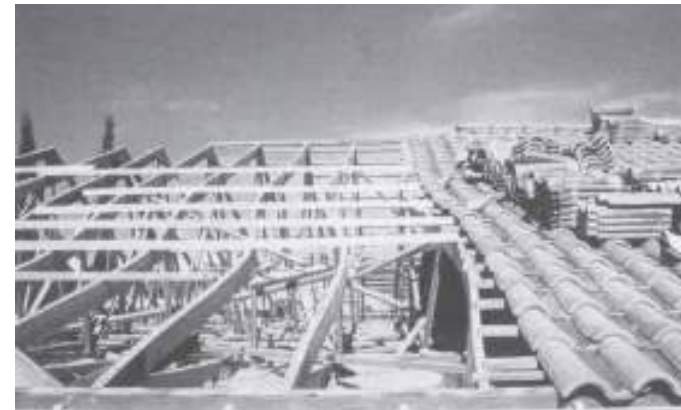
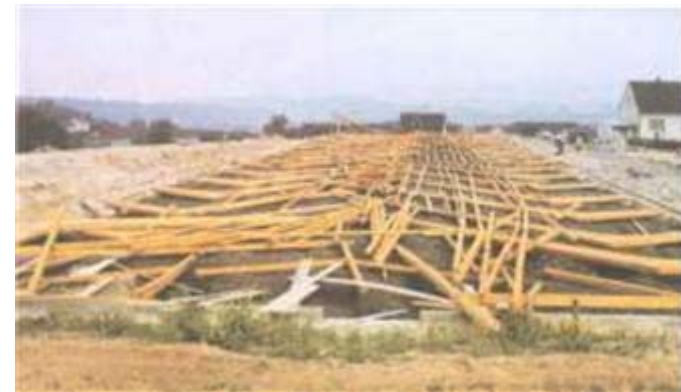
# failure modes

- **instability** 30
- bending failure 15
- **tension failure perp. to grain** 11
- shear failure 9
- drying cracks 9
- excessive deflection 7
- tension failure 5
- corrosion of fasteners / decay 4
- withdrawal of fasteners 3
- compression (buckling) 2
- other / unknown 21
