Digital image processing in the monitoring of wide-span timber roof structures

Robert Pawlowski, Klaudius Henke, Heinrich Kreuzinger, Stefan Winter

This paper focuses on ways of employing digital image processing in the monitoring of buildings to gauge deformations in wide-span timber roof structures in conjunction with the electronic measuring of snow loads. The practical implementation of digital image processing is introduced and discussed using a pilot project for a gymnasium in Bavaria as an example.

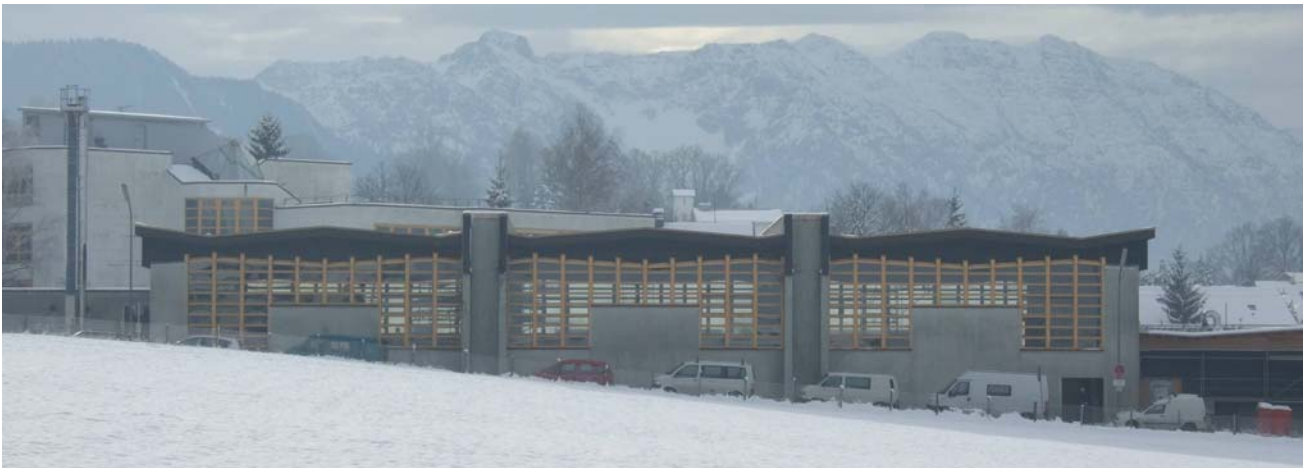
Fig. 3 Gymnasium in Bavaria, Germany

The outer dimensions of the gymnasium are: $W / L / H = 31.55 / 46.08 / 10.00$ m.

The roof structure of the gym consists of the following supports:

- Roof decking, Pos. H1:
Roofing slabs made of particle boards (FPP) according to DIN 68763, thickness $d = 38$ mm.
- Auxiliary beams, Pos. H2:
Glulam BS14 (GL28c), cross-sectional dimensions $W / H = 145 / 650$ to 1400 mm, span (single span girder) $L = 13.01$ to 14.20 m, axial distance $e = 1.25$ m.
- Main beams, Pos. H3:
Glulam BS14 (GL28c), two-beam cross-sectional dimensions $W / H = 2 \times 300 / 2650$ mm, span (single span girder) $L = 31.25$ m.

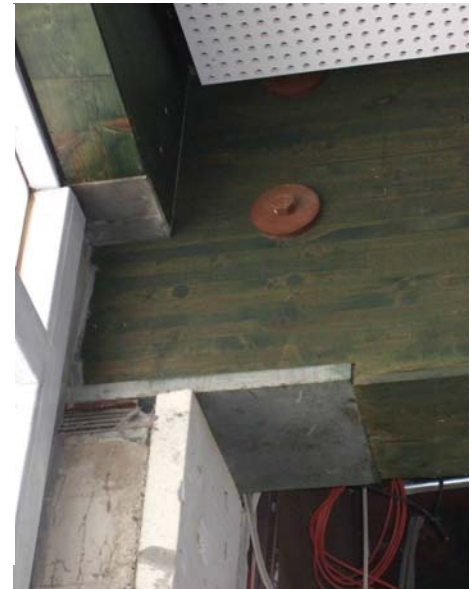
Fig. 5 Main beam Pos. H3 – detail of support

- Main beam support:
 It is not possible to verify the support for the main beam (Pos. H 3.1) according to DIN 1052:2004-08. The operating ratio on the support according to DIN 1052:2004-08 taking the drift pins present in the joint into account (4 pins $\varnothing 20 \text{ mm}$, S 235) is $\eta = 1.60 > 1.00!$
- Main beams (Pos. H 3.1 and H 3.2):
 The operating ratio of the main beam for the full snow load on the roof and on the high beams Pos. H 3 is $1.09 > 1.00$.
- Auxiliary beams (Pos. H 2.1 and H 2.2):
 The operating ratio of the auxiliary beam is $\eta = 1.00$.

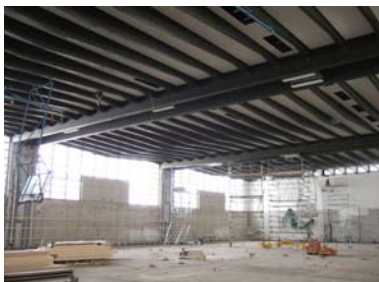
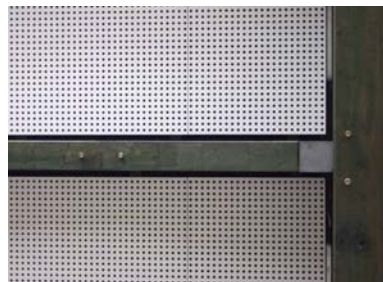
Fig. 6 Main beam Pos. H3 – cross-section with connecting auxiliary beam Pos. H3
