# What is a robust construction?

*Jørgen Munch-Andersen, Danish Timber Information, 2008-08-01*

## Siemens Arena

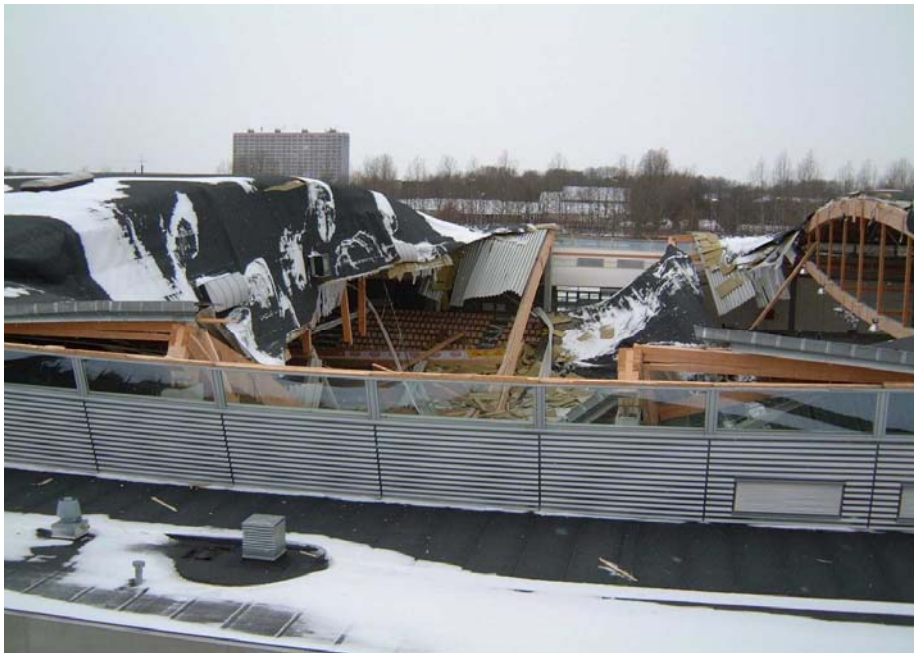
Figure 1. The roof of Siemens Arena after the collapse of two trusses. An intact truss is seen to the right.

On one morning two trusses in the roof of Siemens Arena suddenly collapsed, see Figure 1. It happened just a few months after the inauguration of the arena and a few days before a major bicycle event should have taken place.

Each truss was composed by two glulam timber arches with vertical connectors, see Figure 1. The upper arch was mainly exposed to compression and the lower to tension. The horizontal component of the tension and compression forces were neutralised at the corner connections by concealed steel plates connected to both arches by embedded dowels and a few bolts, see Figure 2. The structure appeared as an elegant slim construction with a free span of 73 metres across the arena. The failure occurred suddenly at a time with almost no wind and only a few millimetres of snow.

The 12 m long purlins between the trusses were only moderately fastened, such that a failure of one truss should not initiate progressive collapse. This strategy proved to work fairly well as only two of the 12 trusses collapsed. As all trusses had much lower strength than required it might be fair to conclude that the extent of the collapse was *not* disproportionate to the cause.

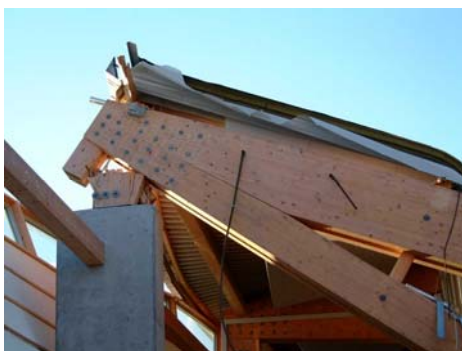
Figure 2. The corner where concealed steel plates connects the timber parts. Between the visible bolts numerous dowels are placed.

- A 48% too high design strength was used for the timber part
- The reduction of the height of the cross section near the ends of the arches, see Figure 2, was not considered
- The holes in the timber for steel plates, bolts and dowels, see Figure 3, were not considered
